SHIPPING ENCAPSULATED CS-137 SOURCES AS SPECIAL AND NORMAL FORM

E.D. Robbins
Westinghouse Hanford Company

D. Carlson
Chem-Nuclear Environmental Services, Inc.

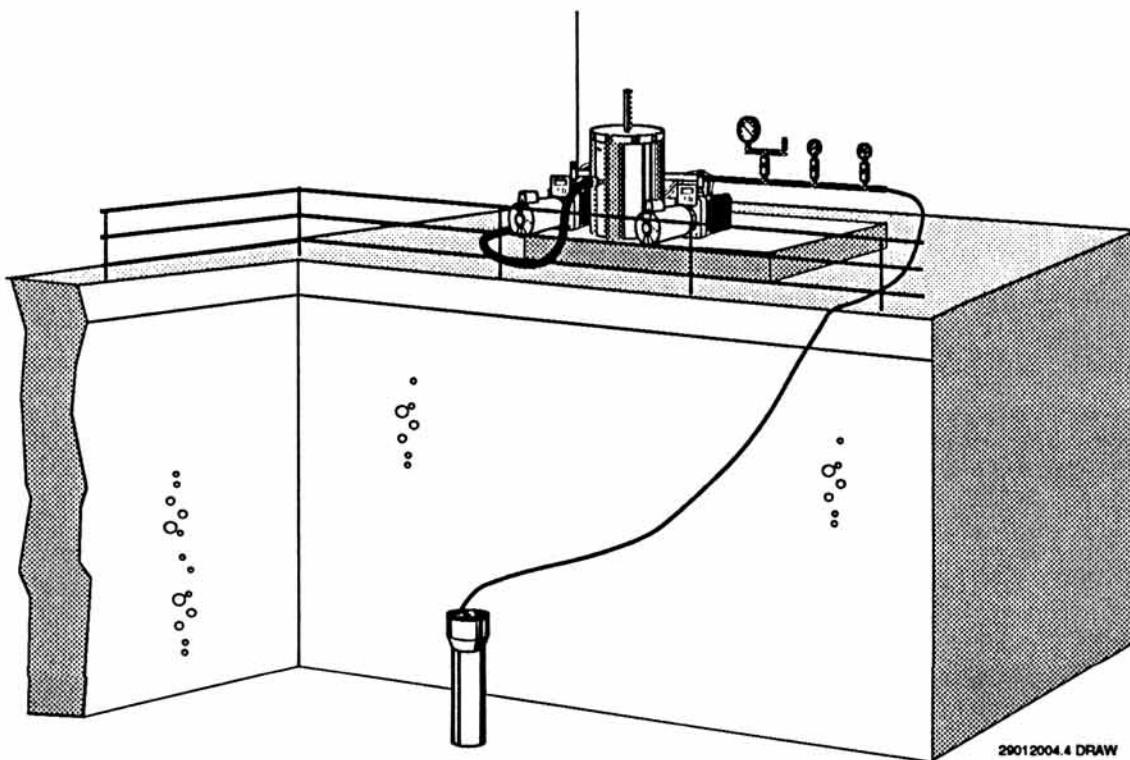
Fig. 3b. Dry vacuuming of new special form canister.

removed. The canister is vacuumed using the same method as the Model GE-600 overpack (Fig. 3b).
