## CHARACTERIZATION OF TANK 241-Z-361

A. M. Hopkins, L. J. Olguin, D. M. Bogen, Fluor Hanford, Inc.;  
S. E. Clarke, U.S. DOE; S. C. Adams, IT Group

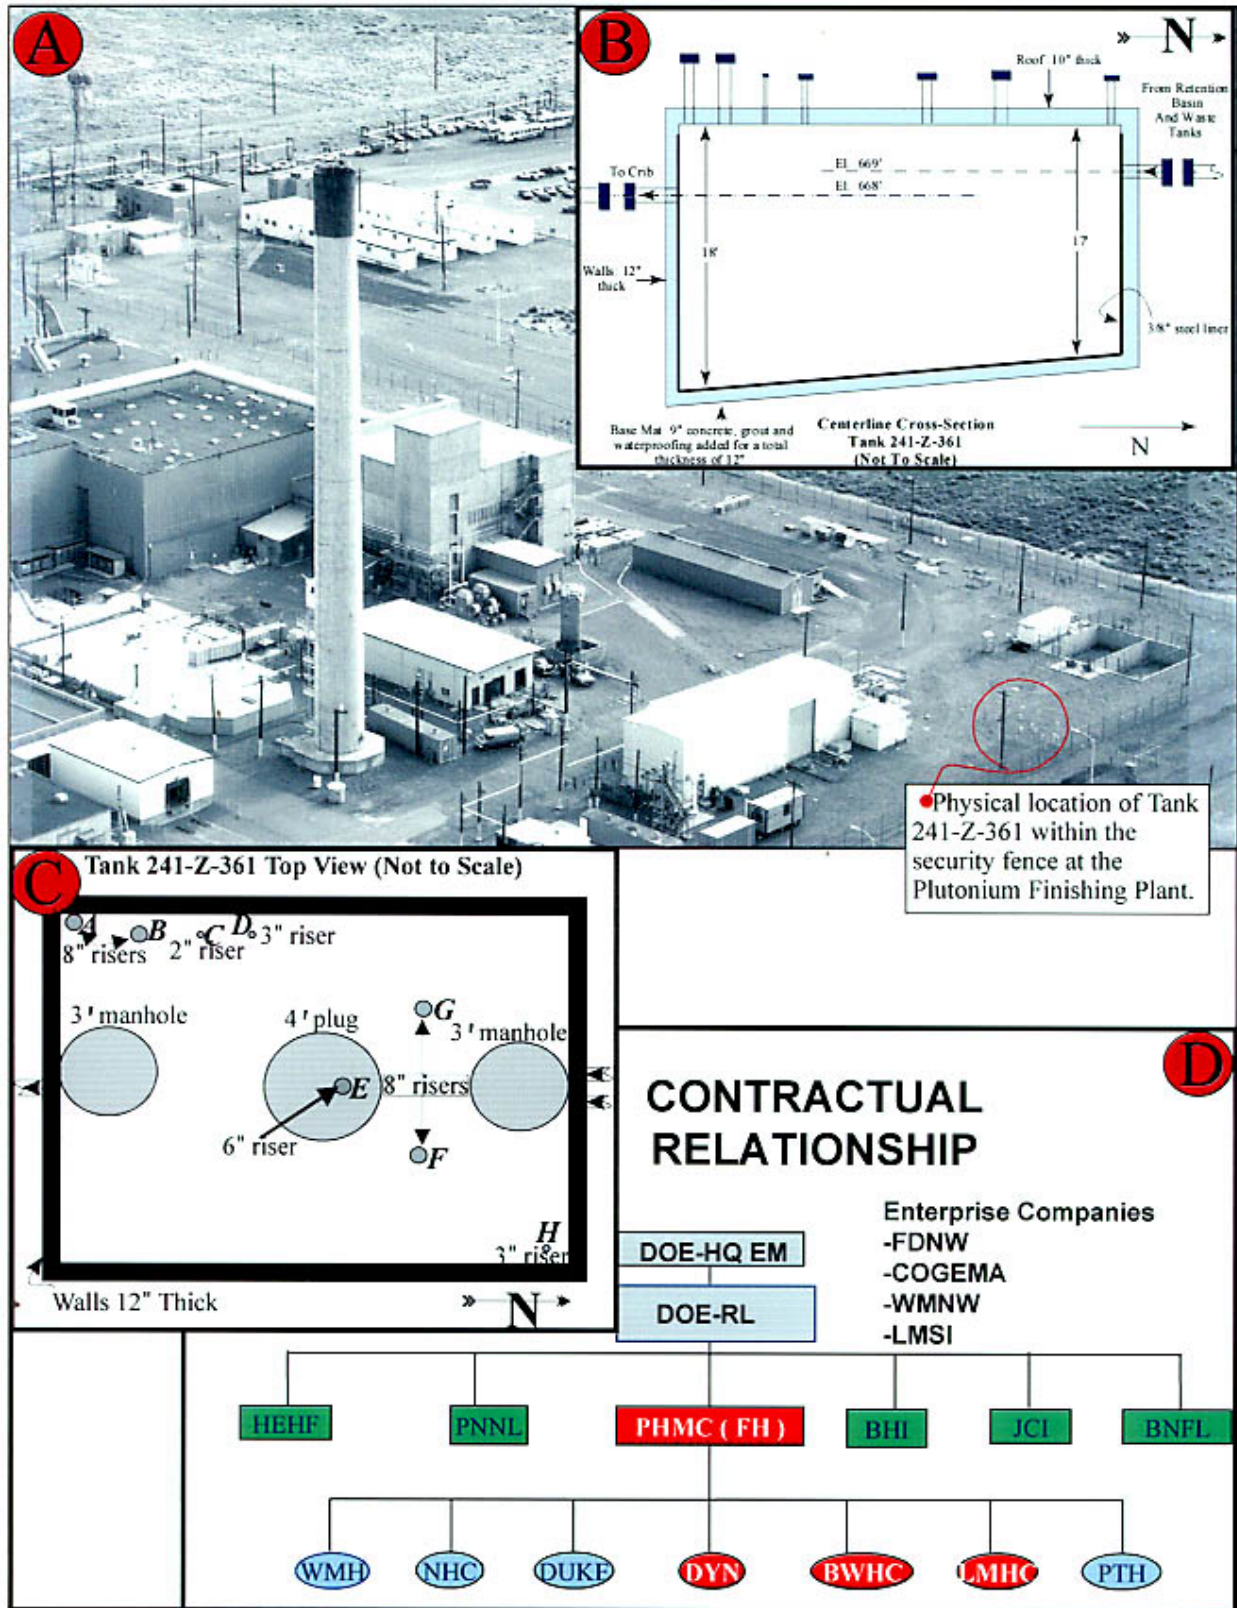
**Figure 1:** A, Physical location within PFP; B, Centerline cross-section of tank; C, Top view of tank; D, Contractual relationship to perform Phase I and II documentation and field activities.

As a result of corrosion, the liner plate below the former liquid level appears to be absent down to the sludge.. One of the south end 20 cm (8") risers had a dry well installed, and it is also corroded away. The inlet and outlet pipes have been isolated and plugged or flanged two feet from the outer wall of the tank. The reinforced concrete poured over the top of the tank has been removed over the two manholes and the tank was opened for sampling in the mid-1970's. The manhole covers were subsequently reinstalled, covered with weather covers and buried. The tank is covered with approximately two feet of soil.

Starting with the presumption that the tank was at ~190,000 Pa (13 psig), a series of calculations were performed to determine flow rates vs. the size of the opening. The 7.6 cm (3") riser in the NE corner of the tank was selected for opening and breather filter installation (Figure 1C, riser H). If that riser were opened 1.6 mm (1/16") all around the flange, the flow rate would be 0.182 m<sup>3</sup>/sec (385 cfm). Since 1.6 mm (1/16") is a very small opening and no portable glovebag could withstand this kind of pressure drop, another means of opening the tank had to be devised. The work had to be performed in a glovebag, with operators and craft on breathing air, so any method chosen had to be relatively simple to implement, and also foolproof to avoid an uncontrolled release. The method developed by LMHC involved installation of a pipe band around the flange (Figure 3A), wedges that could be screwed into the pipe flange gap, and a valved orifice sized to release gas at a controlled rate. A glovebag test was developed to determine how much flow could pass through the filtered glovebag without over pressurizing it. A flow rate of 0.0033 m<sup>3</sup>/sec (7 scfm) caused the glovebag to "balloon" slightly, but would not cause the glovebag to fail. This flow rate was used to calculate the orifice size in the flange band (Figure 3 [B,C&D]).
