## **The MacArthur Maze Fire: How Hot Was It? - 9223**

Christopher S. Bajwa, Earl. P. Easton, and Darrell S. Dunn  
U.S. Nuclear Regulatory Commission  
Washington, DC 20555

### **ABSTRACT**

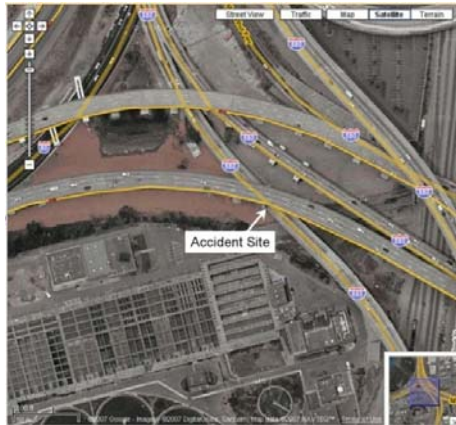
**Fig. 1. Aerial photograph of I-880 and I-580 Interchange**

The accident occurred on Sunday morning, April 29, 2007, in an area commonly known as the "MacArthur Maze", a network of connector ramps that merge highways I-80, I-580, and I-880 in Oakland, California. The fire that eventually led to the overpass collapse started at about 3:38 a.m. when a gasoline tanker truck carrying 32,500 liters [8,600 gallons] of gasoline crashed and caught fire. The tanker truck was heading south along I-880 at the time of the accident. While nearing the I-580 overpass, the vehicle rolled onto its side and slid to a stop on the 50-foot-high ramp connecting westbound I-80 to southbound I-880.
