## **Managing Radiological Accidents: A Responder's Perspective - 11362**

Ella B. McNeil, Manager  
Transportation Emergency Preparedness Program  
Office of Transportation, U.S. Department of Energy  
Washington, DC 20585

### **ABSTRACT**

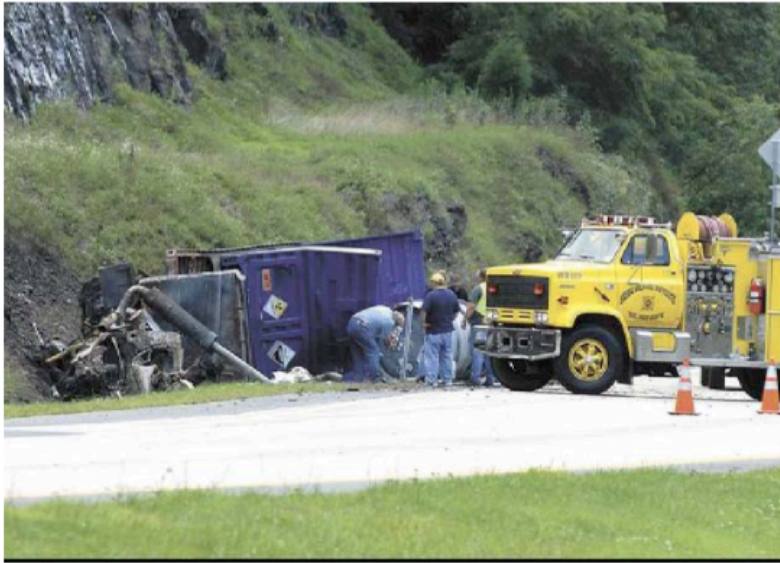
**Figure 3 – Fire Department responders from Beckley, WV were glad they went through MERRTT training before responding to an actual event involving uranium hexafluoride.**

rock embankment, overturned, and caught fire. The driver escaped before the cab of the truck burned. The fire did not affect the UF<sub>6</sub> cylinder, which separated from the trailer. The transport originated at the Honeywell Metropolis Works facility in Metropolis IL, and was headed to Portsmouth, Virginia, for export to a company in the Netherlands. The drivers of both the tractor-trailer and the pickup truck involved in the accident
