Single-Shell Tanks Leak Integrity Elements/ SX Farm Leak Causes and Locations - 12127

ABSTRACT

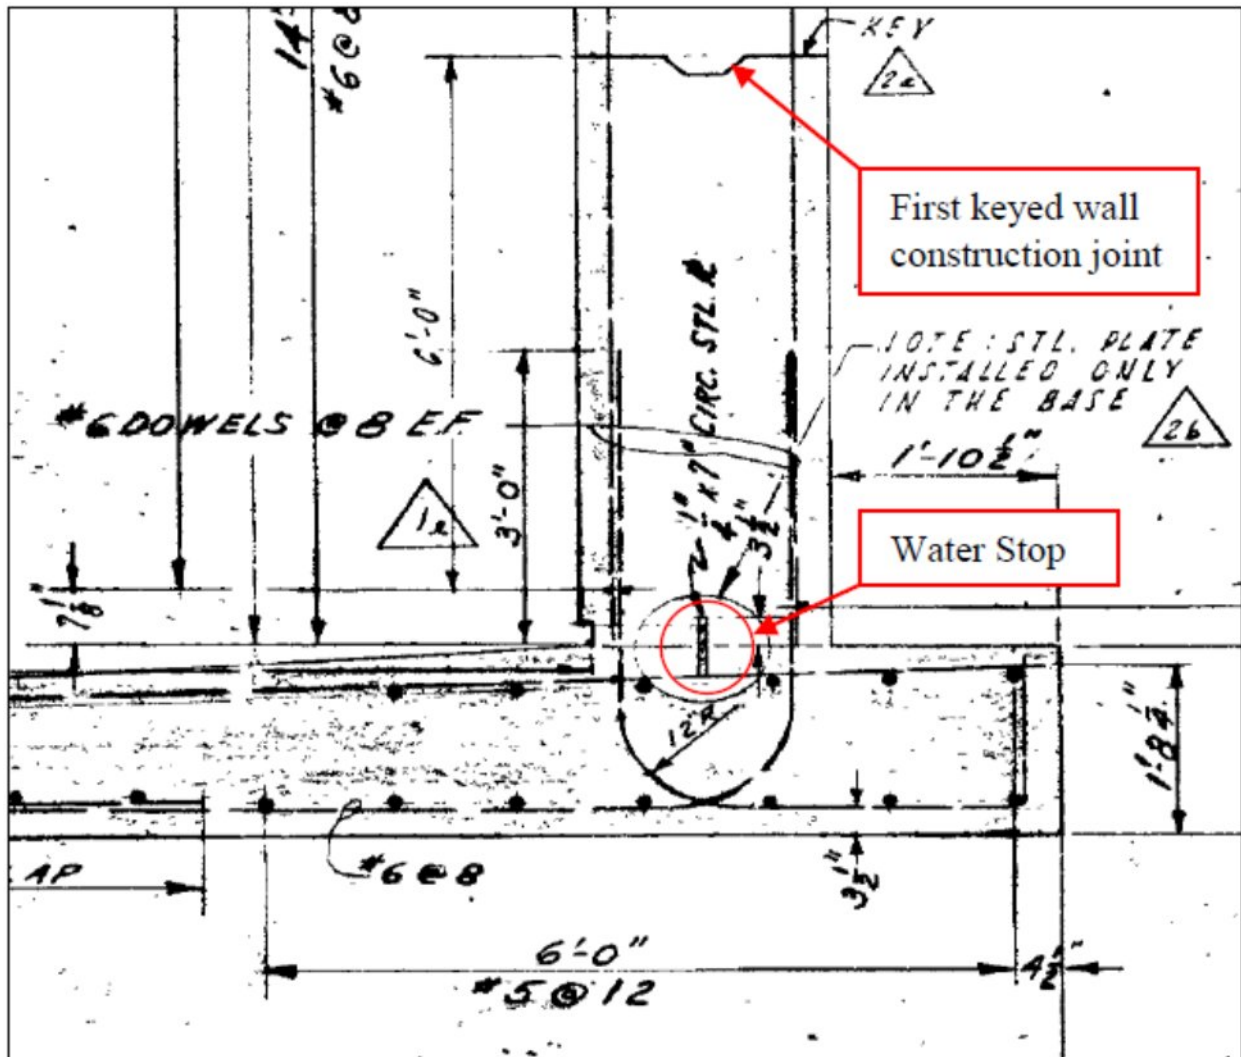
Figure 2. SX Farm Base Footing and Wall Reinforcing [10]

The steel bottom of the SX Farm tanks intersects the sidewalls orthogonally rather than the knuckle transitions in earlier designed tank farms [9]. The SX Farm tank footing to the first keyed wall construction joint is shown on Figure 2 [10]. This figure shows the orthogonal intersection between the dished bottom and the sidewall, water stop at the base footing to wall construction joint and other details. The 7-in wide water stop at the footing construction joint is 2 ¼-in above the joint and 4 ¾-in below the joint. The earlier 241-BCTU tanks notched footing construction joint does not incorporate a water stop.

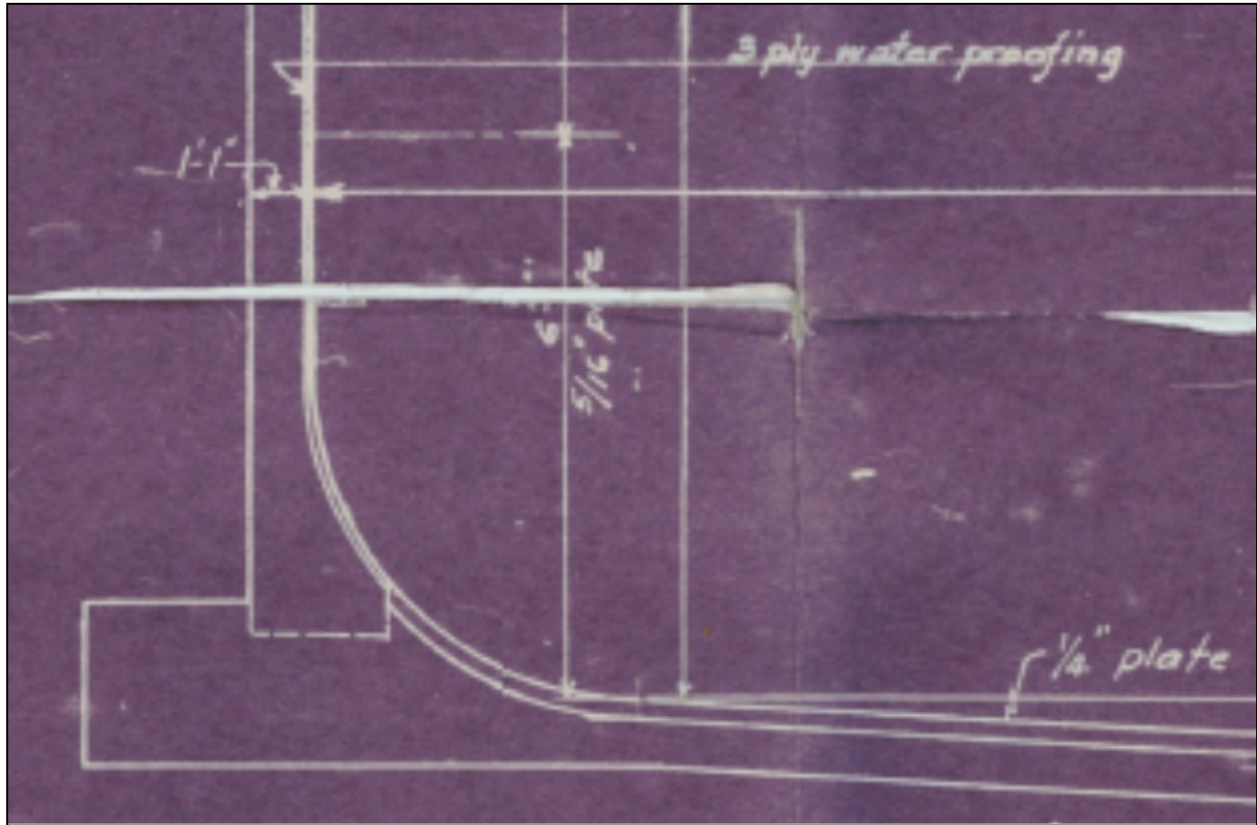
Figure 4. B C T U Farm Tank Knuckle Configuration w/3 Ply Waterproofing [9]

Figure 3 shows the detail of the orthogonal intersection between the bottom and the sidewall with a fillet weld between the bottom and sidewall orthogonal intersection [6]. Full penetration butt welds for BCTU Farm tanks are shown in Figure 4 for the rounded knuckle configuration [9].

The three ply asphaltic membrane waterproofing between the liner and the concrete shell was eliminated from the design of the SX Farm tanks (see Figure 3). An asphaltic membrane was incorporated between the concrete footing and the grout below the liner. The design for BCTU Farm tanks for comparison is shown in Figure 4 which shows the rounded knuckle configuration with the bottom, knuckle, and sidewall three ply water proofing.
