“The Accident at Fukushima: What Happened?”

February 27, 2012

Takao Fujie
President and Chief Executive Officer
Japan Nuclear Technology Institute (JANTI)

WM2012 Conference, February 26 – March 1, 2012, Phoenix, AZ, USA

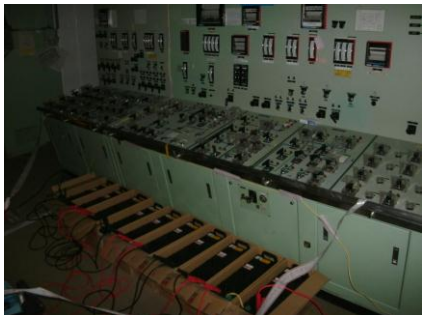
Temporary Batteries

Since instrument power in the main control room had been lost, it was impossible to monitor the status of the reactor. Station personnel now carry heavy batteries from within the power station into the main control room as power supplies for important instruments, such as the reactor water level gauge.

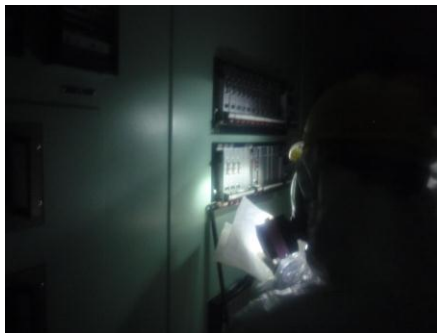
Operator

An operator uses a flashlight to read one of the instruments that was brought to life, using the temporary batteries. Normal communication systems have been rendered inoperable and only the emergency hotline between the main control room and the emergency response center could be used, which greatly impaired accident response efforts.

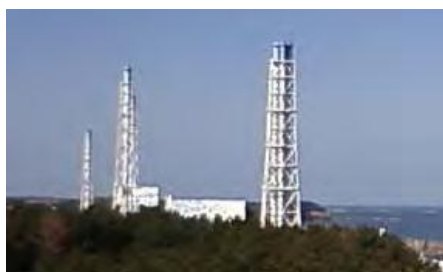
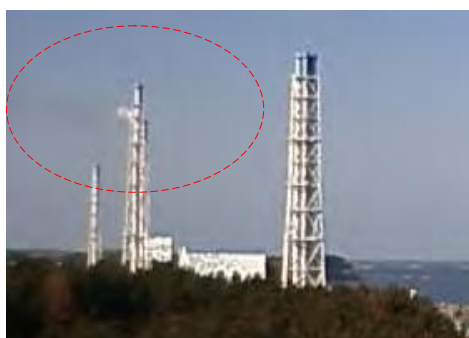
Major Activities at Unit 1 - PCV Venting

Because the pressure inside the containment vessel continued to rise, attempts were made to vent containment vessel pressure for fear of damage. However, since surrounding radiation levels were extremely high and there was neither power nor air to activate the drive mechanisms, it became extremely difficult to open the valves in the vent line.

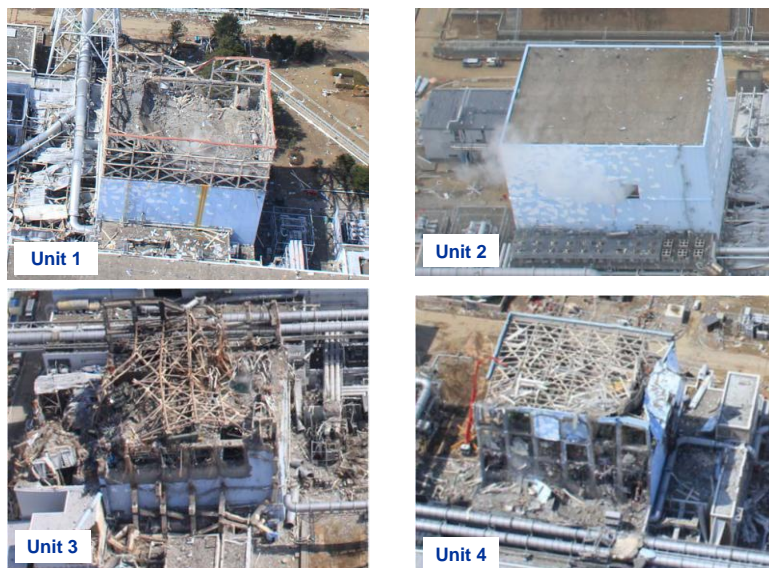
Units 1 - 4 after Hydrogen Explosions

This was taken on March 15, four days after the accident, and shows the condition of the reactor buildings of Units 1 through 4. With the exception of Unit 2, other reactor buildings all show extensive damage due to the hydrogen explosions.
