Observation and Responses to Post-Closure Instances of Localized Instability and Subsidence at the DOE Legacy Management Rocky Flats Site, Colorado—13052

ABSTRACT

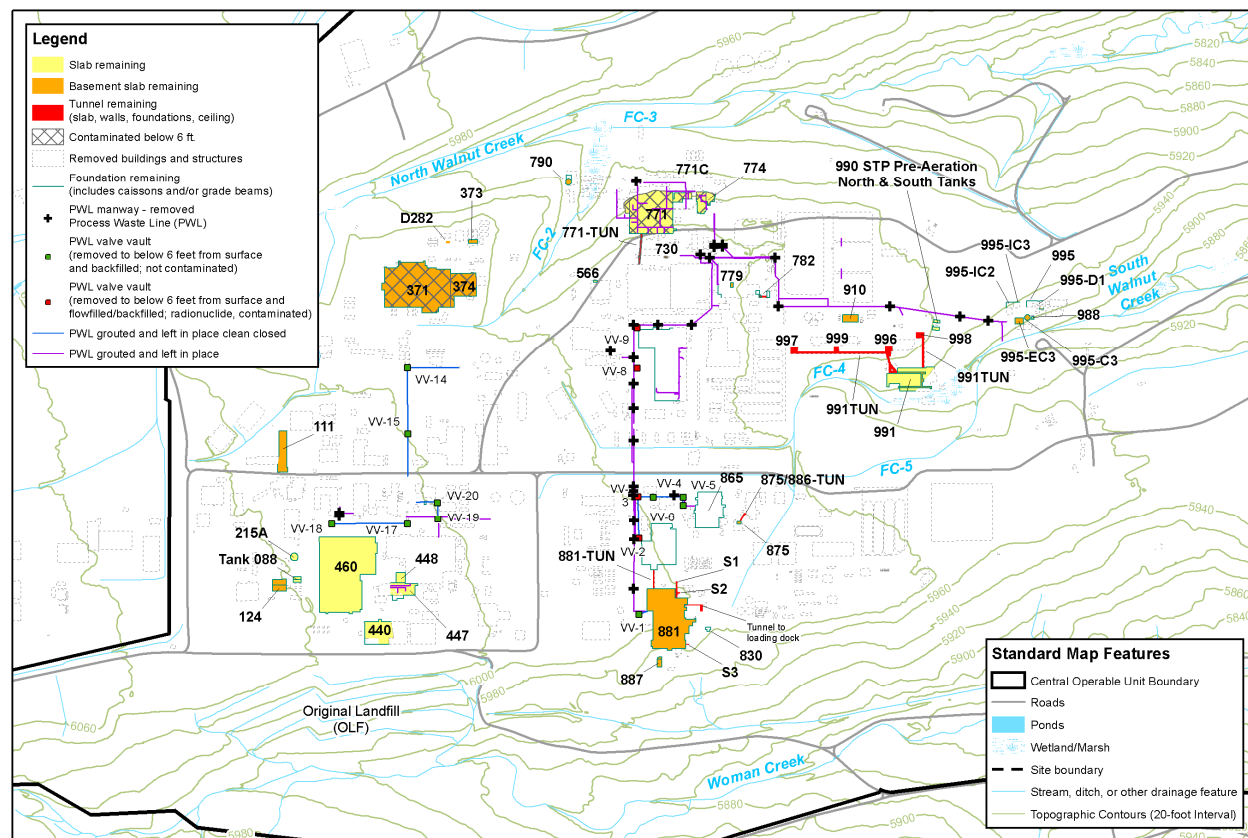
Figure 3. Subsurface Features.

Figure 3 is a map of the remnants of buildings and process waste lines that remain in the Central OU subsurface, and the location of the closed Original Landfill. The outlines of former buildings or structures removed and the locations of the five FCs are also shown on Figure 3.

now inspect these areas quarterly. The surface locations coinciding with these subsurface locations have also been marked with fence posts to assist surface observation. These areas are associated with former buildings 371, 771, 881, and 991 (see Figure 3).

The approximate location of the observed hole was determined using a hand-held GPS. A comparison of the GPS coordinates to survey coordinates for the building location indicated that the hole was near the southeast corner of the remaining buried portions of the south and east walls of Building 771 (see Figure 3). In December 2011 this portion of the gravel road was cordoned off, and a temporary pathway for vehicle use was demarcated about 6 m (20 ft) to the south while the depression was being evaluated.

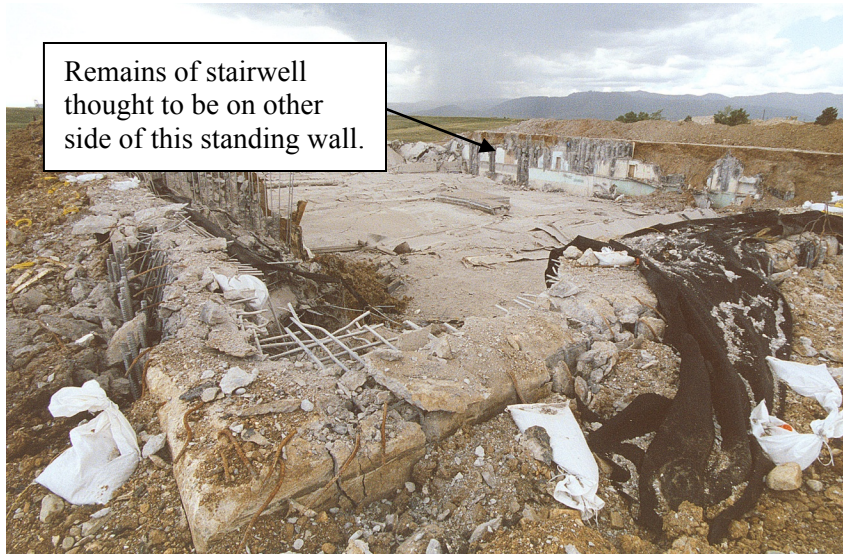
Figure 6. Building 881 after explosive demolition, before backfilling (looking southwest).

Figure 5 is a copy of the building first floor footprint taken from the Building 881 Pre-Demolition Survey Report[6] showing the stairwell location. Figure 6 is a photograph of Building 881 showing the western wall of the building after explosive demolition and before backfilling. A photograph of the wall looking east could not be located in the archives, but the general location of the stairwell is thought to be behind the standing wall as indicated on the Figure 6 photograph.
