## **Forensic Investigation of Hanford Double-Shell Tank AY-102 Radioactive Waste Leak – 14178**

D. J. Washenfelder  
Washington River Protection Solutions LLC  
P. O. Box 8501  
Richland, WA 99352

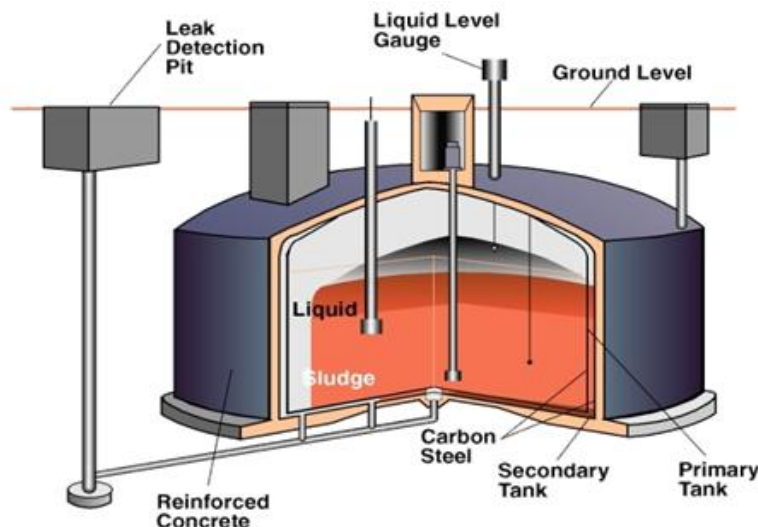
Fig. 1. Hanford Double-Shell Waste Storage Tank Features

The double-shell tank structure consists of a carbon steel primary tank enclosed by a carbon steel secondary liner, inside a concrete shell. The primary tank rests inside the secondary steel liner on an insulating refractory pad on top of the secondary liner and structural foundation. An annular space 0.75 m wide (2.5 ft) is formed between the primary tank and the wall of the secondary liner. The primary tank and annulus have separate ventilation systems, designed to maintain the internal pressures negative with respect to ambient pressure (Refer to Figure 1).

up to a height of 11.7 m (38 ft-4 in) above the floor of the primary tank to where the secondary liner meets the top knuckle of the primary tank. The annulus has 22 risers that allow for the insertion of inspection equipment and placement of instruments. Six additional risers act as annulus ventilation outlets.
