**Double-Shell Tank Visual Inspection Changes Resulting from the Tank 241-AY-102
Primary Tank Leak – 14193**

Crystal Girardot *, Jason Engeman *, Dennis Washenfelder *, Jeremy Johnson **

* Washington River Protection Solutions, LLC

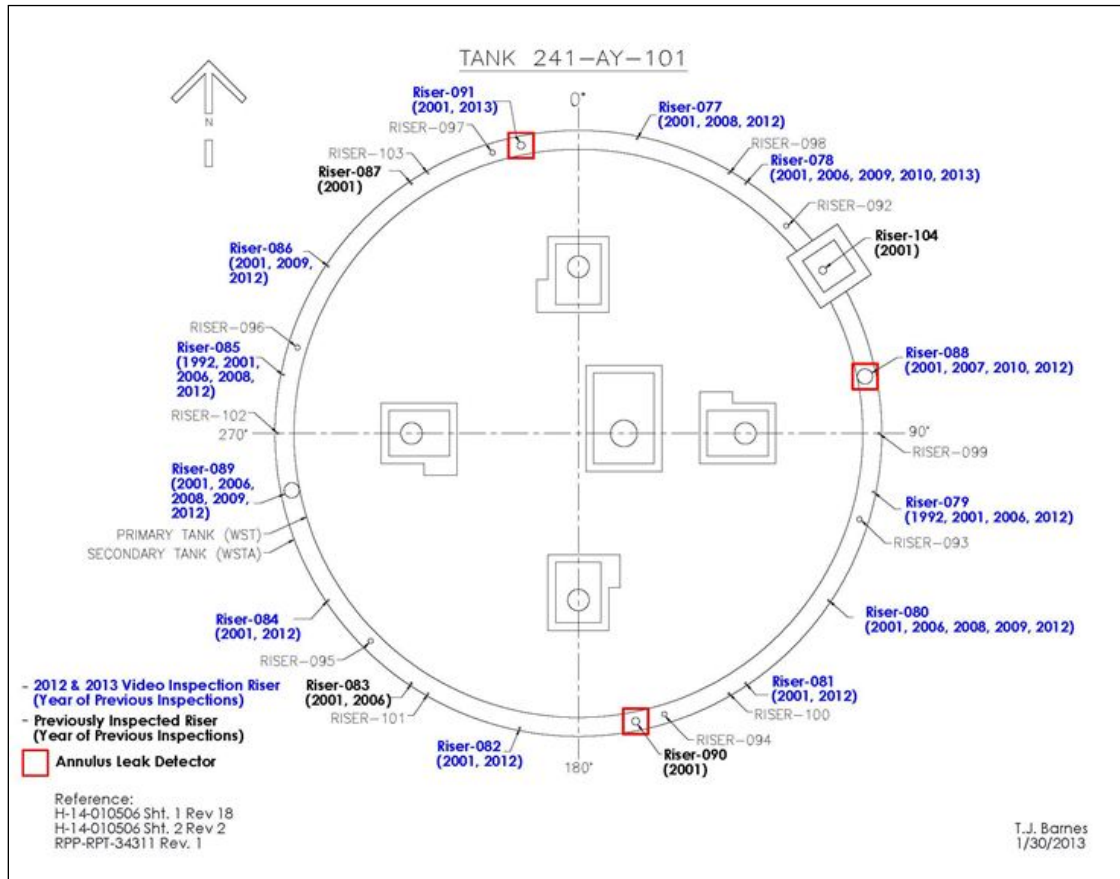
Fig. 3. Tank AY-101 Annulus Video Inspection Risers.

Twelve risers were used for the enhanced visual inspections performed in the tank AY-101 annulus between October 2012 and February 2013 (see Fig. 3). There is evidence of beachlines on the annulus floor as seen from many inspection risers which can be attributed to water couplant used during ultrasonic inspection examinations collecting on the annulus floor at some time and before it evaporated.

Though mineral formations are seen on the top knuckle, some of the changes in the condition of the white and yellow material in the top knuckle region cannot be determined because previous inspections did not view these areas. In regions which did show change, these portions of the top knuckle would be considered to have a small amount of water intrusion since the last inspection.

These indications were above the tank waste level and therefore do not indicate a tank leak.

Despite the presence of foreign material in the annulus, there is no indication that any radioactivity is associated with the material. The annulus of tank AY-101 is operated at a lower pressure than the primary tank so any significant pathways from the primary air space should cause the continuous air monitor to alarm. To date, no clear evidence exists that would indicate either the containment or structural integrity have been compromised in tank AY-101. Future annulus visual inspections, ultrasonic testing, and continuous air monitor surveillance should be continued to identify any changes in the integrity of tank AY-101.

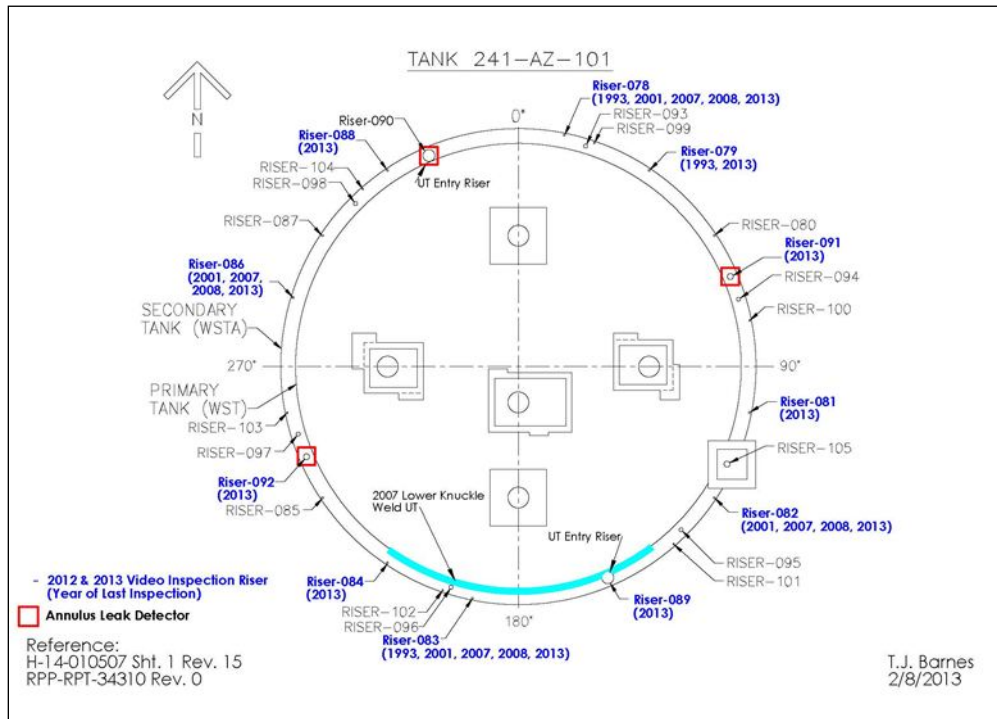
Fig. 5. Tank AZ-101 Annulus Video Inspection Risers.

Eleven risers were used for the enhanced visual inspections performed in the tank AZ-101 and tank AZ-102 annulus between January 2013 and February 2013 (see Fig. 5 and Fig. 6). There is evidence of beachlines on the annulus floor as seen from many inspection risers which can be attributed to water couplant used during ultrasonic inspection examinations collecting on the annulus floor at some time and before it evaporated.

Annulus inspections identified small amounts of change on the annulus floor of tanks AZ-101 (see Fig. 7) and AZ-102 (see Fig. 8) as compared to areas previously inspected. These changes are likely attributed to evaporated couplant water from UT examinations that occurred in nearby risers after the previous visual inspection. Additional stains were also identified on the annulus floor of tanks AZ-101 and AZ-102, however, these stains can be correlated back to existing equipment locations (e.g., annulus pump pit, riser penetrations, ENRAFs, etc.). Despite the changes identified in the current inspection, there was no indication of active water intrusion or a primary tank leak for tanks AZ-101 and AZ-102.

In regions which did show a change in condition, these portions of the annulus floor were near risers utilized for UT examinations. To date, no evidence exists that would indicate either the containment or structural integrity have been compromised in tanks AZ-101 and AZ-102.

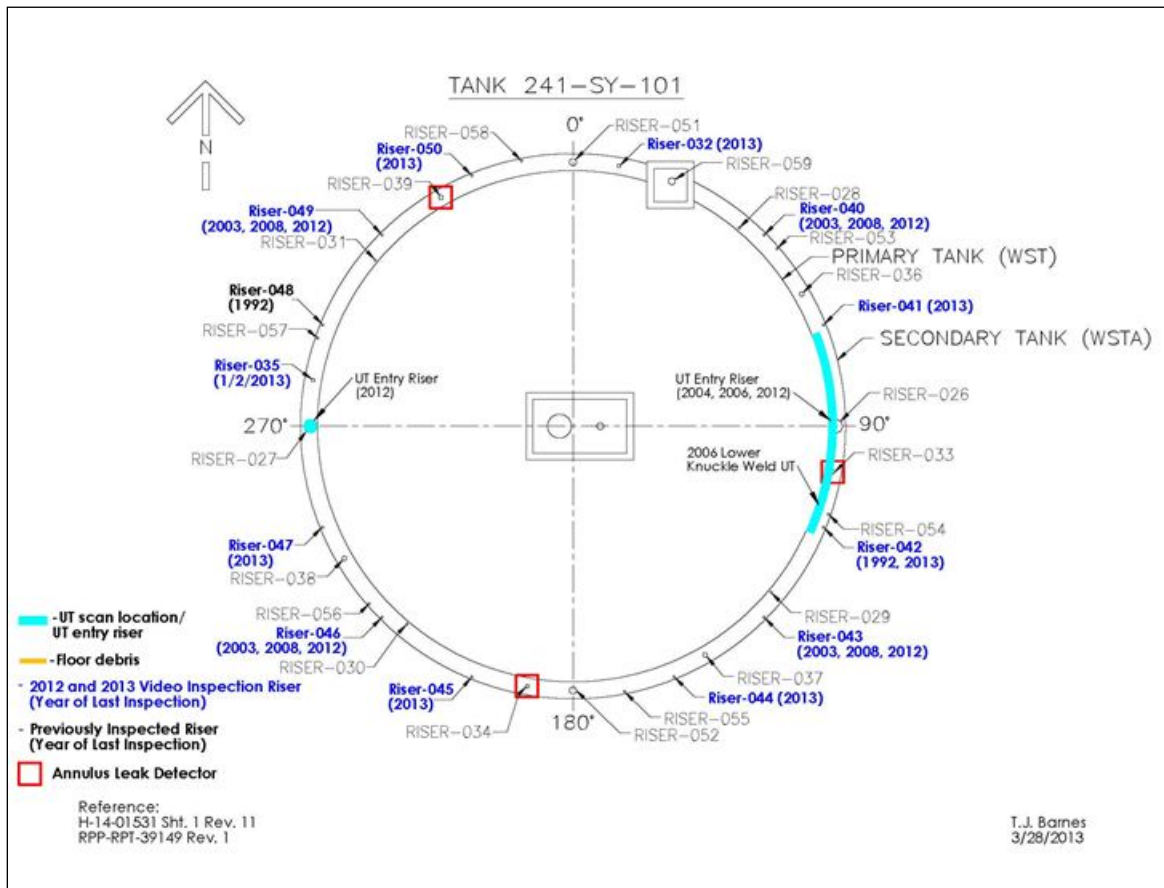
Fig. 9. Tank SY-101 Annulus Video Inspection Risers.

Eleven and twelve risers were used for the enhanced visual inspections performed in the tank SY-101, tank SY-102, and tank SY-103 annulus between May 2012 and March 2013 (see Fig. 9 through Fig. 11). Annulus inspections identified small amounts of change on the annulus floor of tanks SY-101 and SY-102 (see Fig. 12 and Fig. 13, respectively) as compared to areas previously inspected. Additional stains were also identified on the annulus floor of tanks SY-101, SY-102, and SY-103. These changes are attributed to couplant water used during UT examinations, accumulation of condensation on the annulus floor, and/or removal of the annulus pump (see Fig. 12, Fig. 13, and Fig. 14, respectively). The couplant water appears to affect most of the annulus floor as it collects on the annulus floor during UT examinations which can leave additional stains and beachlines after evaporating. Despite the changes identified in the current inspection, there was no evidence indicative of water intrusion or a primary tank leak for tanks SY-101, SY-102, and SY-103.

Previous cracking and surface degradation of the refractory in SY tanks was noted in prior inspections and the surface degradation of the refractory appears consistently on all three tanks. It is likely some of this loose surface layer has washed down and transported to the annulus floor during UT examinations. To date, no evidence exists that would indicate either the containment or structural integrity have been compromised in tanks SY-101, SY-102, and SY-103. Future annulus visual inspections and ultrasonic testing will continue to identify any changes in the integrity of tanks SY-101, SY-102, and SY-103.
