**Detection and Monitoring of Cracks in a Concrete Buffer from DIC and AE
Measurements – 14439**

WM2014 Conference, March 2 – 6, 2014, Phoenix, Arizona, USA

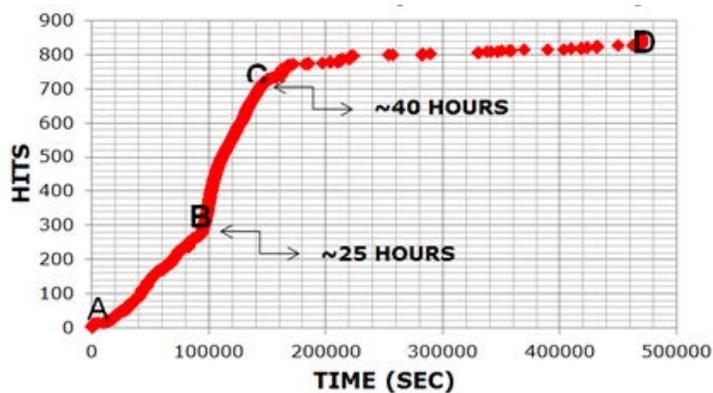
In the first phase of the test, during the first two days following the casting of the buffer on 16th of April, 2013, AE measurements registered a high number of hits, as shown in Figure 6. The measured AE activity is mostly due to the initial settlement of the concrete and the effects of hydration.

Fig. 6. Measurements in the beginning of the first phase of the test showing cumulative AE hits recorded in Window 2.
