**241-AY-102 Leak Detection Pit Drain Line Visual Inspection – 15678**

Theodore Venetz \*, Kayle Boomer \*, Jason Engeman \*, Jason Gunter \*, John Garfield \*\*, Brandon Vazquez \*, Cameron Joslyn\*

\* Washington River Protection Solutions  
\*\* AEM Consulting, LLC

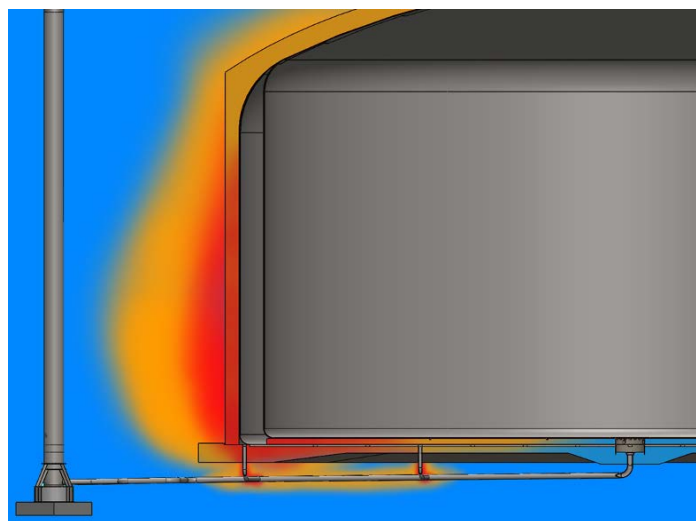
**FIGURE XV: Plausible Thermal Profile (Theoretical) Vacuum and Water Intrusion**

The annulus air is distributed radially through a central air distributor in the refractory layer, which leaves the refractory and concrete foundation cooler in the middle and warmer toward the outer radius (see Figure XIV), as indicated by embedded thermocouples. Thermal gradients as depicted in Figure XIV give a means for air flow to transport dissolved moisture (100% relative humidity air) which will condense in some portions of the system and subsequently evaporate in others depending on the local temperature driven by thermal gradients. Figure XV gives a theoretical thermal profile (cross section view) of the Tank AY-102 and surrounding soil which shows the air moisture transport mechanism is present within the system. Confirmation of these thermal gradients would require a second entry with the IHI robotic pipe crawler equipped with onboard temperature/pressure/humidity sensory devices.
