Failure Evaluation of Savannah River Site High-Level Waste Evaporator 242-25H – Part II – 17353

Charles Keilers *, Bruce Wiersma **, John Schwenker *, Thomas Yamamoto *

* Savannah River Remediation, LLC

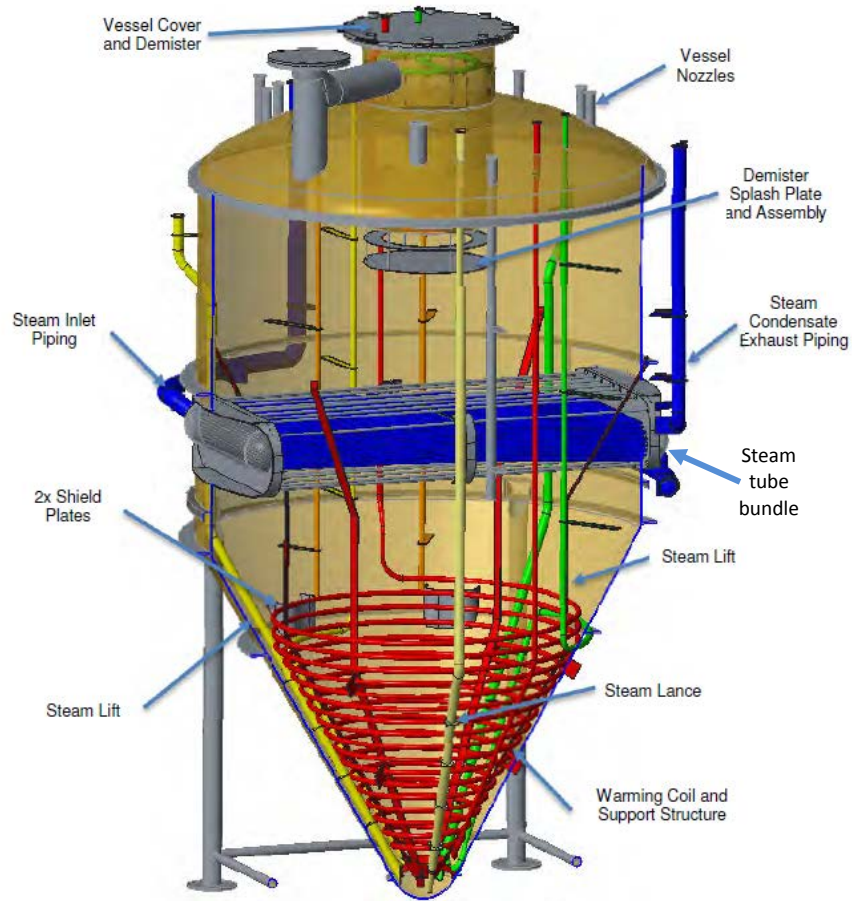
Fig.1. Major components of the 25H Evaporator (figure is from [3]).

The 25H Evaporator is a single-stage “pot” evaporator, as shown in Figure 1, and is about 8 meters tall by 4 meters in diameter. It is functionally identical to earlier SRS evaporators but about four times larger in volume and made from a more corrosion-resistant material (i.e., nickel-based Alloy G-3 instead of 304L stainless steel). The vessel consists of a lower conical section supported by four legs; an upper cylindrical section with a horizontal steam tube bundle; and a vessel head. The tube-bundle has hundreds of slightly curved tubes running between two thick vertical tube-sheets on opposite sides of the vessel. A steam lance injects steam into the vessel bottom and keeps the waste mobilized. Two steam and two lift lines also run to the bottom of the vessel cone to remove concentrated waste.

The 25H Evaporator steam warming coil, shown in Figure 1, developed a leak in 2004. This was attributed to the coil piping rubbing on the coil frame and wearing about a 2 mm diameter hole in the piping. While this did not impact evaporator operation, it does indicate the possibility of relative motion occurring among the components in the cone that could lead to rubbing and wear between the components and the shell.
