RESOLVING THE TECHNICAL UNCERTAINTIES IN THE DECOMMISSIONING OF AN ACCIDENT DAMAGED REACTOR – WINDSCALE PILE 1

M.T. Cross, W. C. Mullineaux, J. C. Jennings, W. A. Ingamells, M. L. Ferris United Kingdom Atomic Energy Authority Windscale, Seascale, Cumbria, CA20 1PF, United Kingdom

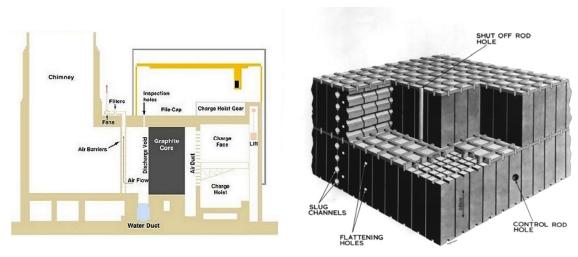
Fig. 1. Cross-section through Pile 1 structure^a.

A sectional view of Pile 1 is shown in Figure 1. The reactor core consists of a 2000 te graphite moderator/reflector comprising about 50,000 blocks of graphite keyed together using a system of graphite slats and tiles (Figure 2) generating an interlocking structure of approx. 15x15m in section and 7.5m deep. The core is penetrated by 3444 horizontal fuel channels of 100mm diameter and 977 isotope channels of 44mm diameter. Each fuel channel contained a stringer of 21 solid uranium metal fuel rods clad in finned aluminium, each resting on individual, linked graphite 'boats' for loading and discharge purposes. The fresh fuel was loaded from the charge face from an ascending platform. Fuel discharge was effected by pushing out the irradiated fuel by the incoming train of fresh fuel until it fell under gravity from the pile discharge face into a transfer skip contained in a water-filled duct (see Figure 1). Transfer skips were then towed remotely into a cooling pond prior to subsequent reprocessing of the irradiated fuel. The pile was designed to operate at up to 180 MW_t power (no electricity was produced) and cooled from a bank of blowers that forced air through the pile into a collection plenum and then exhausted to atmosphere via filters through a vertical stack of ~130 m. The graphite core is surrounded by steel thermal shield plates, a core restraint girder system - all encased in a reinforced concrete bioshield.

^a Figure 1 represents a section through Pile 1 following care and maintenance activities carried out during the late 1980s
