RESPONSE OF A SPENT FUEL TRANSPORTATION CASK TO A TUNNEL FIRE EVENT

C. S. Bajwa, P.E.
U.S. Nuclear Regulatory Commission
11555 Rockville Pike, Rockville MD 20852

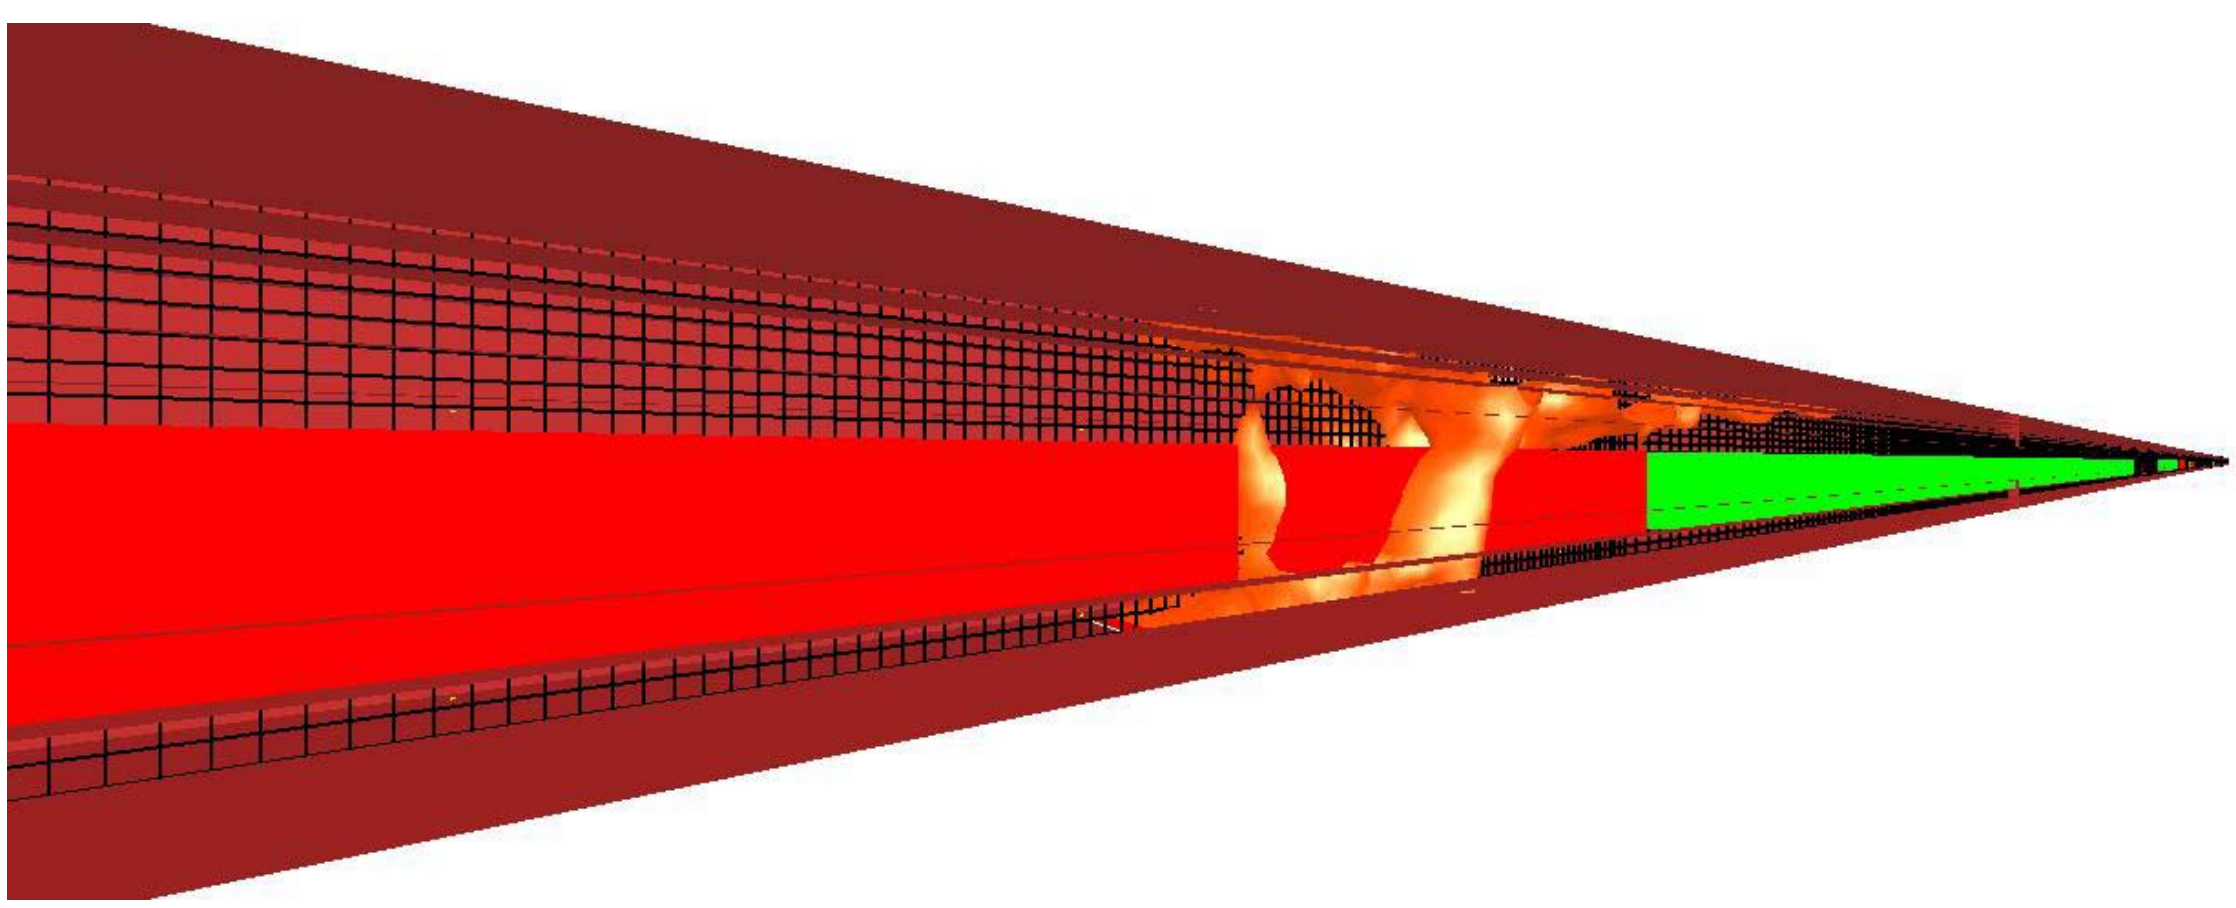
Fig. 1. Howard Street Tunnel Fire Model (Courtesy of NIST)

The Howard Street tunnel model was constructed as a 3 dimensional model, and modeled the entire length of the tunnel, with railcars positioned as they were found following the derailment (Figure 1). The FDS model predicted fire temperatures as high as 1000°C (1800°F) in the narrow flaming region of the fire. The hot gas layer above the railcars, within three rail car lengths of the fire, averaged 500°C (900°F). The tunnel surface wall temperature reached 800°C (1500°F) where the fire directly impinged on the top of the tunnel. The average tunnel ceiling temperature, within a distance of three rail cars from the fire, was 400°C (750°F). (2)

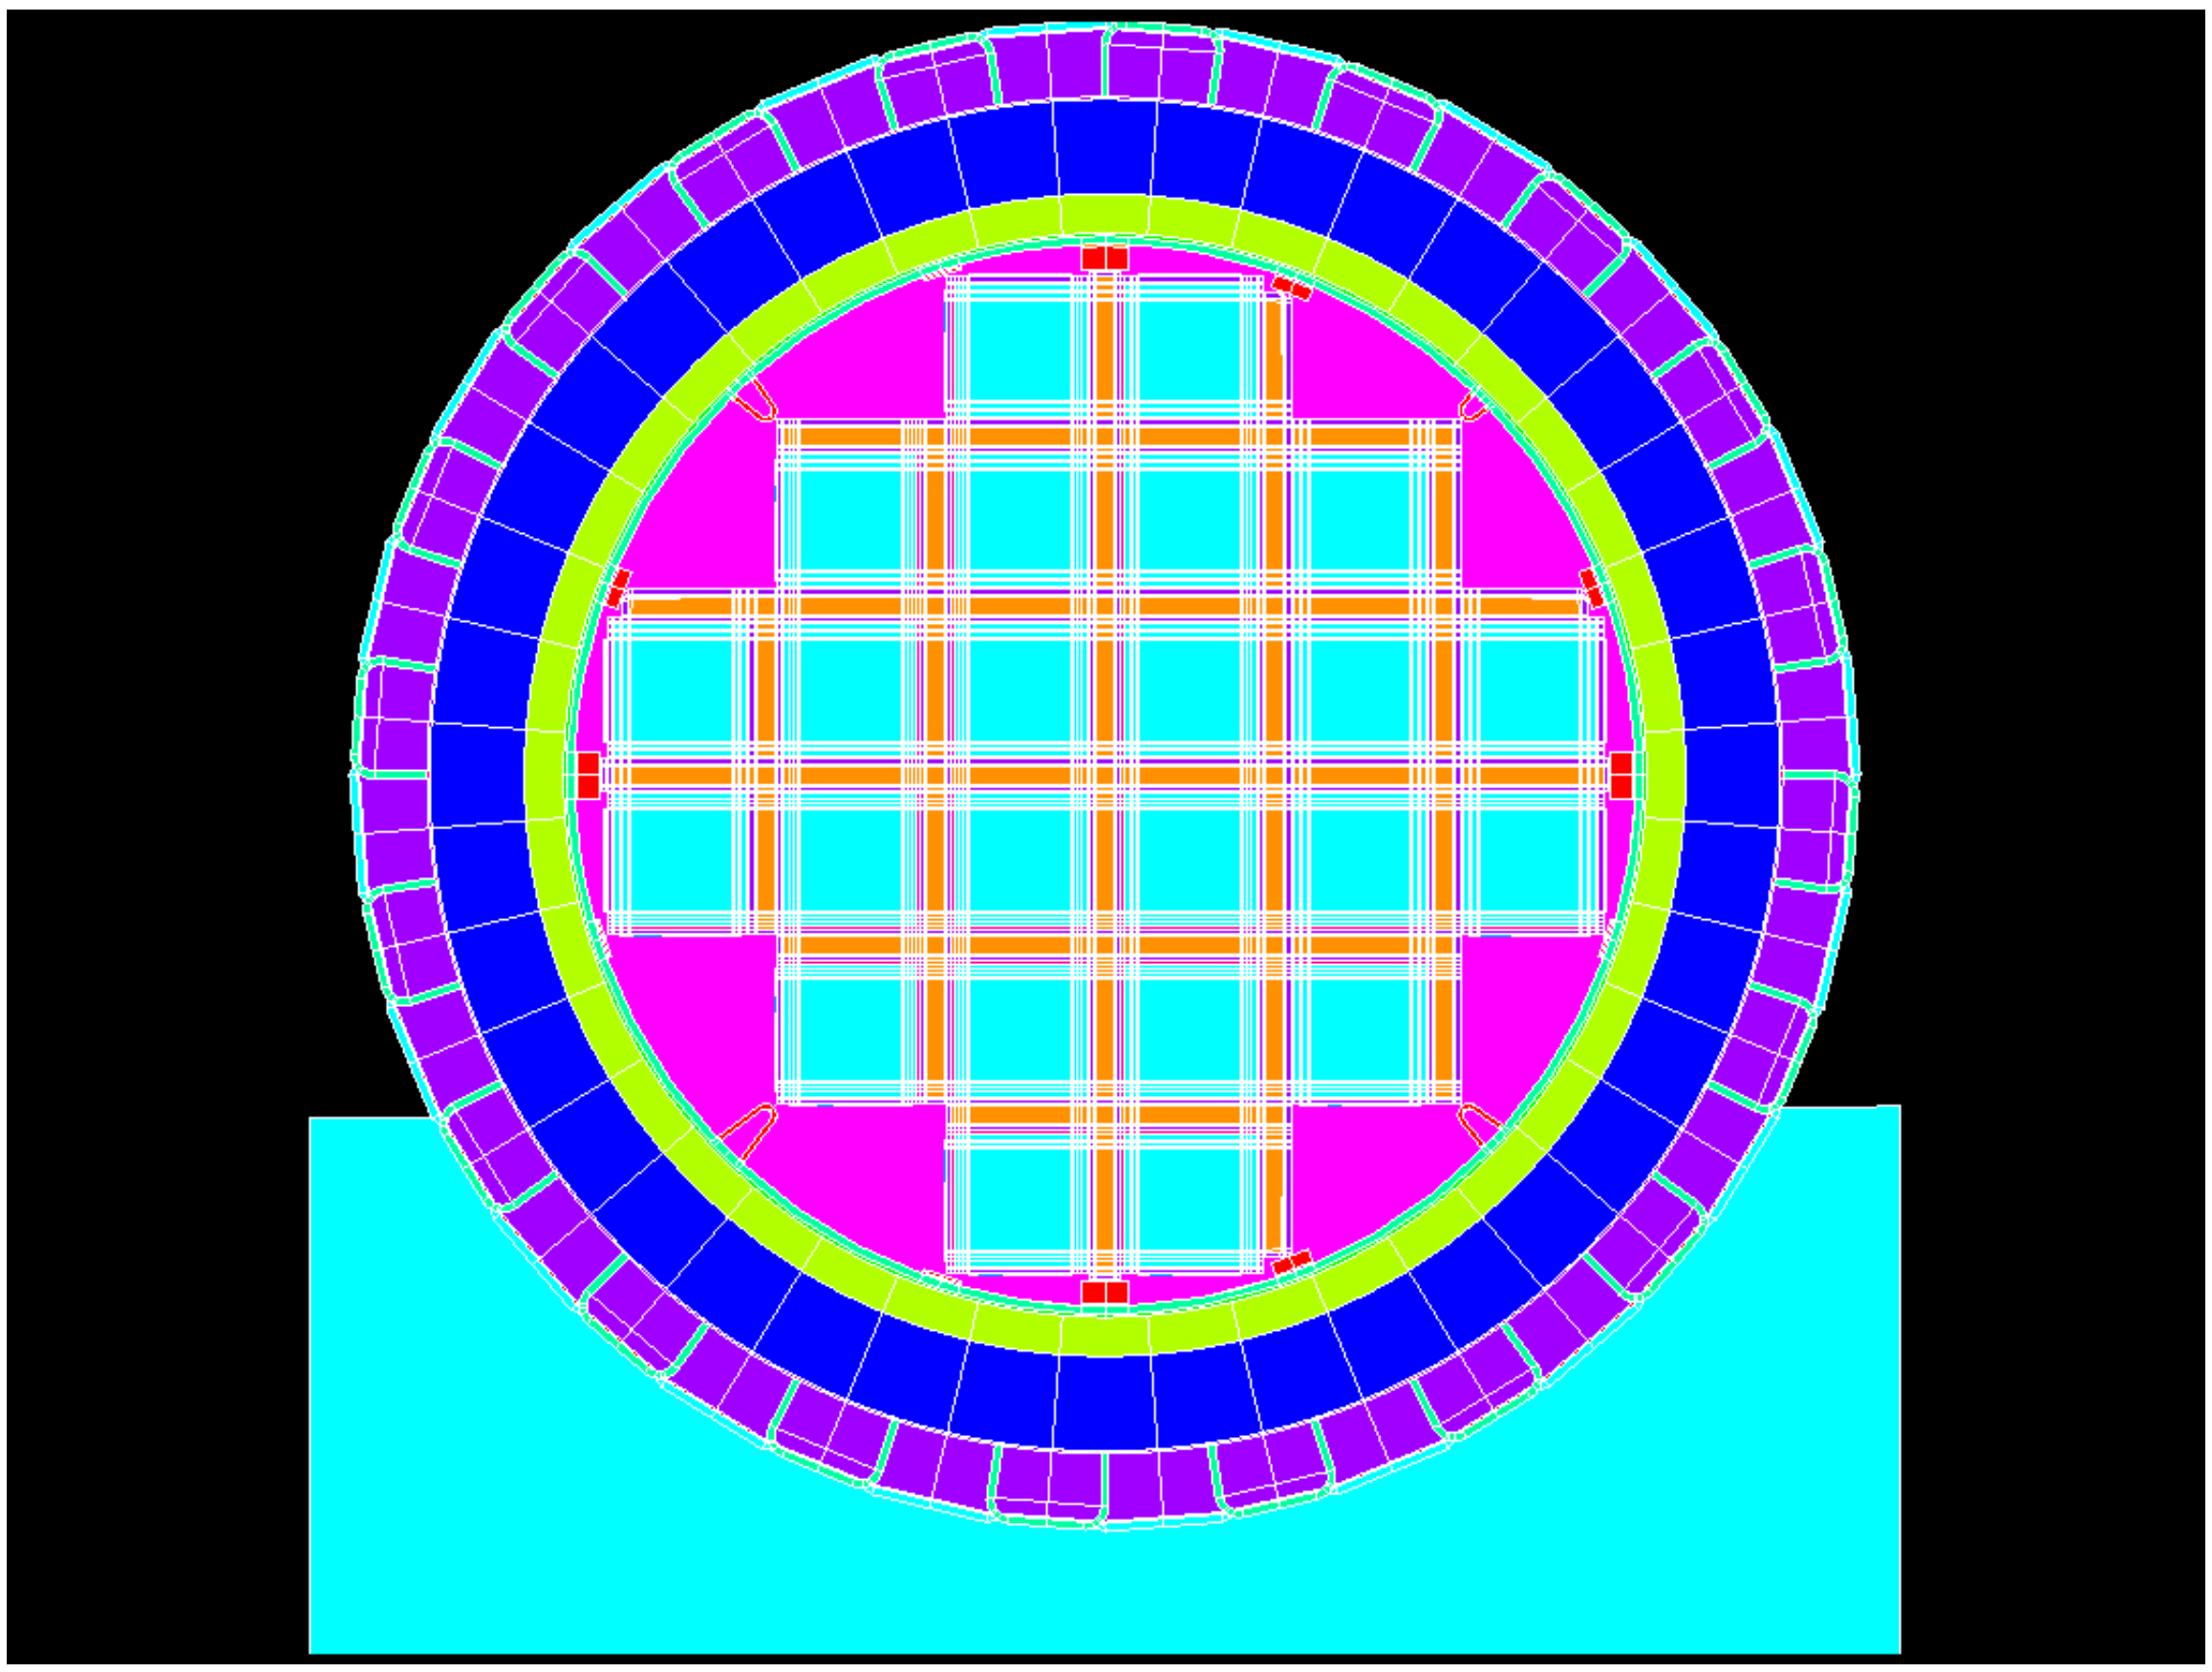
Fig. 2. Finite Element Model of Spent Fuel Transportation Cask

SFPO, with the assistance of thermal analysis experts at Pacific Northwest National Labs (PNNL), developed a 2-dimensional finite element analysis thermal model of a transportation cask, including the rail transport cradle. (Figure 2) The purpose of this model was to perform a thermal assessment of the cask that captured the non-uniform temperature distributions which existed in the Howard Street tunnel fire. The staff imposed both the temperature and flow boundary conditions, calculated by NIST, on the surface of the spent fuel cask analytic model. The model included the maximum spent fuel decay heat load approved for this cask design.

For the 20-meter (65.62-feet) scenario, the analysis indicated that the short-term temperature limit of the Zircalloy fuel cladding, 570°C (1058°F) (4), would have been exceeded 116 hours into the fire exposure. For the 5-meter (16.4-feet) scenario, the fuel cladding temperature limit would have been exceeded at 37 hours into the fire exposure.
