## **Decommissioning the Dresden Unit 1 Spent Fuel Pool**

R.L. Demmer, R.J. Bargelt  
Idaho National Laboratory  
P. O. Box 1625, Idaho Falls, ID 83415-7113  
USA

J.B. Panozzo, R.J. Christensen  
Exelon Generation Company, LLC  
Dresden Nuclear Power Station, Warrenville, IL 60555  
USA

### **ABSTRACT**

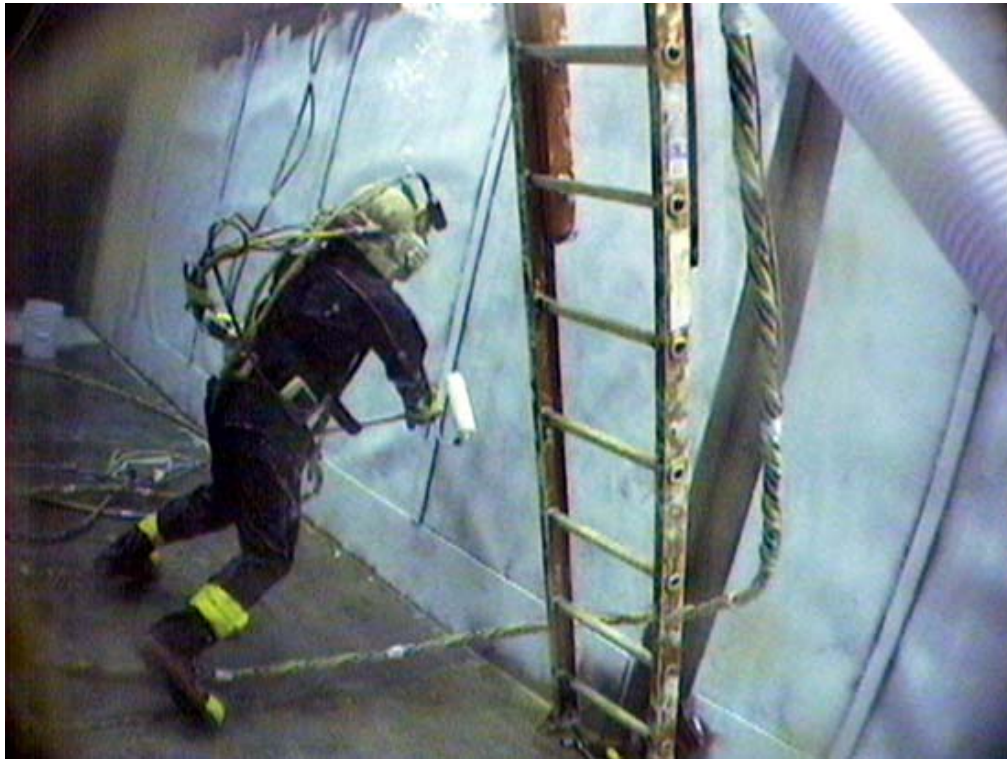
Fig. 2. Special two hose roller system used for wall coating

A special type of paint roller system was used for underwater application of the epoxy coating. It is shown being used underwater in Fig. 2. The system had two separate pumps for the epoxy resin and hardener, which pumped through separate hoses to a mixing manifold about 5 feet from the roller. The roller/extruder system was flexible up to that point, and like a solid wand beyond that point through to the roller head.

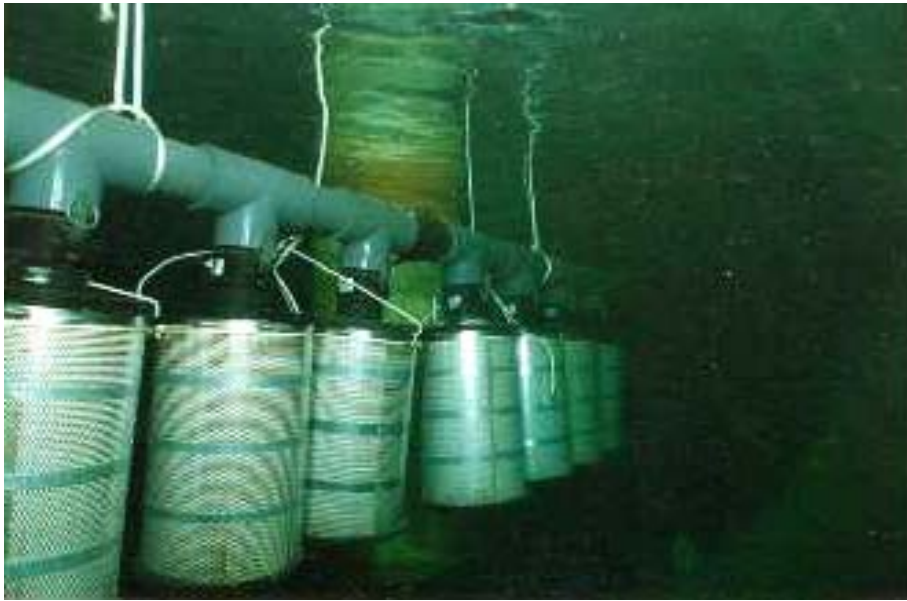
Fig. 3. UCC vacuuming filtration system underwater manifold

A system known as the "Tri-Nuc" Filter System (Tri-Nuclear Corp., model UFV-100) was placed in the pool to maintain long term water quality. The Tri-Nuke is a canister type, shielded filter about 30 inches long and 7 inches in diameter. It is a self-contained system that contains a submersible pump and is easily maintained (easy filter removal). After the peroxide injection and 3 weeks of Tri-Nuc filter operation, the pool water became crystal clear and maintained this clarity throughout the project. Over the course of the project, 50 of the Tri-Nuke filters were used. A skimmer system was added to the Tri-Nuc to clear the floating algae debris. The underwater diving contractor (UCC) brought a separate vacuum/filtering system, consisting of a pump and eight 15" filters on a manifold (Fig. 3). This system also helped to maintain water clarity, but its primary purpose was to contain the paint chips and floor debris. A "rock catcher" screen was used on the UCC system to prevent larger particles from going through the pump.
