Characterization and Remediation of 91B Radioactive Waste Sites under Performance Based Contracts at Lackland Air Force Base, San Antonio, Texas

P.A. Trujillo, IV, K.D. Anderson
ECC
1746 Cole Boulevard, Suite 350, Lakewood, Colorado 80401
USA

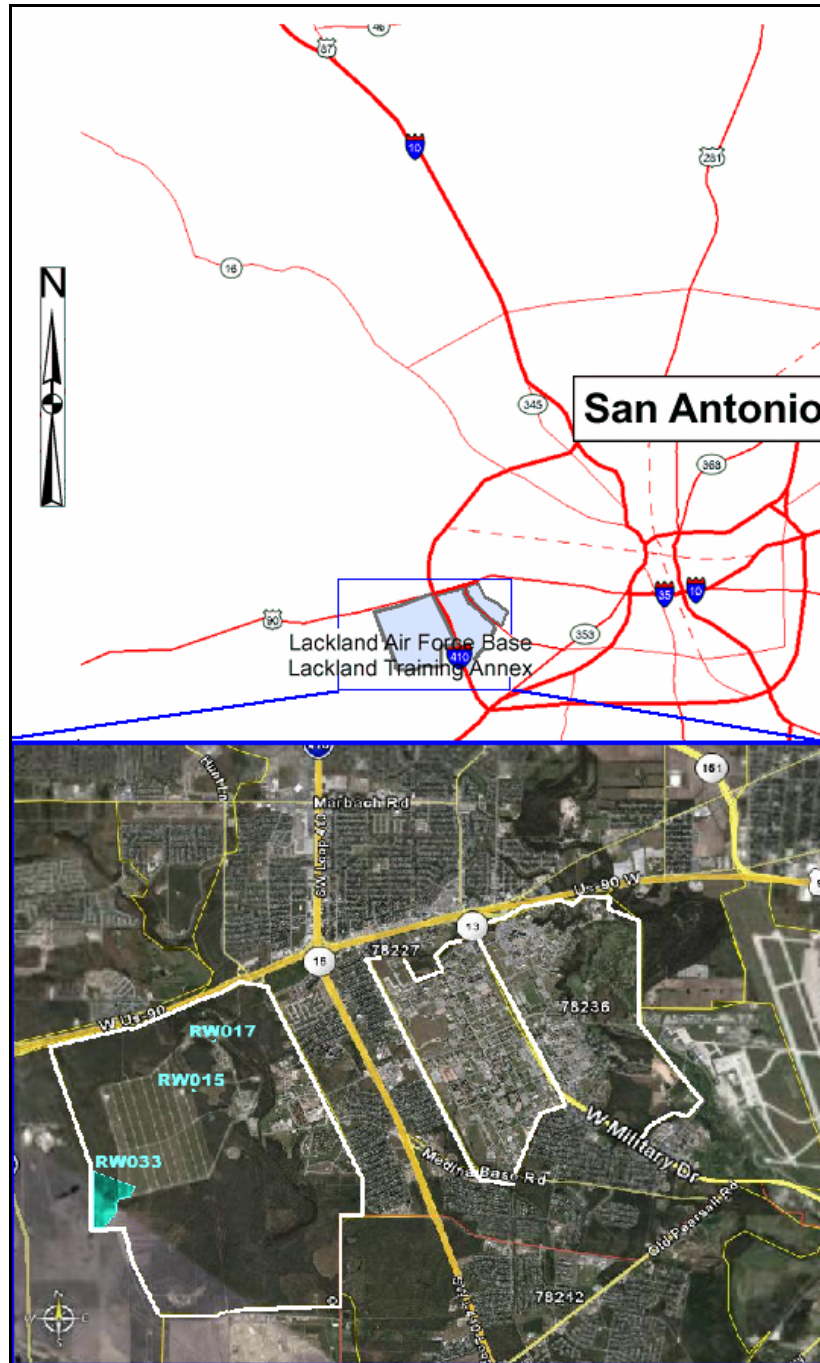
Figure 1. Area map and site locations

RW017 is located in the north-central portion of the Lackland Training Annex (LTA), 184 meters (600 feet) by 122 meters (400 feet). RW015 is located in the northeastern portion of the LTA and is now a gravel-paved area, 15 meters (50 feet) by 30 meters (100 feet), enclosed by a chain-link fence. RW033 is located in the western portion of the LTA and encompasses about 0.356 square kilometers (88 acres). As shown in the **Figure 1**, Area Map and Site Locations.

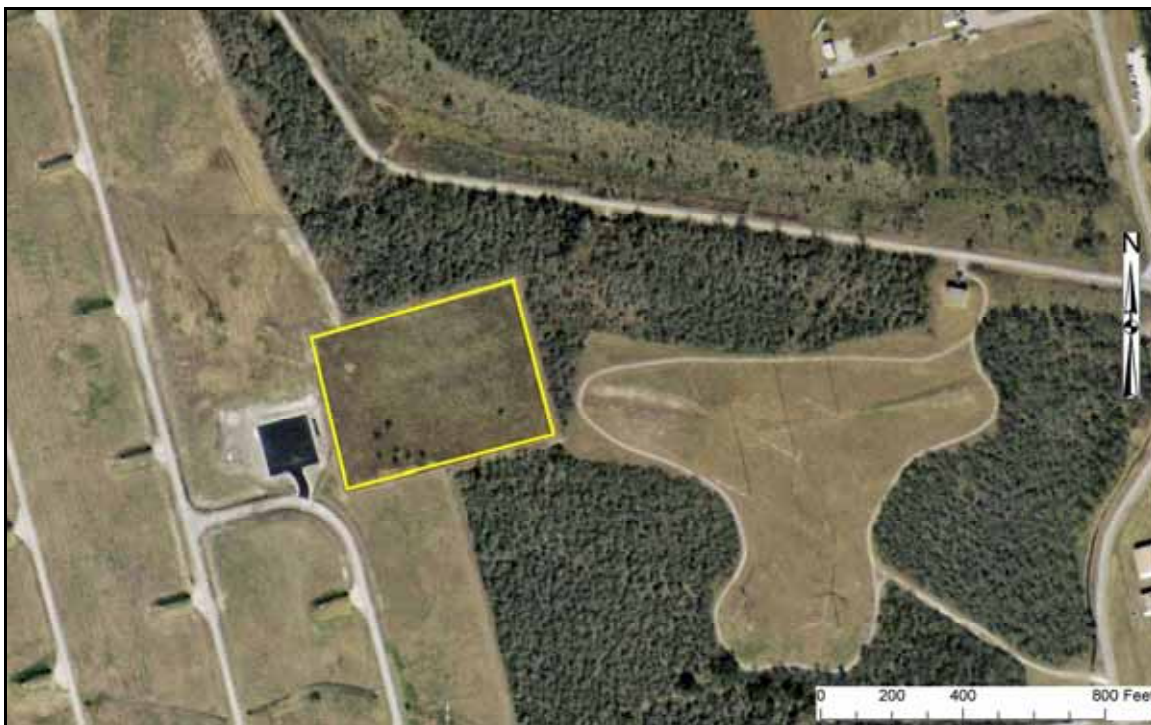
Figure 2. RW015 land area aerial

RW015 was the primary collection point for all wastes generated by Mason & Hanger, Silas Mason CO. at Lackland Modification Center. This included all waste generated from maintenance, modifications, and demilitarization of weapons. This burial site was so large, that it soon became home to waste collected at various broken arrow accidents around the world. It is known that Plutonium, Uranium, and various metals like Aluminum, Polonium, Beryllium, and Lithium were collected at this site. At the end of the AEC tenure at Lackland, the burial site was exhumed and the waste was transferred to the Pantex Plant in Amarillo, Texas. However, no records or interview subjects could confirm the integrity of all the material removed. Furthermore, some of the material transferred to Pantex, and which ultimately went to Frenchmen Flats at the Nevada Test Site (NTS), was found to be leaking from 7 the storage containers [1]. **Figure 2**, shown below provides an aerial overview of the RW015 site.

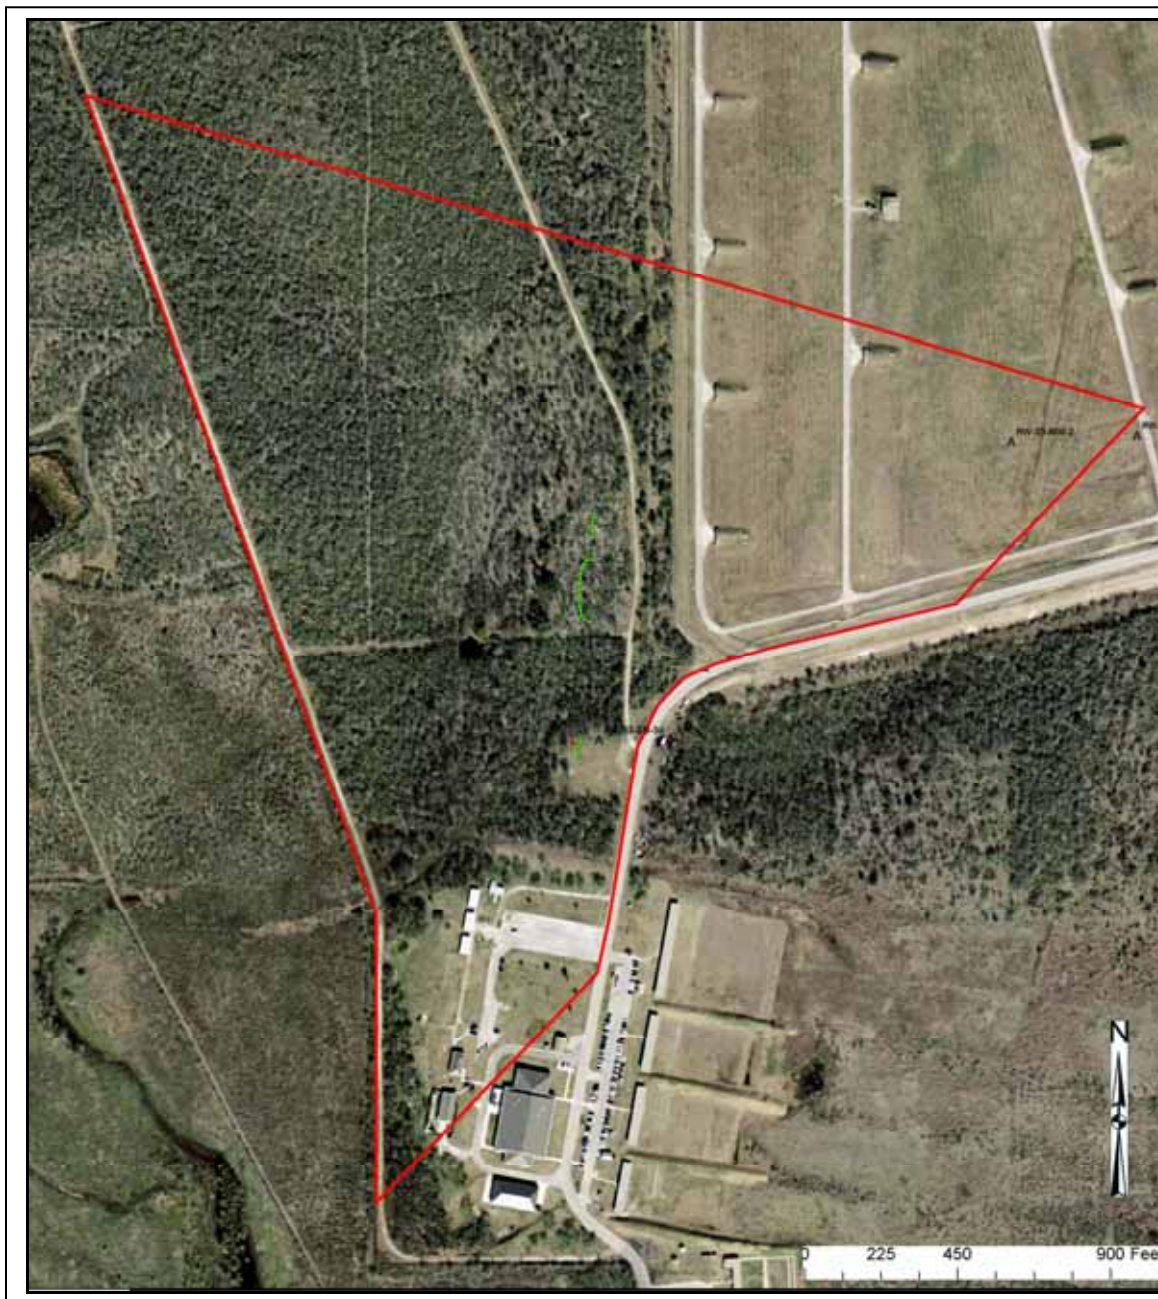
Figure 4. RW033 land area aerial

here. Approximately $\frac{1}{4}$ to $\frac{1}{2}$ mile to the Southeast of RW033 is OT-012. This site was used to demilitarize high explosive components from the special weapons demilitarized at Lackland. There are reports that during some of the operations, explosions occurred when materials were stacked too high, causing the materials to detonate rather than deflagrate. Some of this material may have been ejected as far as RW033. There are some indications that radiological materials such as plutonium or uranium may have been part of this burn [1]. **Figure 4**, shown below provides an aerial overview of the RW033 site.

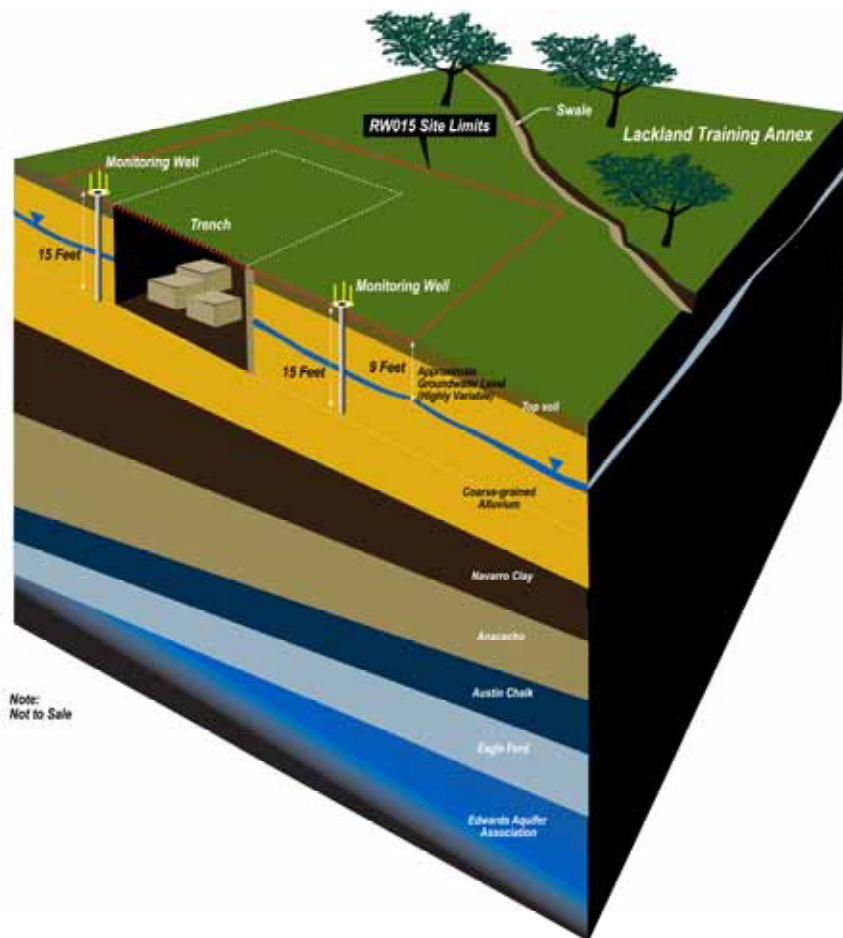
Figure 5. RW015 site conceptual model

Based on the previous RI results, the United States Air Force (USAF) Radioisotope Committee (RIC) determined the site could be released for unrestricted use; however, the AFSC is the regulatory authority for releasing the RW015 site and required that an additional characterization survey be completed [3]. The following figure provides a site conceptual model of the RW015 site.

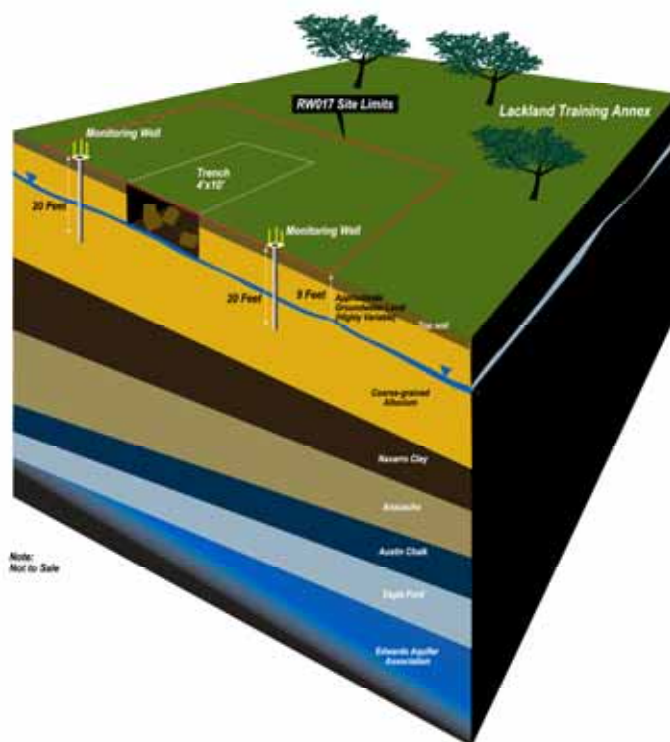
Figure 6. RW017 site conceptual model

The AFSC is the regulatory authority for releasing the RW017 site and required that an additional characterization survey be completed.]. The following figure provides a site conceptual model of the RW017 site.

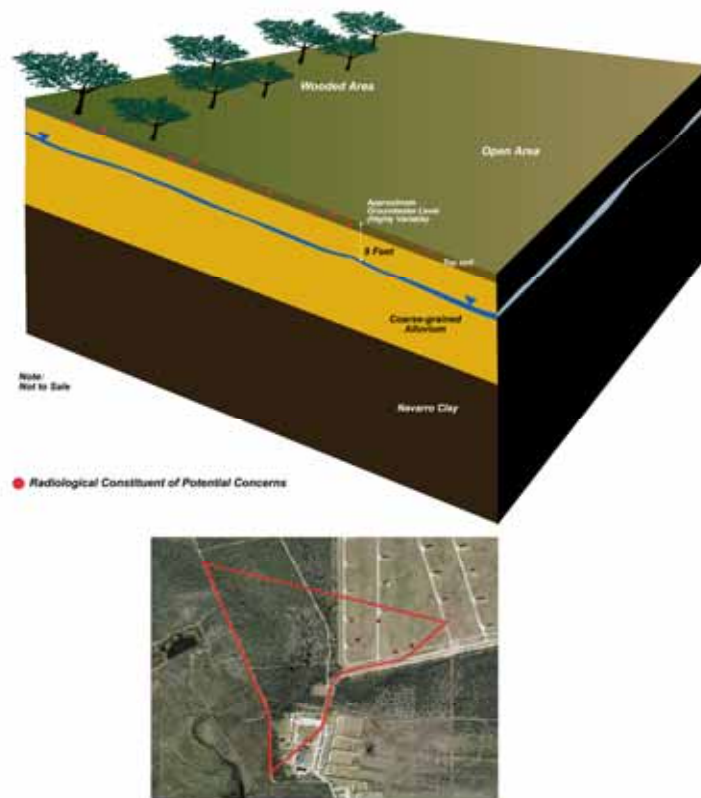
Figure 7. RW033 site conceptual model

The AFSC is the regulatory authority for releasing the RW033 site and required that an additional characterization survey be completed. The following figure provides a site conceptual model of the RW033 site.
