## **Evaluation of Nonmetallic Components in the Hanford Waste Transfer System - 17287**

### **ABSTRACT**

This paper provides results from initial mechanical property testing of EPDM and Garlock® material coupons as well as the initial blowout/leak testing for HIHTL, EPDM O-rings and Garlock® gaskets. In addition, the experimental test loop being used to age the test specimens is described.

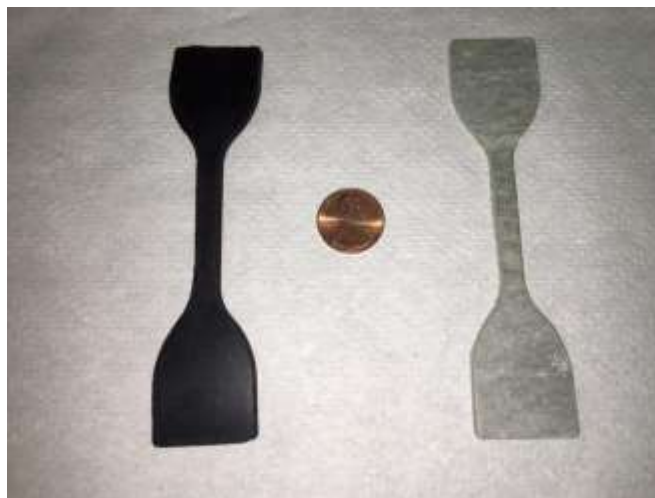
**Figure 1. Coupon dumbbells.**

To assess the baseline material properties of EPDM and Garlock®, sheets of the material were obtained and coupon specimens (Figure 1) were cut using a D412-C die. The specimens were used to determine hardness values obtained using a LECO LMV 50 Series hardness tester. To determine the material hardness, a load of 500 grams was used to create an indentation in the sample and hardness values according to the Rockwell scale and Vickers scale were obtained. Multiple measurements were taken from 3 different Garlock® specimens. These results and the corresponding averages are provided in Table 1. Since EPDM material is a soft material, hardness readings were unable to be obtained with existing equipment.

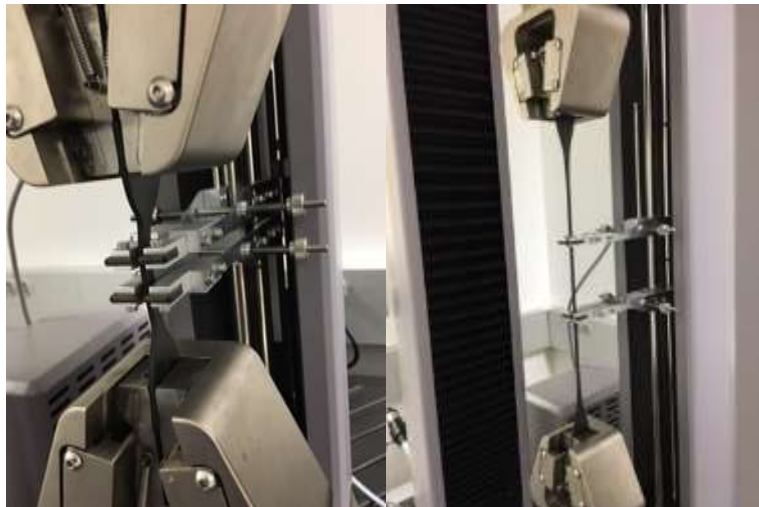
**Figure 2. EPDM coupon testing.**

Baseline coupon tensile testing was conducted for both un-aged EPDM coupons and un-aged Garlock coupons. All procedures used for testing were derived from ASTM D412-16 [3] and were recorded to provide consistency throughout all tensile testing experiments, for both EPDM and Garlock® material coupons. Figure 2 shows the un-aged EPDM coupon in the tensile testing machine before testing (left) and before rupture (right).

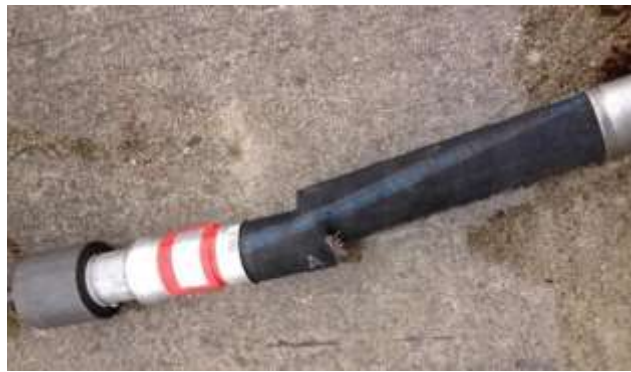
**Figure 3. Ruptured HIHTL test specimen.**

Each specimen experienced a rupture type failure, with the average maximum pressure at  $1.93 \times 10^7$  Pa. Each specimen also experienced a permanent deformation in their lengths, which averaged 0.02 m. A photo of a typical failed hose specimen is shown in Figure 3.

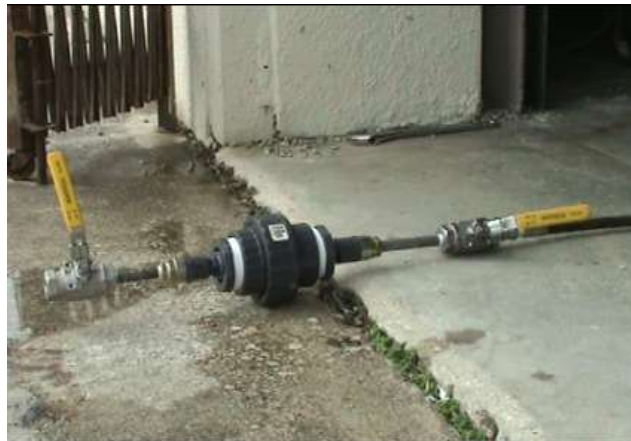
**Figure 4. O-ring pressure test rig.**

The baseline O-ring pressure testing was conducted for three EPDM O-ring specimens. The test rig and the results of the testing are shown in Figure 4 and

Each specimen maintained the allotted pressure for the 5 minute time interval. The average pressure that the O-rings were maintained at was 1.76 x 10<sup>6</sup> Pa, which was 1.38 x 10<sup>5</sup> Pa over our original desired pressure. The change in the prescribed pressure was due to the large variations in our hand-pump.

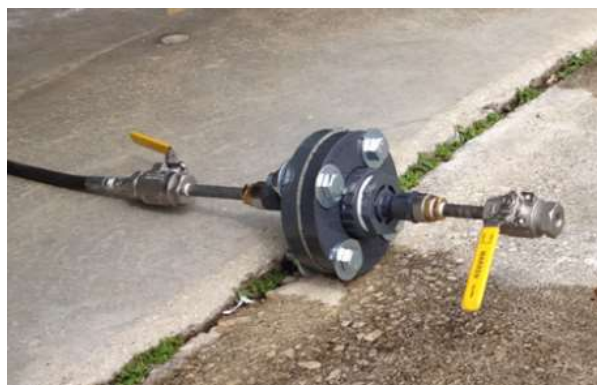
**Figure 5. Gasket baseline pressure test rig.**

The baseline Garlock® gasket pressure testing was conducted for three gasket specimens. The test rig and the results of the testing are shown in Figure 5 and Table 6, respectively.

Each specimen maintained the allotted pressure for the 5 minute time interval. The average pressure that the gaskets were held at was  $1.069 \times 10^6$  Pa, which was only  $3.447 \times 10^4$  Pa over our desired pressure.

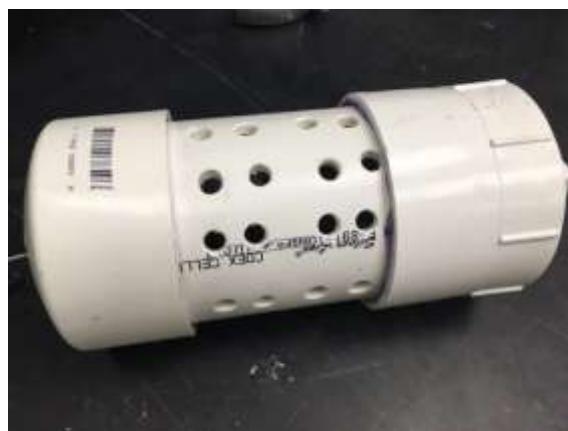
**Figure 7. Coupon aging vessel.**

The coupon aging experiment setup consisted of one coupon aging vessel (Figure 7) submerged in each of the three test loop's storage tanks. This resulted in exposing the coupons to the same conditions as the in-service configuration tests; the circulating fluid is the same 25% sodium hydroxide solution. Each vessel contains 10 coupons (5 of each type of EPDM and Garlock® materials) and was submerged in the bath for duration of 180 and 365 days.
