# **Challenges for Enhancing Fukushima Environmental Remediation**

**Dr. Yasuhiro UEZU**  
**Fukushima Environmental Safety Center**  
**Japan Atomic Energy Agency (JAEA)**

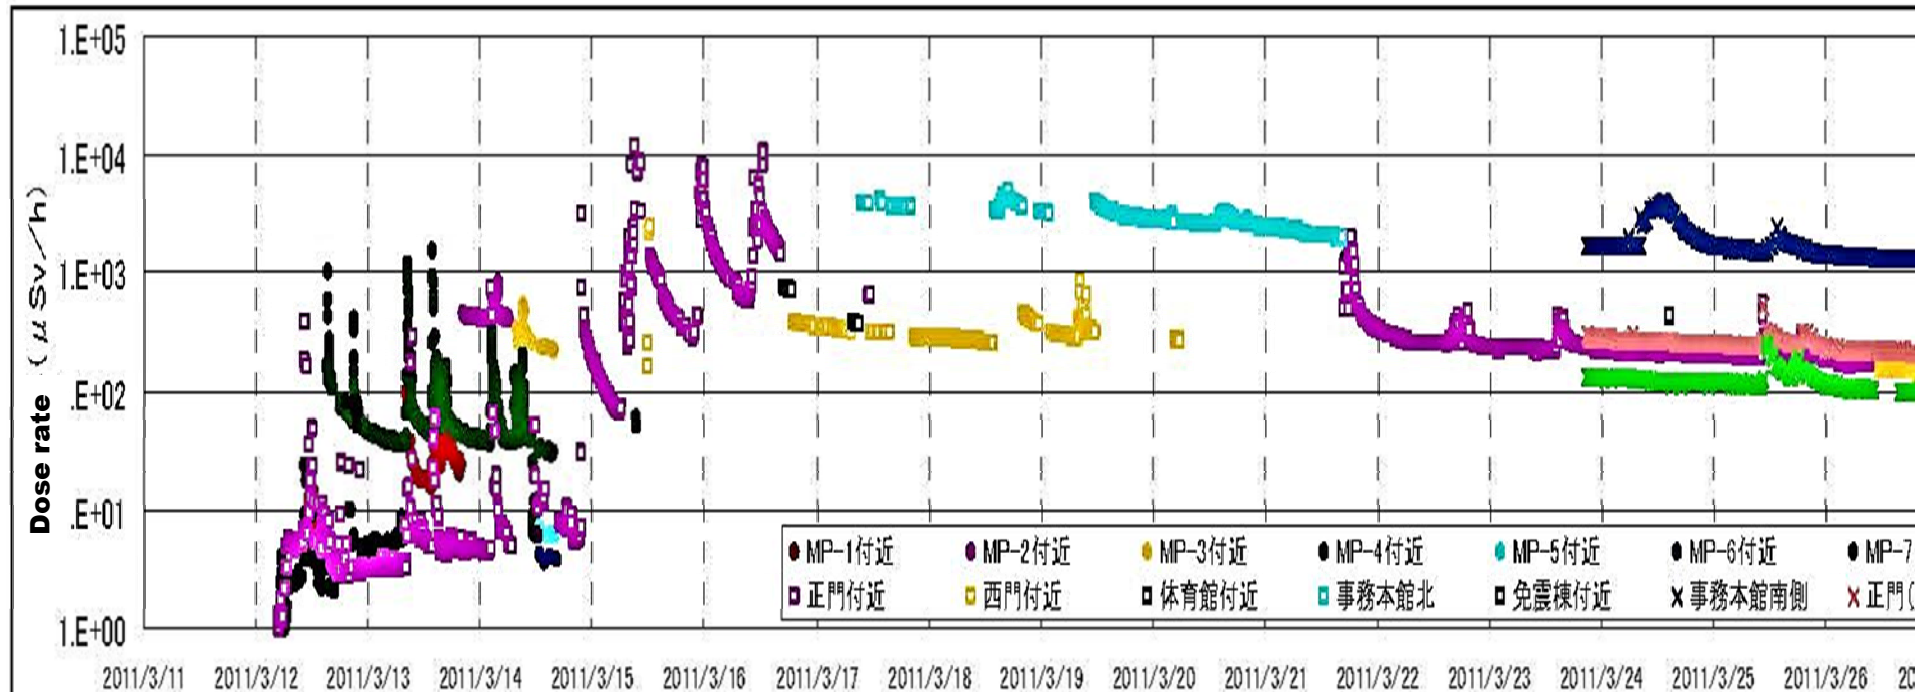
# Increasing air dose rate around plant

| ● Near MP1 | ● Near MP2 | ● Near MP3 | ● Near MP4 |
| □ Near main gate | □ Near west gate | □ Near gym. | □ North side of office buil. |
| ● Near MP5 | ● Near MP6 | ● Near MP7 | ● Near MP8 |
| □ Near seismic isolated buil. | □ South side main office Buil. | □ Main gate (Transportable MP) | □ West gate (Transportable MP) |

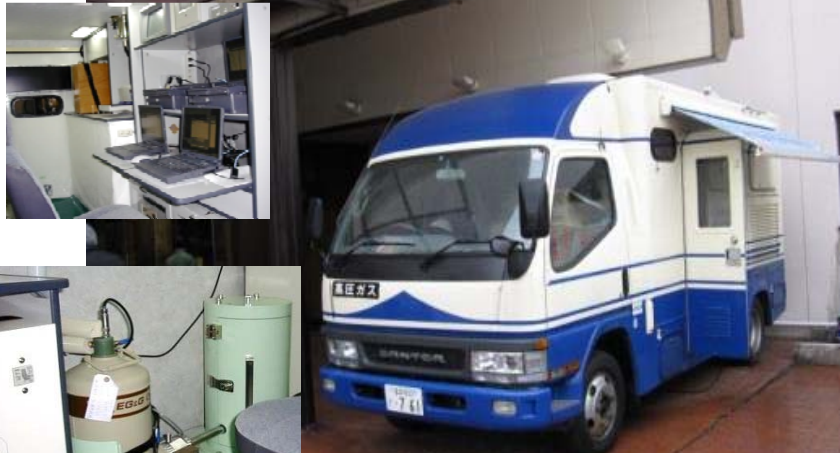
## Monitoring vehicle installed Ge spectrometer with shielding

- **Mar.14** : monitoring vehicle installed Ge detector was dispatched from NEAT-Fukui

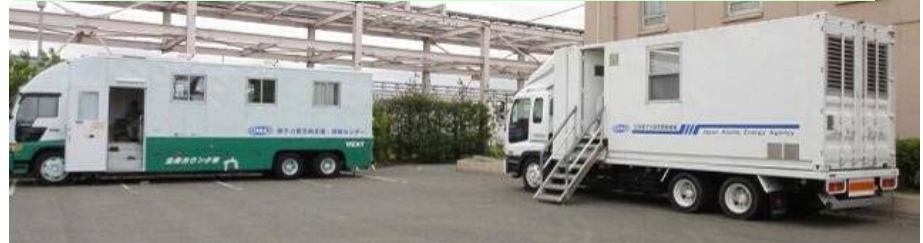
## Whole-body counter (WBC) vehicle for Internal Exposure survey for occupational

- **Mar.12** : Dispatched from NEAT-Ibaraki
- **Mar.16** : Located at Fukushima Medical College.
- **Mar.21** : Located at TEPCO Onahama
- **May.30** : Another WBC vehicle was dispatched
- Internal doses were measured and evaluated for about 330 workers until April 25.

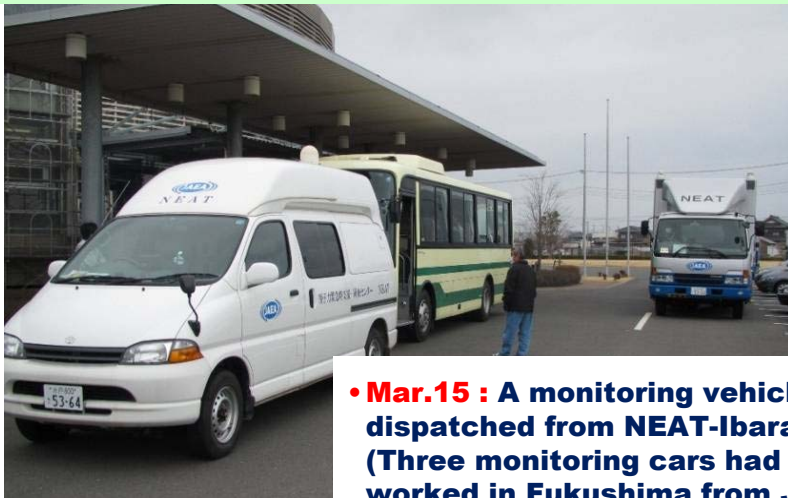
## Monitoring vehicle

- **Mar.15** : A monitoring vehicle was dispatched from NEAT-Ibaraki (Three monitoring cars had been worked in Fukushima from JAEA)

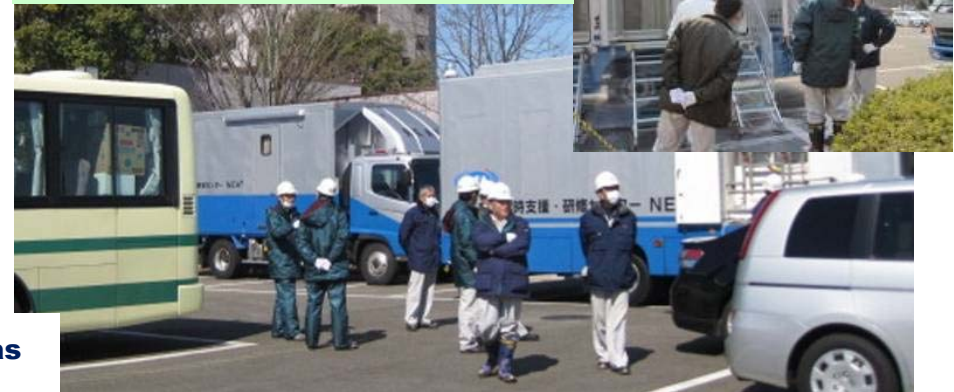
## Surface contamination monitoring vehicle and decontamination vehicle

- **Mar.15** : Dispatched from NEAT-Ibaraki
- **Mar.16** : Located at Fukushima Medical College.

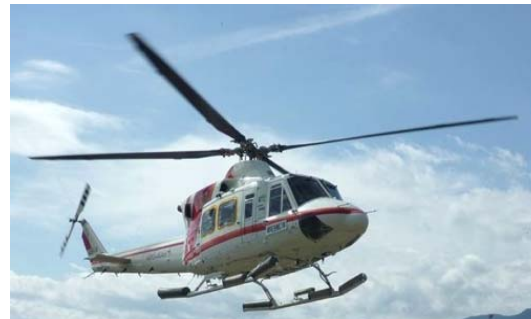
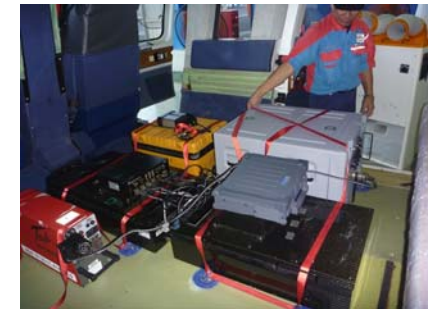
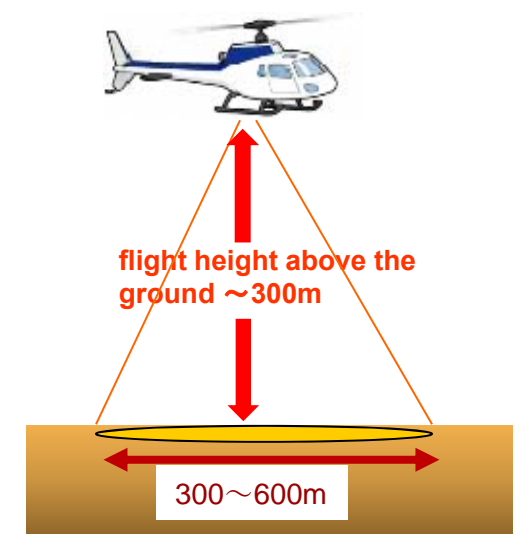
## Aerial monitoring

Det.size(inch), quantity	Energy range	Channel	Altimeter
16" × 4" × 2", 6 detector	0.02 - 3 MeV	1,024 ch	GPS

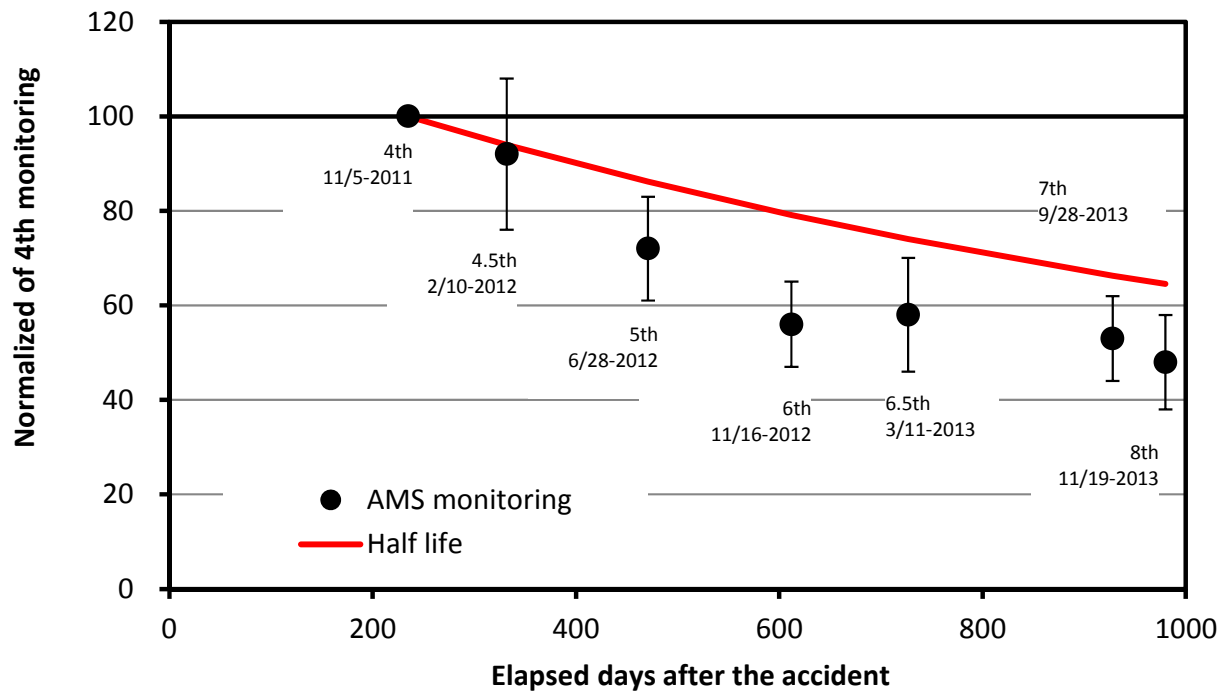
## Dose rate variation with time based on airborne monitoring

FY	2011				2012				2013			
	4-6	7-9	10-12	1-3	4-6	7-9	10-12	1-3	4-6	7-9	10-12	1-3
<80 km	1st	3rd	4th		5th		6th			7th		8th
>80 km	2nd *	East Japan 1st		West Japan and Hokkaido		East Japan 2nd		East Japan 3rd		East Japan 4th

9<sup>th</sup> monitoring after 42 months  
(2014.09.20)

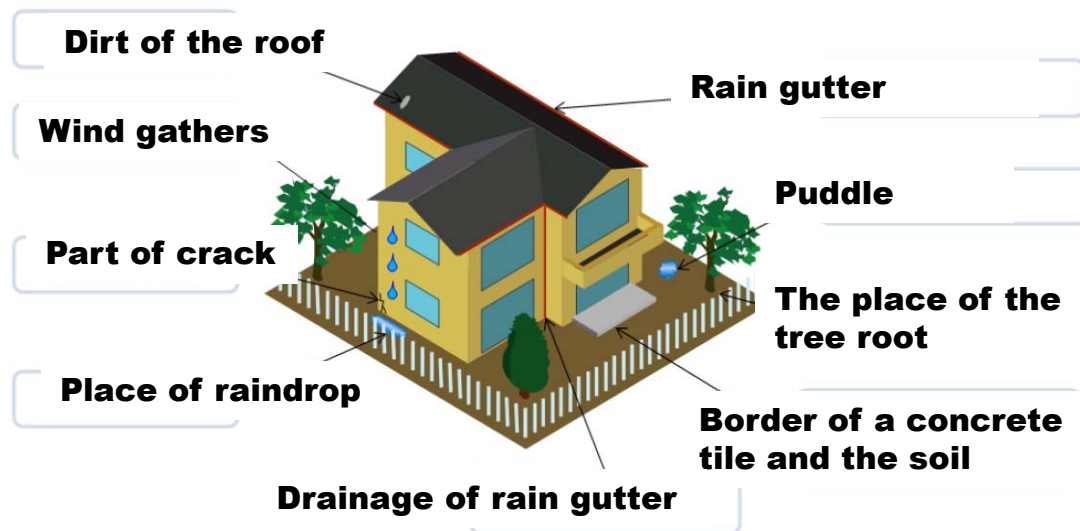
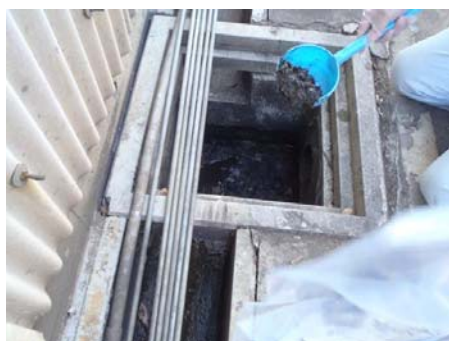
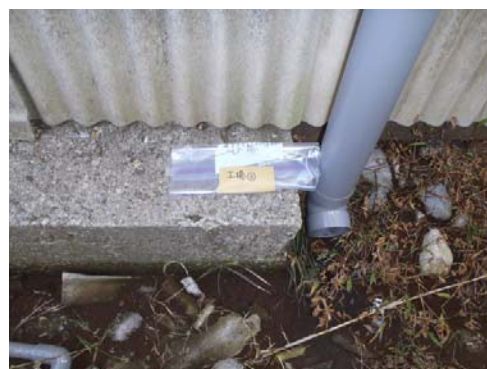
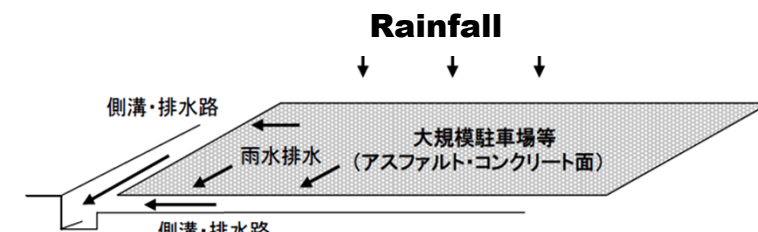
### Places of hotspots around housing

**Cs is moved to drainage with rain water**

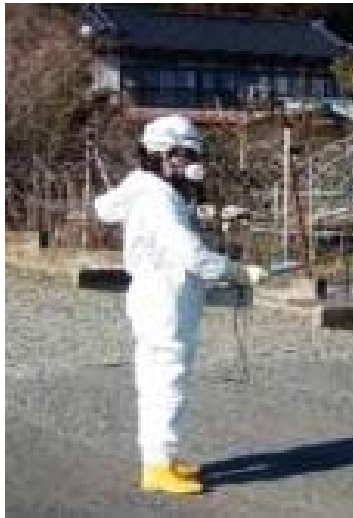
Survey for horizontal distribution of dose rate

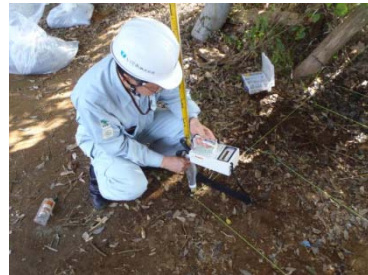
Measurement at 1cm high

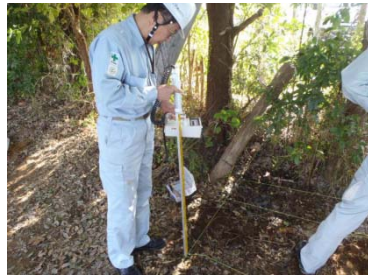
Measurement at 1m high

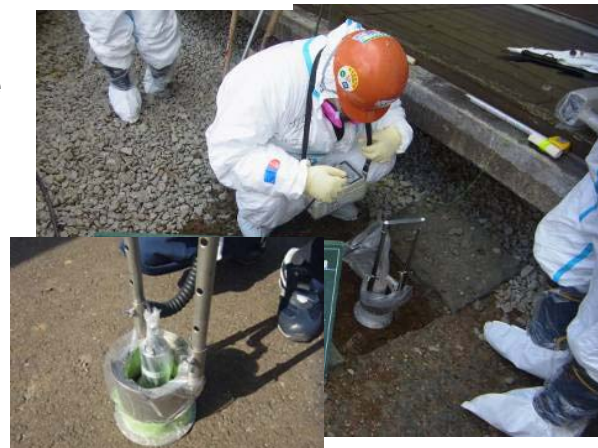
Measurement using the Collimator to eliminate scatter radiation from far area

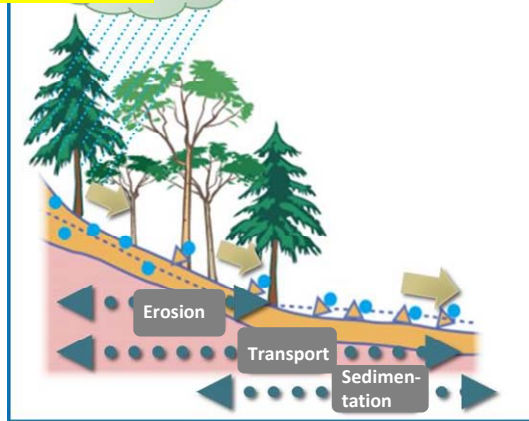
**Forest** Transport process

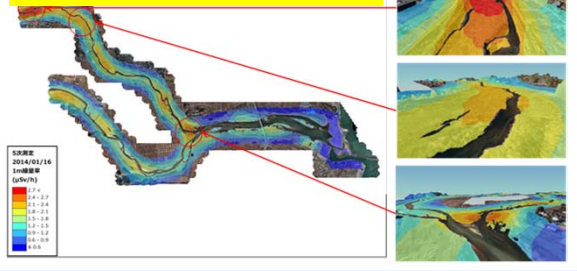
**River/Floodplain**

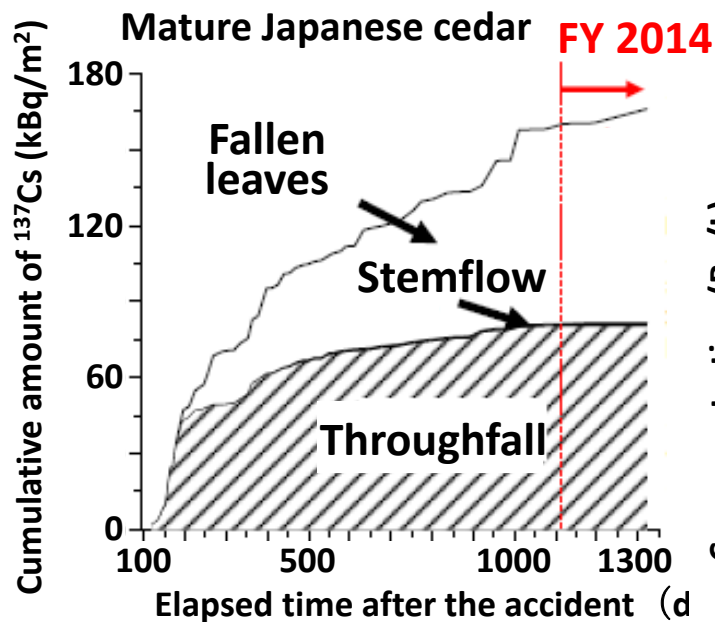
- Currently, most of Cs deposited on tree has transported to forest floor

Evolution of cumulative Cs due to transport from tree crowns to forest floor

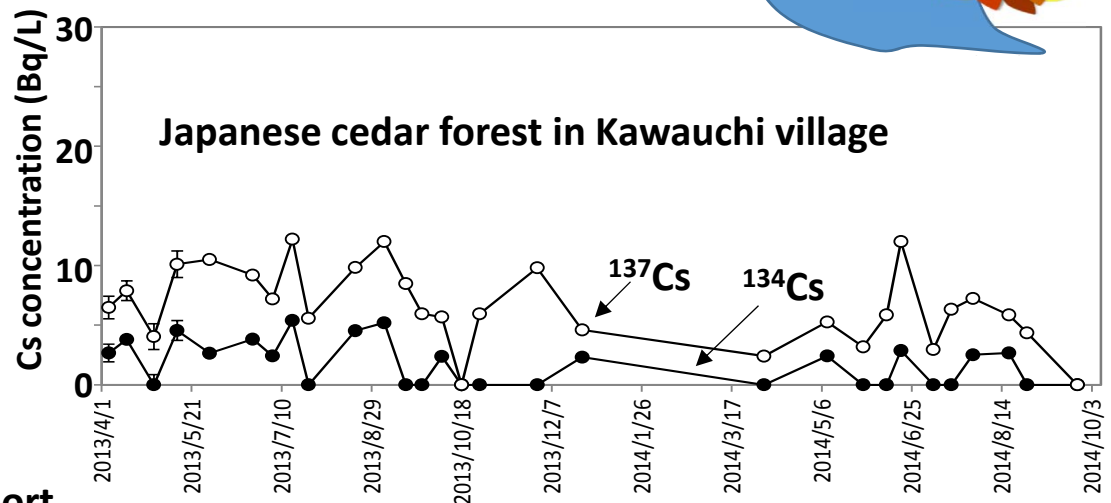
Evolution of Cs concentration in stemflow ( $\text{Bq}/\text{L}$ )
