REMEDIATION OF TWO BASINS CONTAINING RADIOACTIVE SLUDGE AT THE OAK RIDGE NATIONAL LAB – LOW TECH MEETS HIGH TECH

Angie Brill Safety and Ecology Corporation

Elizabeth Krispin Lynn Whitehead Bechtel Jacobs Company, LLC

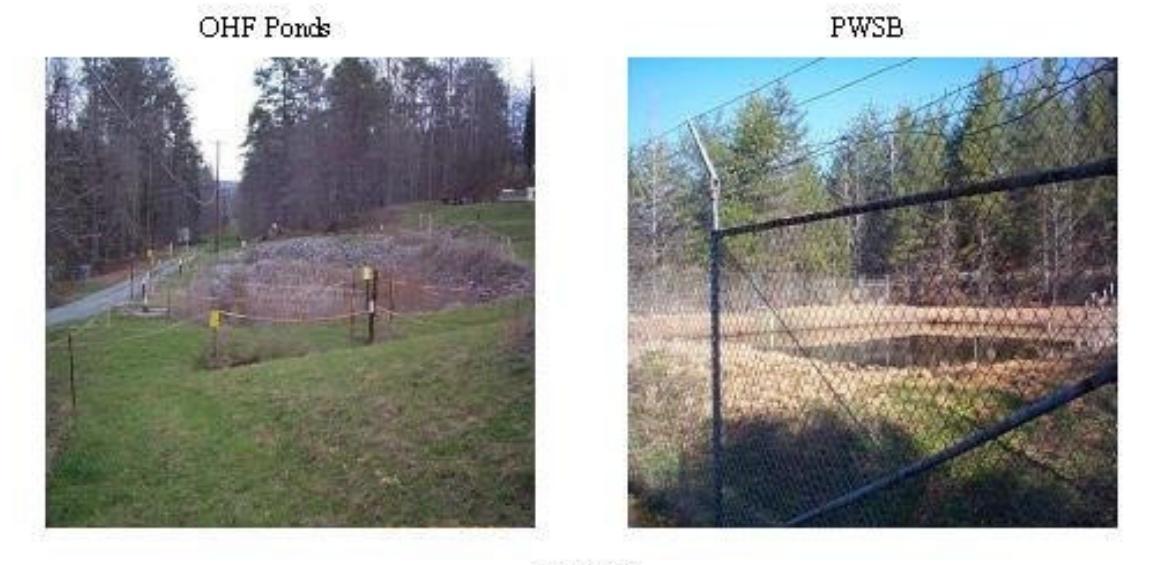
BEFORE

AFTER

Fig. 1. Basins before and after remediation.

The PWSB and OHF Pond were backfilled and covered with topsoil, then graded and contoured utilizing a dozer. The grading directed surface water flow away from the site to facilitate proper drainage and to avoid erosion. Erosion control measures (e.g., hay bales and silt fencing) were provided to stabilize the area and promote vegetative growth and prevent sediment runoff. The area was seeded using Kentucky 31 fescue and covered with straw for protection. The seed was applied at 50 lb/acre. Upon completion of these remedial activities, both the OHF Pond and PWSB sites were surveyed for radiation and the radiation postings were removed.
