#### Demolishing a Cold-War-Era Fuel-Storage Basin Superstructure Laden with Asbestos - 9475

E.R. Lloyd, J.M. Stevens, L.C. Zinsli, M.A. Green, C.H. Larson Fluor Hanford, Inc. P.O. Box 1000, Richland WA 99352

Phase Two, and the focus of this paper, is the demolition of the superstructure (above grade) portion of the KE Basin, which included the above-grade structure immediately covering the basin, a portion of the administrative area adjacent to the basin, and the reactor basin interface area.

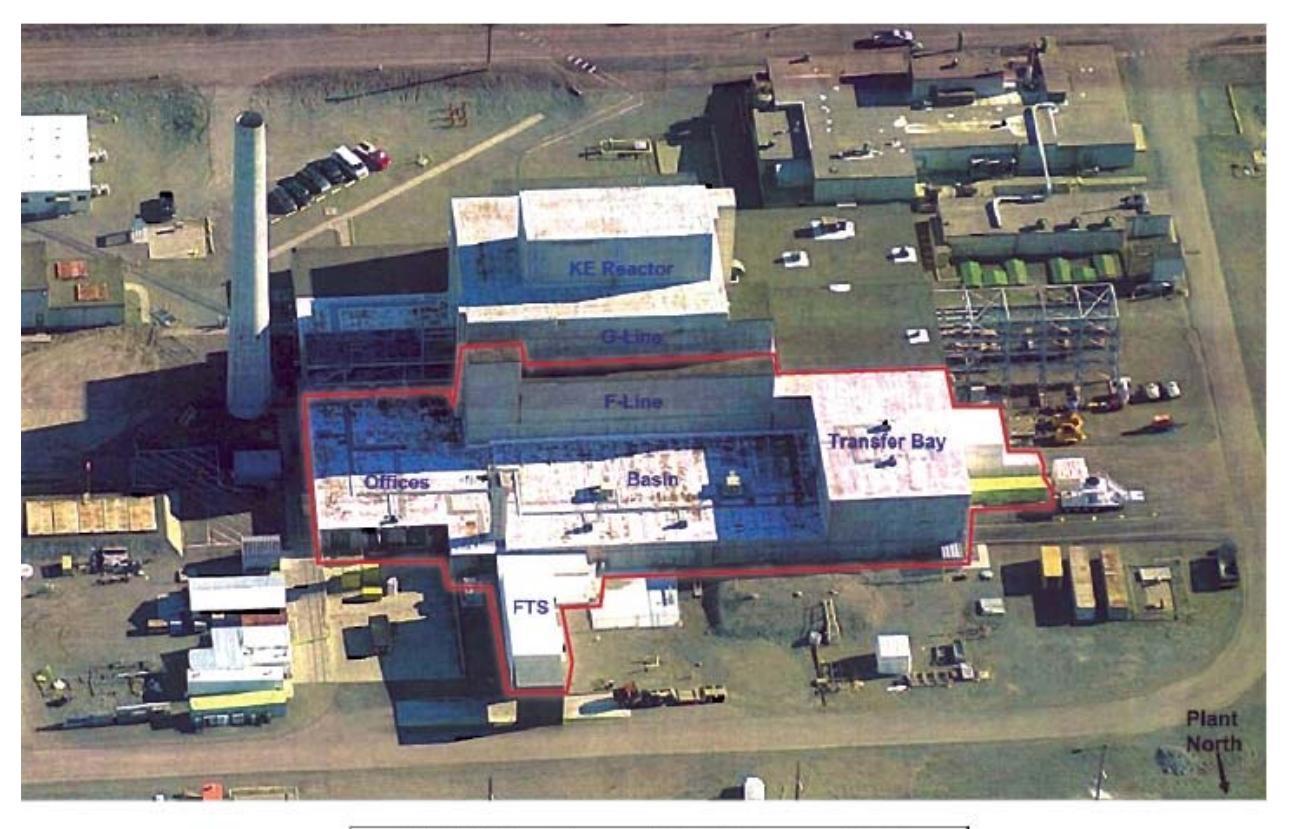
The project scope included the KE Basin superstructure covering of the basin proper, the Fuel Transfer Station (FTS), the office complex, the transfer bay and the F-to-G line portion where the superstructure is attached to the main reactor building (Fig. 1). The basin's superstructure was primarily steel columns and beams covered with cement asbestos board (CAB) siding and CAB/built up roof. The superstructure built immediately over the basins and transfer bay ranged from 5 meters to 12 meters high and was 23 meters wide and 71 meters long. The F-G Line, or reactor basin interface area, ranged in height from 12 to 22 meters high, 5 meters wide, and 71 meters long. The office area was 5 meters high, 17 meters wide and 22 meters long. The FTS annex was a metal-skinned steel structure built in the early 1980s.

Fig. 1. This aerial view shows the superstructure covering the KE Basin facilities.

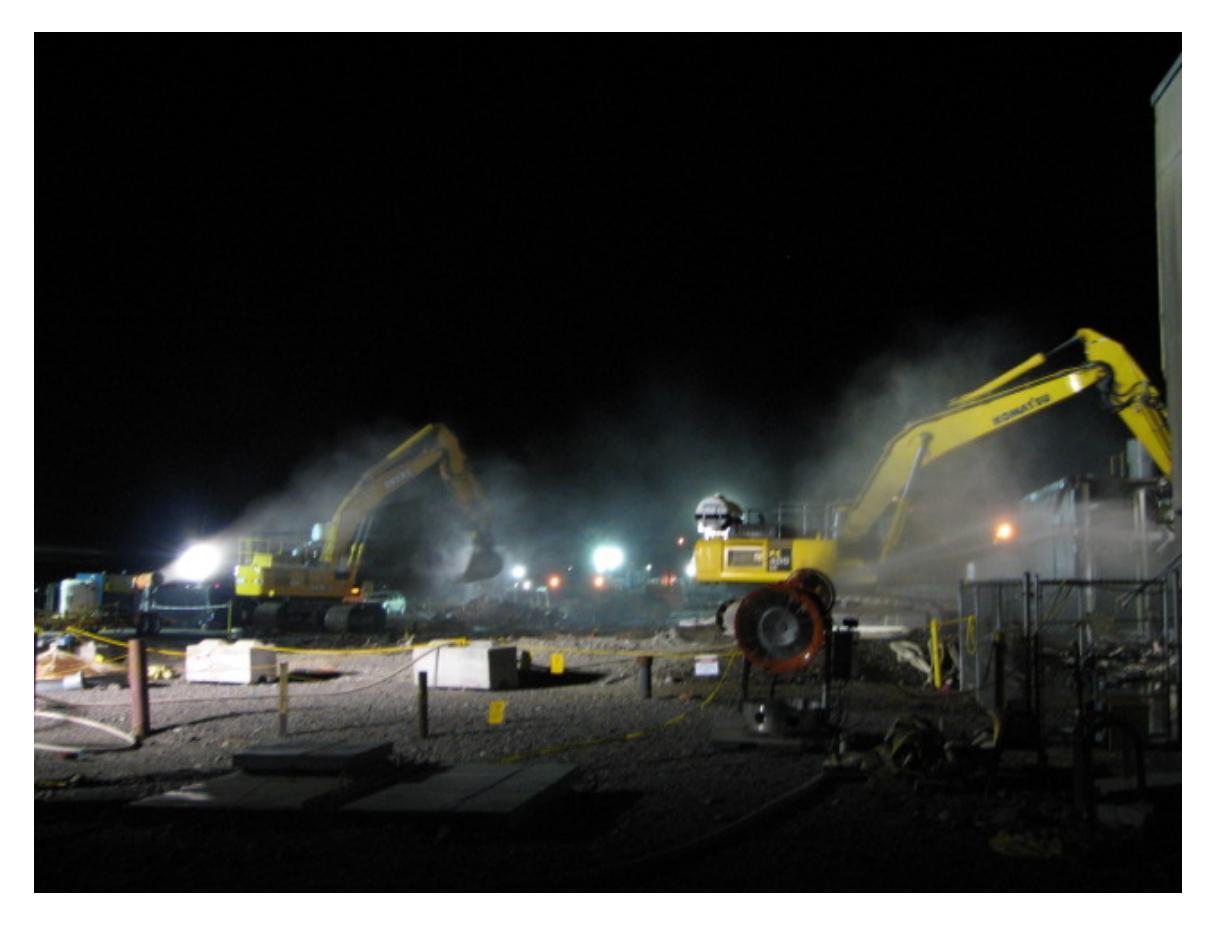
The demolition progressed with two 10-hour shifts. The day crew focused on demolition because the lighting provided better working conditions, especially with the high-reach operations. The night shift demolition crew's focus was on removing waste and packaging the material demolished during the day shift (Fig. 2).

### Fig. 2. Demolition of the KE Basin's superstructure literally continued round-the-clock.

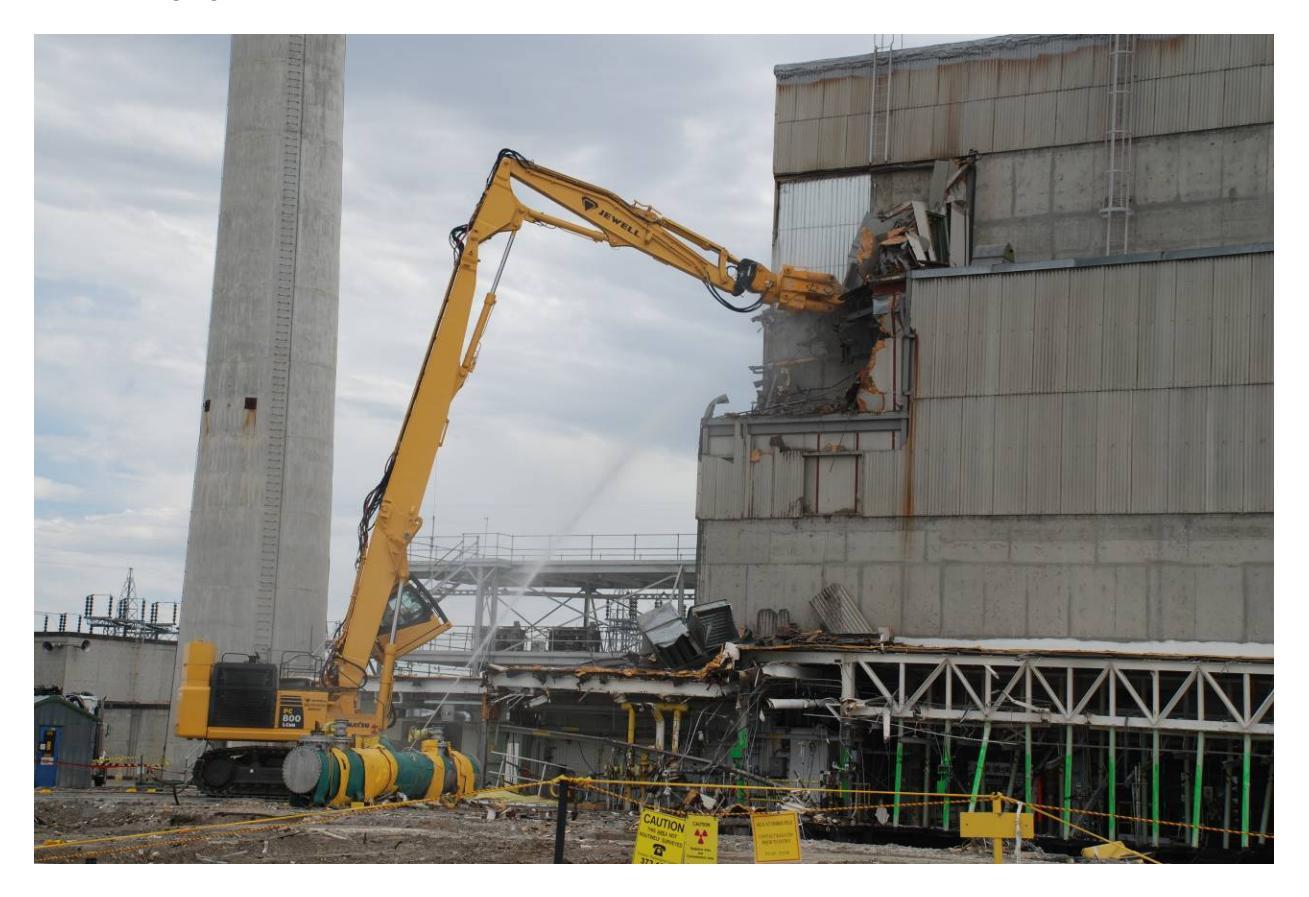
The taller sections of the project were removed by a high-reach demolition excavator (Fig. 3). This equipment provided a safe method to bring the building to the ground while minimizing damage to the reactor wall as the floors were structurally "tied" into the reactor wall. All piping and conduit penetrations of the wall were isolated during demolition preparation activities, so there was no concern about damaging the wall or items on the other side of the wall.

Fig. 3. A high-reach excavator was used to demolish the F-G (reactor interface area) area.

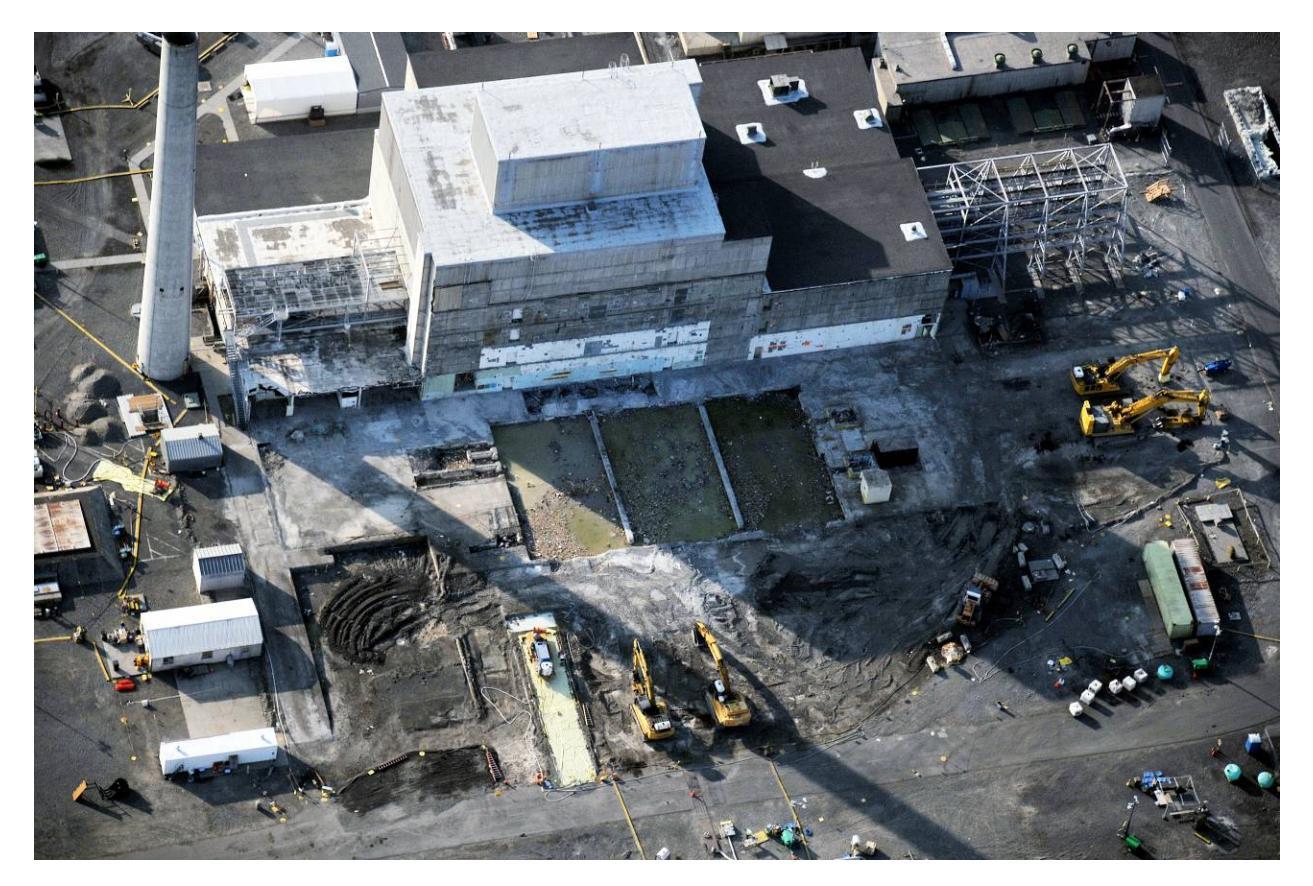
At the conclusion of the basin superstructure demolition activities (Fig. 4), the area was prepared for phase three, basin removal.

Fig. 4. The superstructure has been completely removed to slab-on-grade.
