Design, Development, Pre-Testing and Preparation for Full Scale Cold Testing of a System for Field Remediation of Vertical Pipe Units at the Hanford Site 618-10 Burial Grounds -12495

Stephen Halliwell, VJ Technologies Inc. 89 Carlough Road, Bohemia, New York, 11716, USA

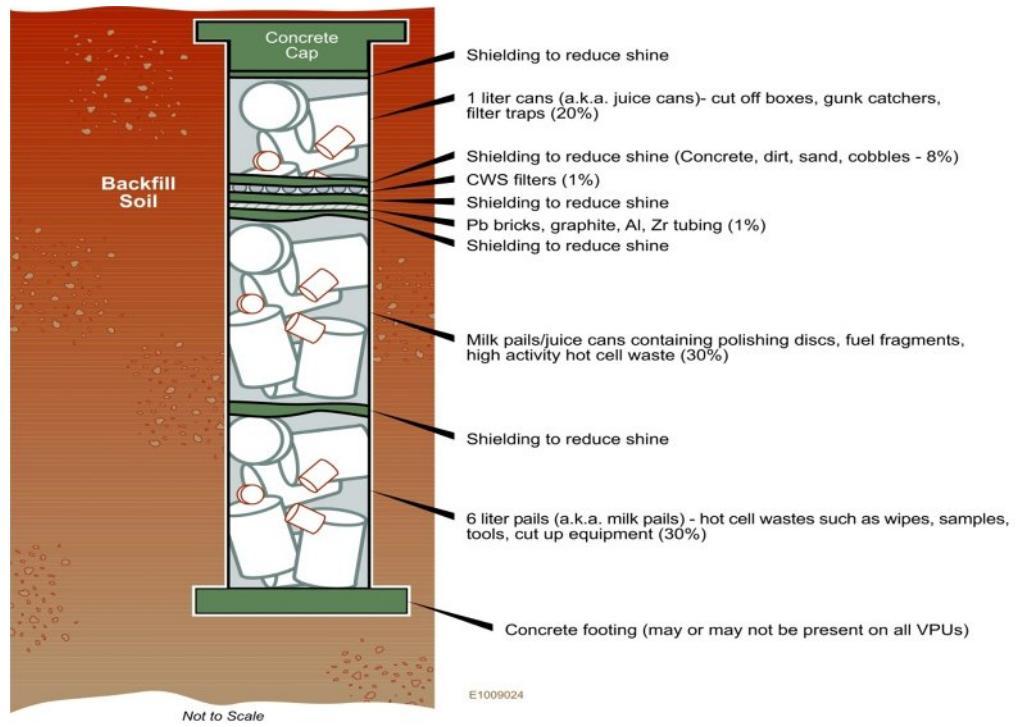
Figure 1. Diagram of Vertical Pipe Unit

TRU wastes and other high dose rate waste with contact doses up to 500 R/h, and was packaged in "milk pail" disposal cans and placed in the VPUs. In addition to radioactive wastes, it is possible that quantities of energetic reactants have been placed in the VPUs. The VPU bounding condition for reactants is considered to be a single can containing 270 grams of un-reacted sodium potassium (NaK) that has oxidized to 120 grams of potassium superoxide (KO₂); that represents approximately 2.6E+05 joules of energy to be released in an explosion of the superoxide. This represents the bounding condition for any combination of energetic reactants (e.g., NaK and picric acid). Figure 1 shows a diagram of the VPU construction and contents.

Most of the vertical pipe units were constructed by cutting the tops and bottoms out of 200 liter (55-gallon) drums and welding five drums together to form a cylinder, approximately 4572mm (15 feet) long and 559mm (22 inches) in diameter. To install the 200 liter (55 gallon)-style VPUs, an excavation was prepared to a depth of about 4572mm (15 feet) and the VPUs were set vertically on the soil or a concrete footing (possibly cinder blocks or concrete payers) and the excavation was backfilled. The VPUs were positioned on approximate 3048mm (10 ft) centers.

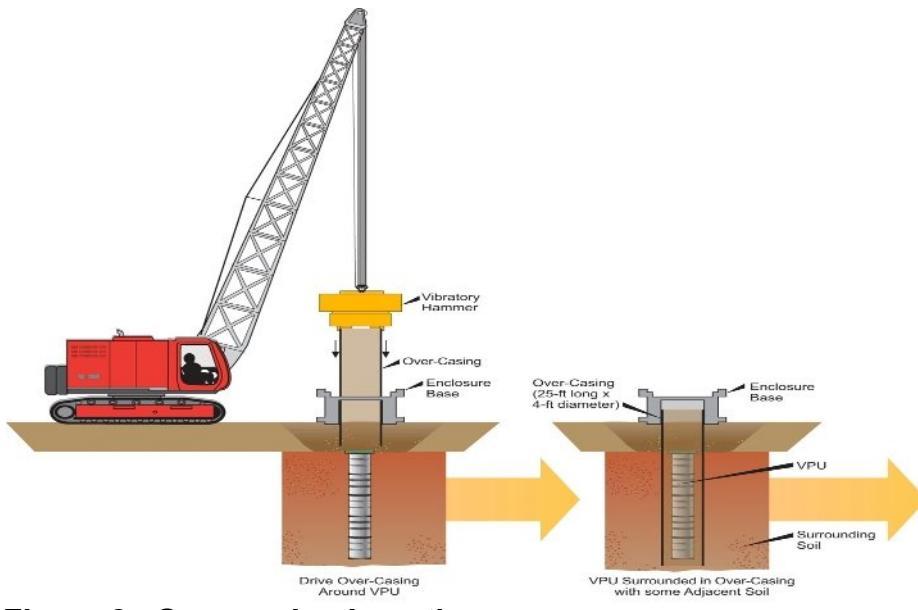
Figure 2. Over-casing Insertion

Step 1: Insertion by vibratory hammer of a 7620mm (25 feet) long, 1219mm (48 inches) diameter, steel tube into the ground, to form an over-casing around the

VPU, and extending approximately 1524mm (5 feet) beyond the bottom of the VPU. See figure 2.

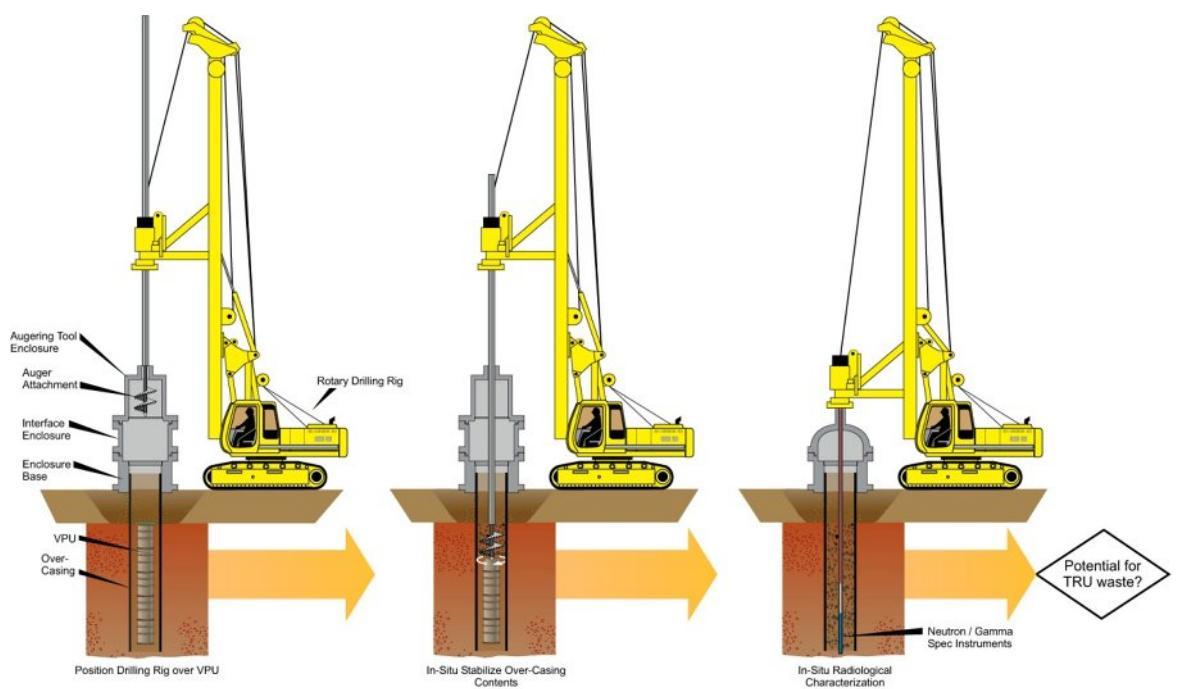
Figure 3. Size Reduction, Stabilization and Mixing.

Step 2: Size reduce and stabilize the contents of the VPU, within the steel overcasing by means of a 1168mm (46 inch) diameter auger. See figure 3.

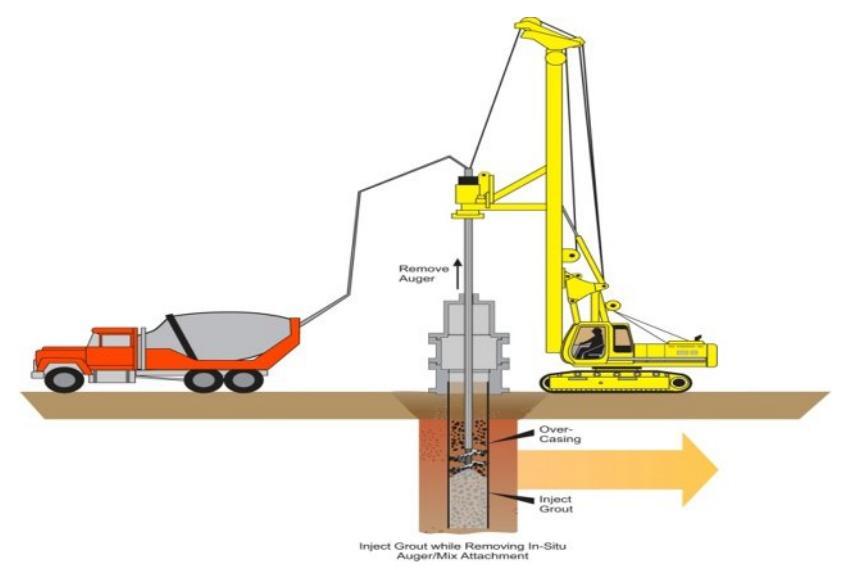
Figure 4. Grouting of Over-casing and VPU

Step 4: If the waste is acceptable for disposal at ERDF, introduce a highly penetrating cement based grout mix with the size reduced VPU contents. When cured the steel over-casing will contain the grouted VPU contents in "monolith" form. See figure 4.

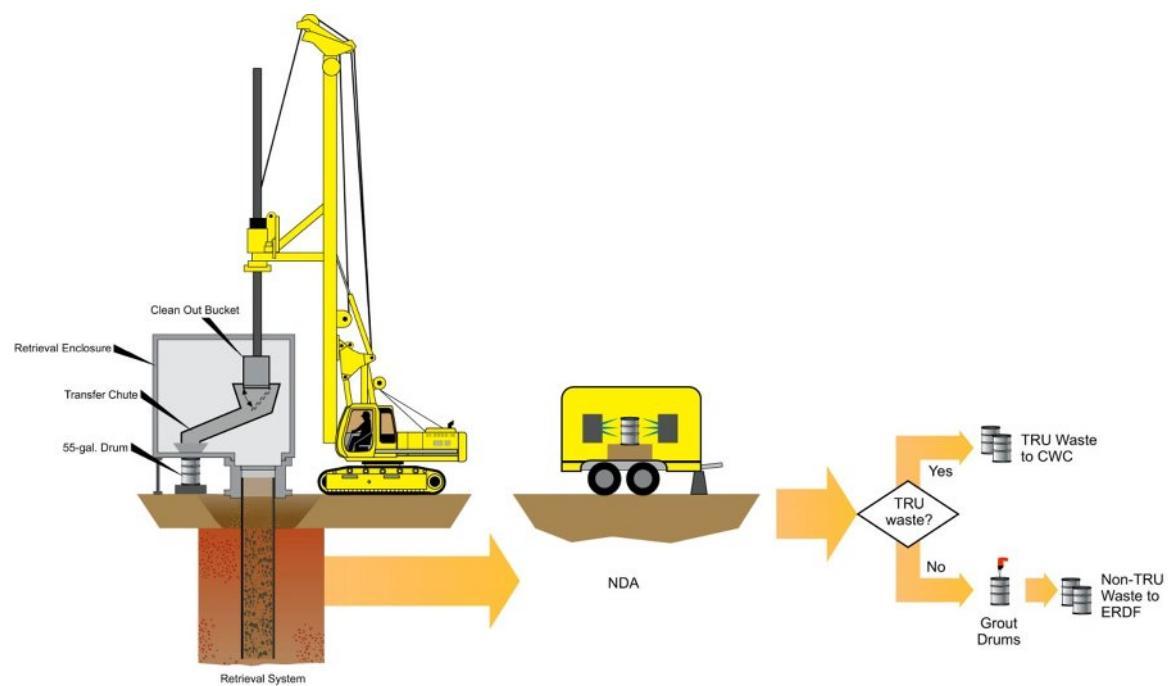
Figure 4. Waste Removal

Step 5: If the waste is suspect TRU, remove the waste and place into 55 gallon drums for characterization at CWC Hanford. See figure 4.

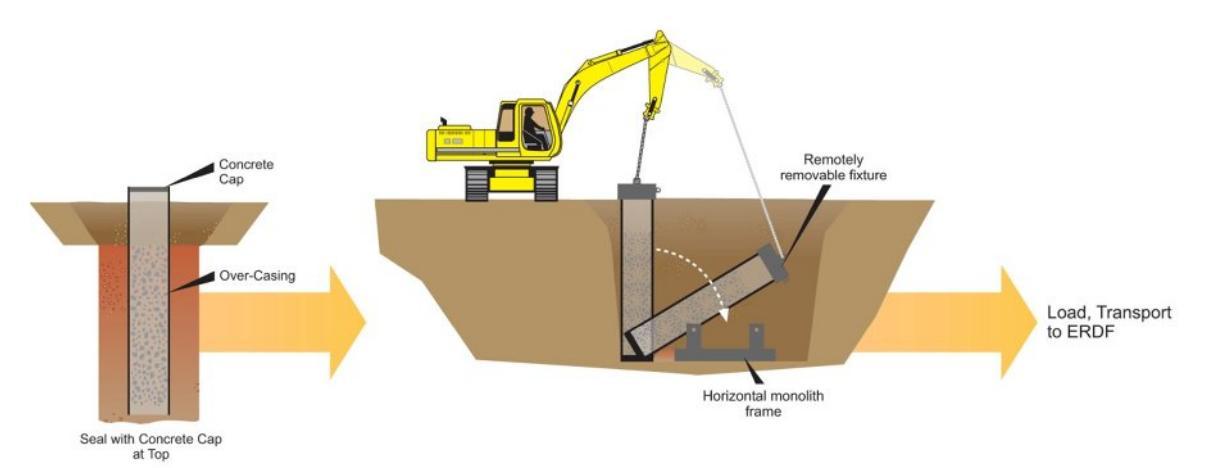
Figure 5. Removal of Grouted Monoliths

Step 6: The cured monoliths will be removed by removing the soils alongside the VPUs to form a large trench that will enable the VPU monolith to be tilted, lowered to the horizontal, and moved to ERDF.

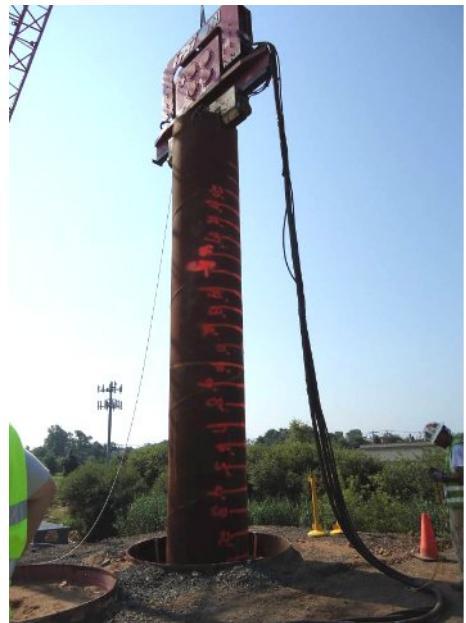
Figure 6: Over-casing with vibratory hammer

Figure 6 shows a 1219mm (48 inches) over-casing and vibratory hammer at the test facility during pre-testing.

Vibratory hammers contain a system of counter-rotating eccentric weights, powered by hydraulic motors, and designed in such a way that horizontal vibrations cancel out, while vertical vibrations are transmitted into the over-casing, to which the vibratory hammer is fastened by a clamp mechanism.

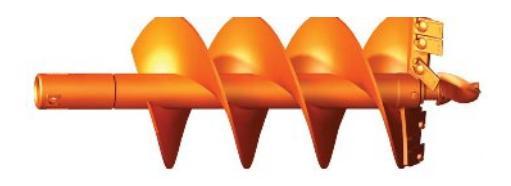
Figure 7: Earth Auger

Earth auger- These augers are primarily made for digging holes in dirt. They are efficient at penetrating soil, scooping material, and bringing material to the surface. The teeth of the auger are flat and angled horizontal relative to the surface of the ground. This orientation increases its ability to scoop material but greatly restricts it to grinding harder material. Its grinding and penetrating power is weak relative to other augers.

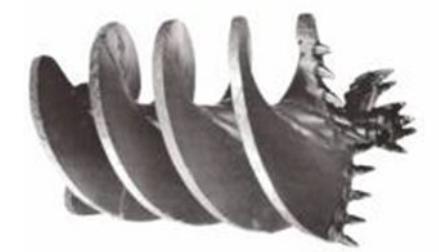
Figure 8: Rock Auger

Rock auger- Rock augers are designed for penetration of hard materials and surfaces. Appropriately specified, it optimizes the ability to grind and mix material while penetrating deeper depths. These augers can utilize carbide teeth, which help the augers ability to grind and shred material.

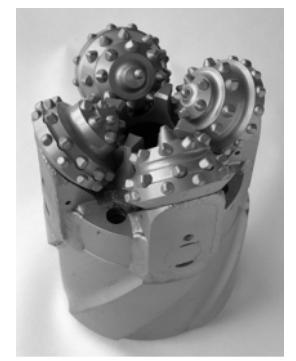
Figure 9: Tri-cone Auger

Vertical shaft Tri-cone augers - This auger configuration uses a tri-cone bit to grind material at the bit surface. Although it is very effective at shredding rock and concrete it requires either air or water to move material to the surface and away from the bit head.

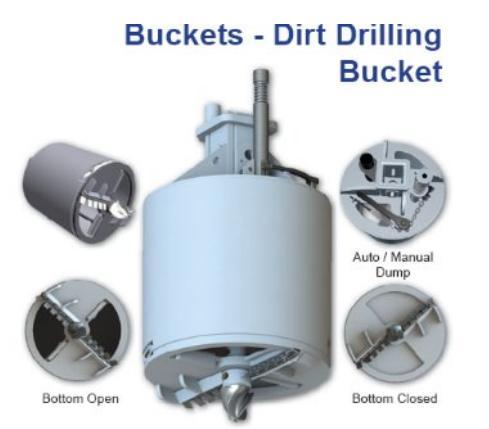
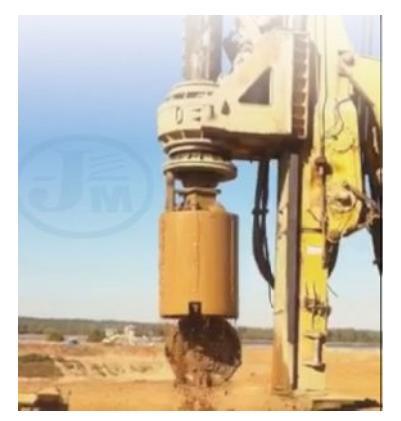
The retrieval bucket was selected for pre-testing as the most appropriate method of waste removal. These buckets are shown in figures 10 and 11.

Figure 10. Drawing of Retrieval Bucket

Figure 11. Retrieval Bucket in use

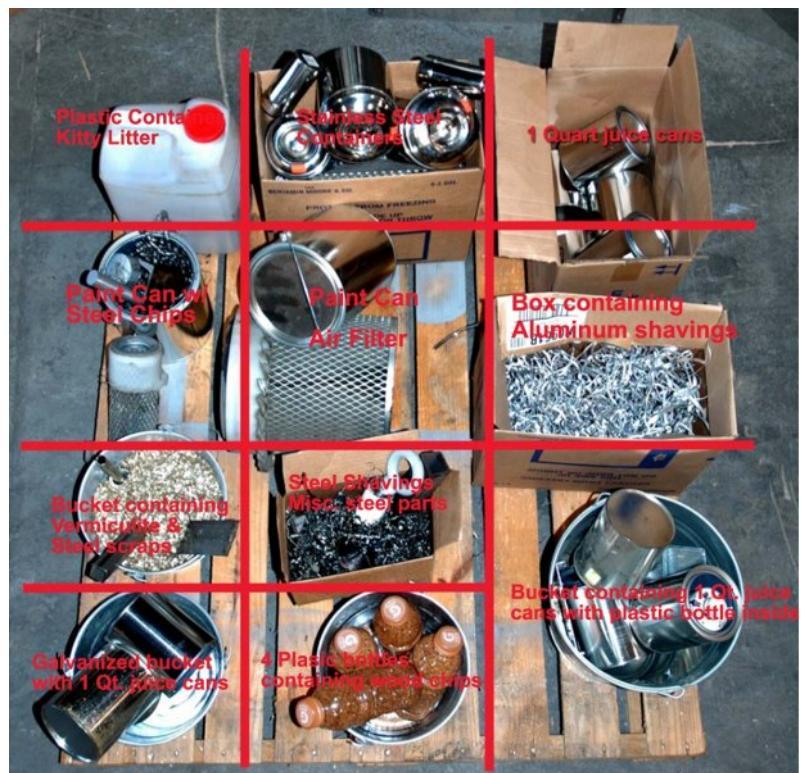
Figure 12. Surrogate VPU Contents

The surrogate VPUs were constructed from 200 liter drums, 5 of which were filled with materials to represent the contents of the Hanford VPUs. Figure 12 shows a selection of contents of the surrogate VPUs, and figure 13 shows the various stages of assembly of the surrogate VPUs.

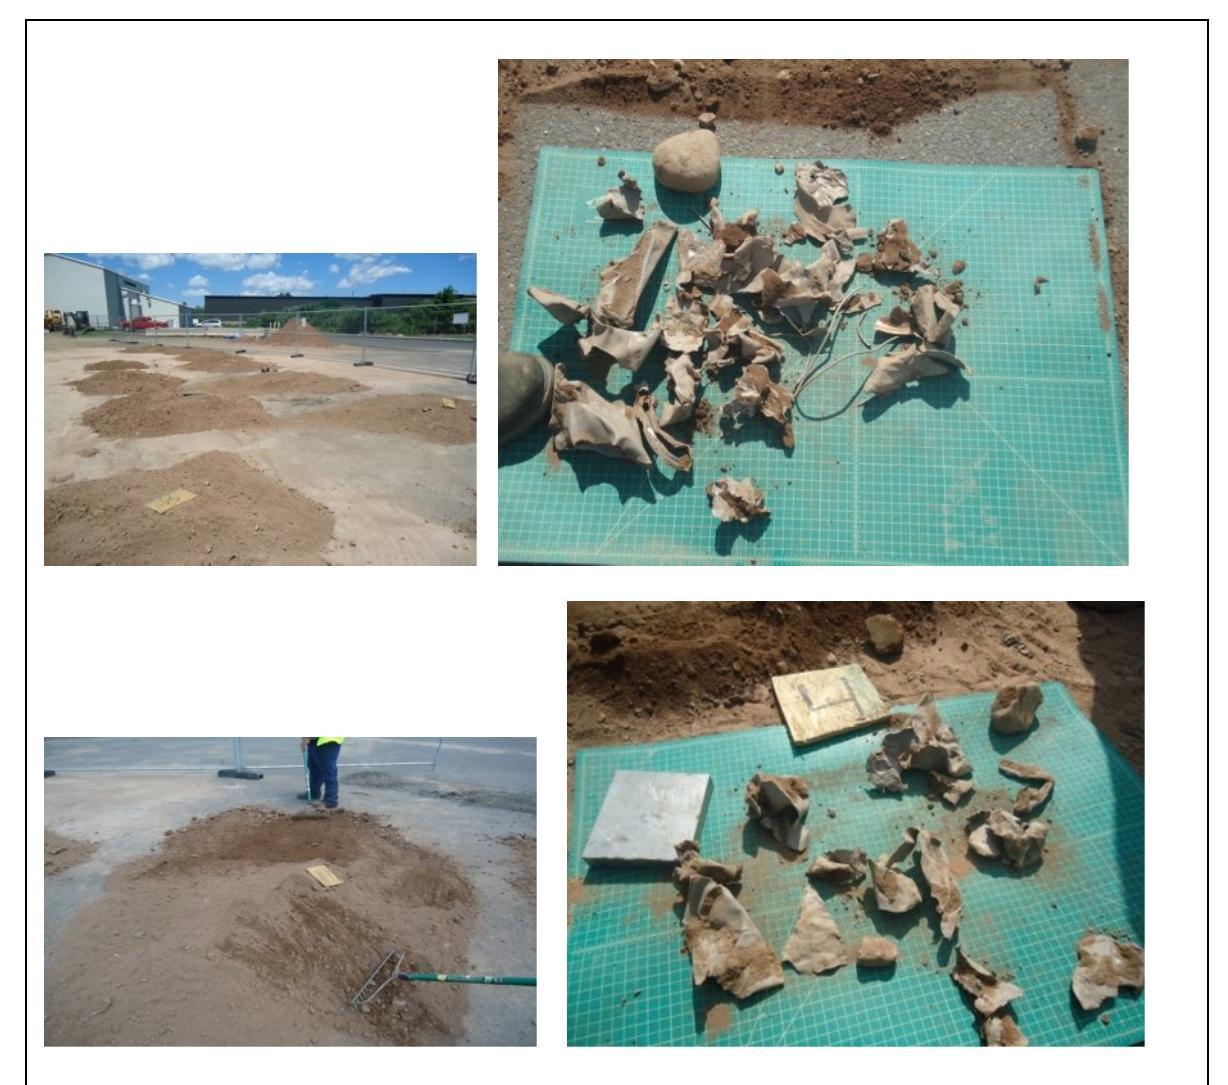
Figure 14. Size Reduced VPU Contents

A number of sizes of augers and auger types were tested, and it was proved that the surrogate VPUs could be size reduced as required, and that all containers within the VPUs were breached and that the VPU contents and surrounding soils were effectively mixed. Effective mixing will stabilize, in-ground any reactive materials such as un-reacted NaK or super oxides. The size reduced VPU contents were removed from the over-casing for examination. See figure 14.

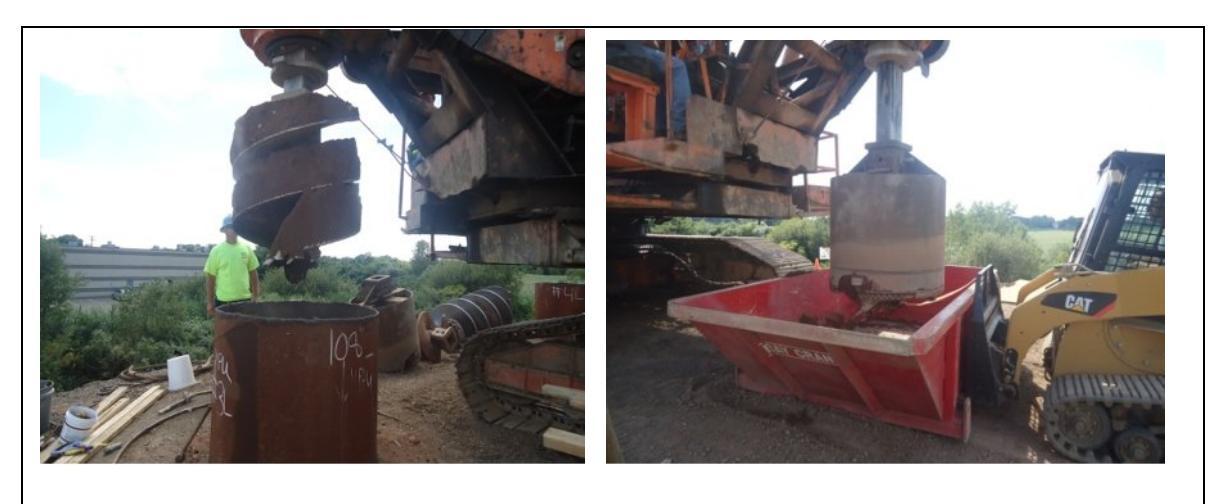
Retrieval of size reduced materials was effectively done using a bucket auger and a rock auger. See figure 15.

Figure 15. Removal by Rock Auger (Left photo) and by Bucket Auger (Right photo)
