Linde FUSRAP Site Remediation: Engineering Challenges and Solutions of Remedial Activities on an Active Industrial Facility – 13506

Christopher M. Beres*, E. Joseph Fort*, and James D. Boyle** *Cabrera Services, Inc., 473 Silver Lane, East Hartford, CT 06118, cberes@cabreraservices.com **United States Army Corps of Engineers – Buffalo, 1776 Niagara Street, Buffalo, NY 14207

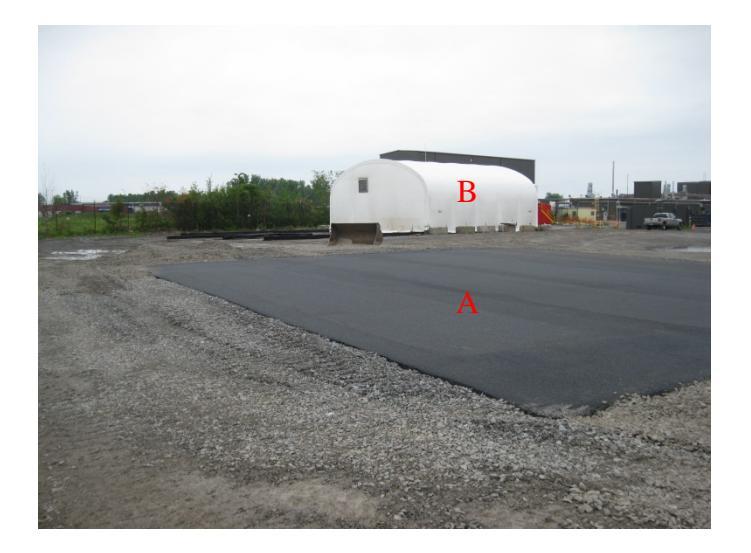
A: New asphalt pad B: Salt Barn in old location

Fig. 1. Asphalt pad in relocation spot with salt barn in previously existing location.

USACE and CABRERA coordinated with Praxair to select the relocation spot. It was agreed the salt barn would be placed on a heavy duty asphalt pad approximately fifty-three meters northeast of its current location while also being rotated approximately 100 degrees. This location positioned the salt barn atop previously remediated areas while providing at least three meter clearance from the nearest active underground utility and eight meter clearance from nearby high voltage power lines. The heavy duty asphalt pad was constructed of thirty centimeters of NYS Department of Transportation (DOT) #2 run-of-crusher stone subbase compacted to ninety-five percent standard proctor density, ten centimeters of NYSDOT Type 3 binder, and five centimeters of NYSDOT Type 7 top coat. The pad was constructed three meters larger than the salt barn in each dimension to provide ample space for positioning. The pad was also constructed approximately thirty centimeters higher than the surrounding grade with a half percent slope to keep surface water off the pad while promoting positive drainage. An asphalt ramp approximately eight meters wide by eight meters long was constructed to provide access for salt storage and loading. The asphalt pad and old salt barn location are shown in Figure 1. An asphalt pad was selected over a reinforced concrete slab-on-grade to maintain the semipermanent nature of the whole structure.

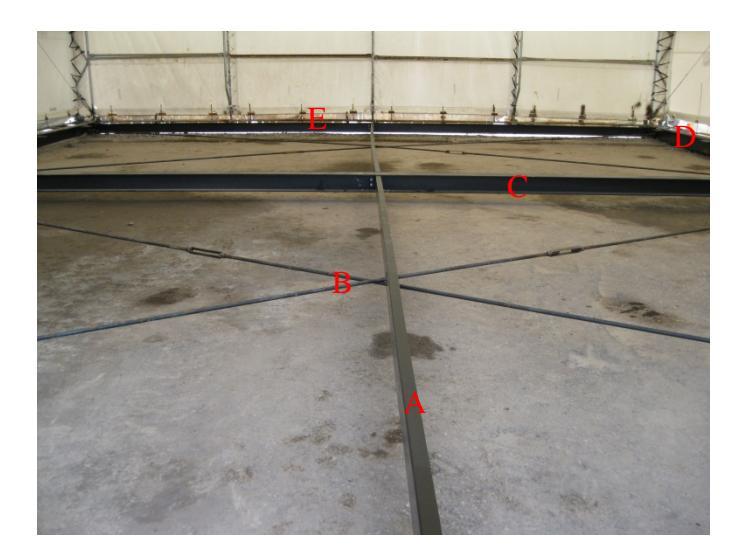
- A: C8x13.7 channel
- B: Threaded rod cross brace
- C: W8x35 beam
- D: W10x49 beam with support plates
- E: W8x35 beam with support plates

Fig. 2. Salt barn frame support system.

The most challenging task was designing a system capable of supporting the salt barn from collapse while allowing it to traverse rugged terrain during the move to its new location. The final design utilized a series of support plates and "I" beams to support the salt barn frame. One W10x49 beam with eight, two centimeter thick support plates welded to it was specified to run

each length of the salt barn. Six of the support plates were located where the six trusses attach to the base beam. The remaining two support plates were installed for permanent anchoring in the new location. The base beam was connected to the support plates using two, one centimeter "U" bolts. One W8x35 beam with three welded support plates supported the rear (opposite the opening) of the salt barn. The base beam was attached to these support plates with one, one centimeter "U" bolt. A second W8x35 beam was placed across the width of the salt barn halfway down its length. This beam was bisected with two C8x13.7 channel pieces. The front of the salt barn required two W8x35 beams with two support plates each and one W8x35 beam with no support plates. The beams with support plates were used to support the salt barn frame (similar to the rear) while the beam without support plates spanned across the salt barn opening. Splicing using nuts and bolts and/or welds was required at all locations where beams and channel were joined or intersections existed. The beams and channel were tensioned using cross braces created with two and one-half centimeter diameter threaded rods and turnbuckles. The assembled salt barn frame support system is shown in Figure 2.

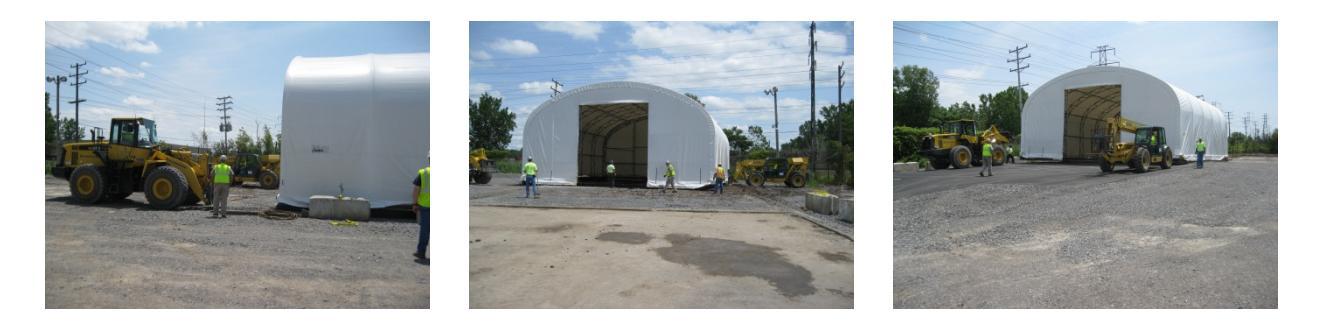
Fig. 3. From left to right, phase one, phase two, and phase three of the salt barn move.

To move the salt barn, skid plates were welded to the bottom of the four corners and midpoints of the support beams. The skid plates were one centimeter thick steel with thirty to forty degree upward bends which allowed the beams to ride over the terrain instead of plowing through it. Moving the salt barn required two pieces of heavy equipment and would be completed in three phases. In phase one, each piece of heavy equipment pulled from the rear of the salt barn with parallel and equal tension. This moved the salt barn approximately thirty meters due East from its former location. Phase two was the most difficult part of the move; rotating the salt barn. The heavy equipment were placed at opposite corners of the salt barn and pulled with equal tension in opposite directions thus rotating the salt barn approximately 100 degrees. The rotation properly oriented the salt barn with the new asphalt pad. Phase three, like phase one, pulled with parallel and equal tension except the pull was made from the front of the salt barn in a northern direction for approximately thirty-eight meters to the new asphalt pad. The three phases of the salt barn move are shown in Figure 3.

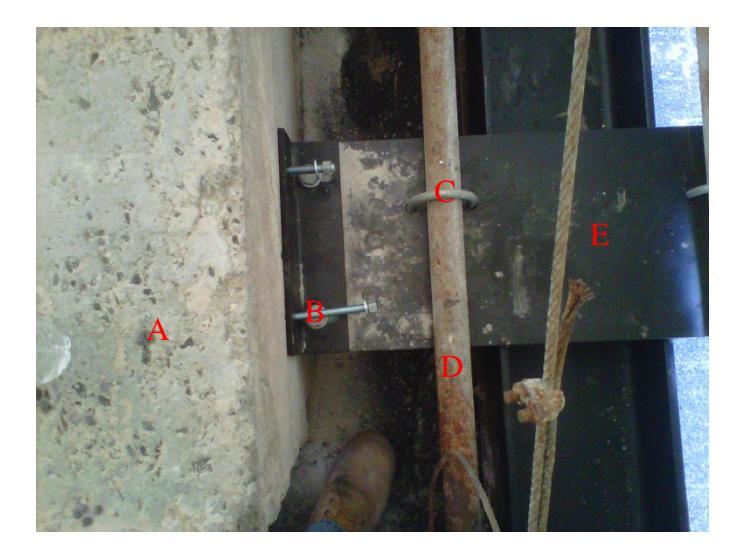
A: Anchor blockB: Anchor boltC: "U" boltD: Salt barn base beamE: Support plate

Fig. 4. New permanent anchoring system.

Anchoring the salt barn to the asphalt pad was not desired so a new permanent anchoring system would need to be designed. When properly anchored, the salt barn is designed to withstand wind loads of 145 kilometers per hour and snow loads of two and one-half newtons per square meter with the cover attached. The new anchoring system would need to allow the salt barn to at least meet these design criteria and is shown in Figure 4. The support plates required for supporting the salt barn during transport were anchored to a concrete block (anchor block). Each anchor block is approximately one-half meter by one-half meter by two meters and weighs roughly 1,600 kilograms. The support plate was anchored to the block using two, one centimeter anchor bolts and Hilti HIT HY 150 concrete adhesive. While a single anchor block at each truss location was capable of securing the salt barn, additional blocks were placed on the anchor blocks for increased factor of safety.

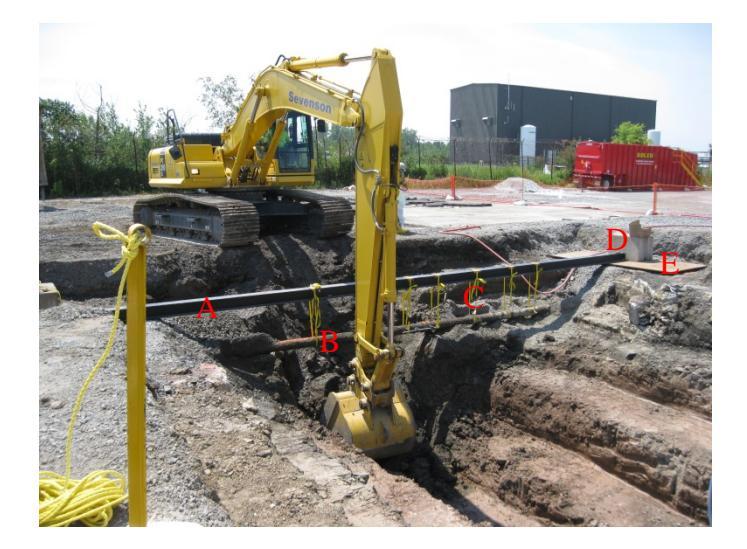
A: W8x35 beam B: Active water line C: Nylon sling D: Concrete block E: Steel bearing plate

Fig. 5. Structural support of an active ductile iron water line.

After investigating the level of effort required to install bypass piping, it was determined structurally supporting the water line was a more cost effective option. The designed support system needed to provide a safe working zone below the water line as well as maintain the integrity of the pipe. However, before the support system could be designed and constructed the water line integrity needed to be evaluated. This was accomplished by removing the overburden and exposing the top of the water line. Once exposed, a NYS PE inspected the line and deemed it structurally capable of being supported. The designed support system included a series of nylon slings hung from a steel beam supported by steel plates. The beam was a W8x35 "I" beam previously used during salt barn relocation. At each end, the beam was welded to one meter by two meter by two and one-half centimeter thick steel bearing plates. The beam and attached plates were placed on one and one-half meter wide excavation benches and centered over the water line. To act as counterbalance, one-half meter by one-half meter by two meter concrete blocks were placed on each bearing plate. With the beam in place the nylon slings could be installed. Each nylon sling was five centimeters wide with a ratcheting mechanism and had a 225 kilogram minimum capacity. The slings were spaced approximately one meter apart and ratcheted to apply just a slight amount of tension to the water line. At this point the underlying soils and sanitary sewer could be remediated as shown in Figure 5. After remediation was complete backfilling operations began. Backfilling immediately under the water line (less than one-half meter) would not be possible, however it was very important to provide a firm and uniform bearing surface before slings were removed.

Beneficial reuse material (firm silty-clay) was placed and compacted to ninety-five percent standard proctor density to a depth approximately one-half meter below the water line. To complete backfilling and provide support, pea gravel was evenly distributed under and around the sides of the water line. The slings were then removed and backfilling over the water line was completed.

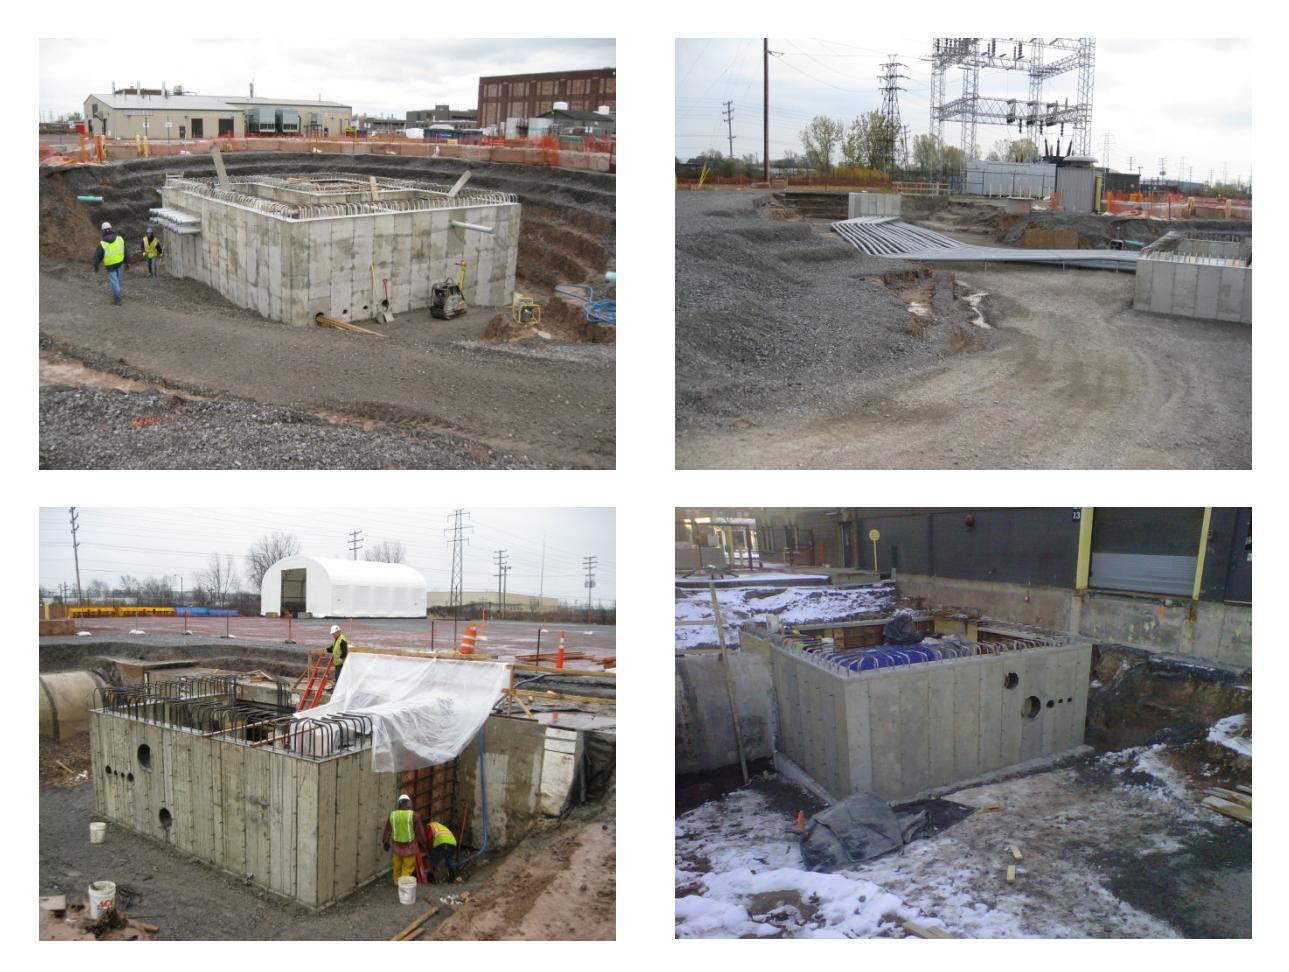
Fig. 6. From top left to bottom right, JB 7A, electrical vault (with extension) and conduits for duct bank, JB 8A, and JB 9A.

junction boxes (JB 7A, 8A, and 9A) with direct buried utilities between the junction boxes. It also included construction of an enlargement to the electrical vault with a new concrete electrical duct bank. Junction boxes 8A and 9A were doweled into the existing tunnel network, replacing JB 8 and extending the function of JB 9. This required excavation of soils immediately adjacent to active utility tunnels followed by controlled saw cutting of those tunnel sections. With saw cutting complete the new junction boxes were formed and poured. The electrical vault enlargement (extension) also was a cast-in-place reinforced concrete structure doweled into the existing electrical vault. However, saw cutting to remove a wall separating the existing vault from the extension could not take place with live 4160 volt (4160V) electrical lines. The saw cutting would need to take place during scheduled electrical system shutdowns (more discussion to follow). JB 7A was constructed as a stand-alone structure near the existing JB 7. With the vault extension and JB 7A in place, a new concrete electrical duct bank connecting the vault and JB 7A was formed and poured with electrical conduits embedded. The new junction boxes and electrical duct bank are shown in Figure 6.

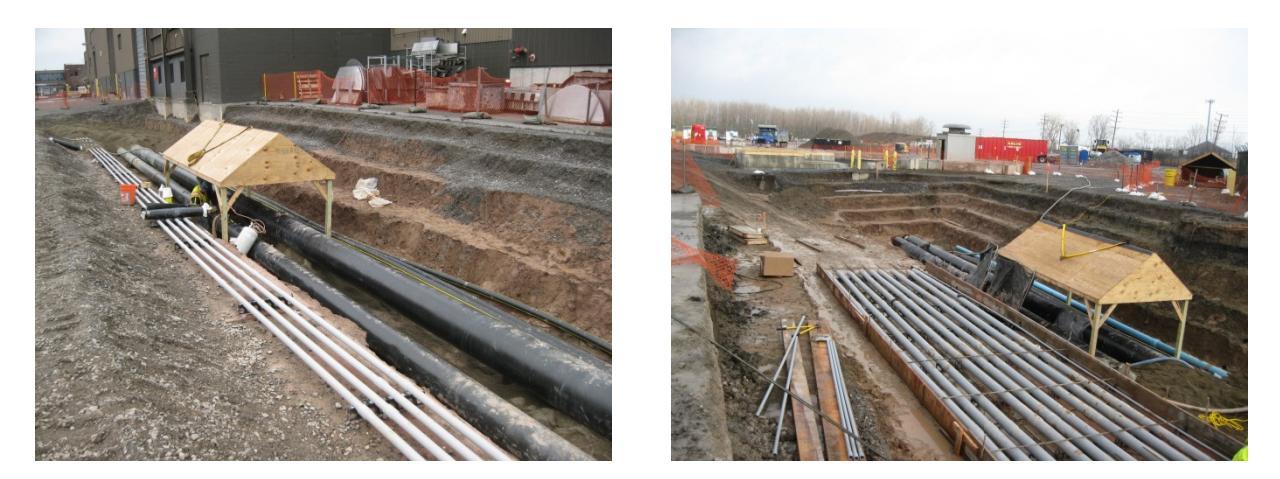
Fig. 7. Performing direct buried utility installation.

buried utilities consisted of twenty-five centimeter low pressure steam, fifteen centimeter low pressure condensate, fifteen centimeter domestic water, fifteen centimeter compressed air, ten centimeter low pressure gas, ten centimeter high pressure gas (the mechanical utilities), ten distinct 4160V electrical circuits, and various communication utilities (the electrical utilities). Of the ten electrical circuits, five circuits traveled between JB 7A and JB 9A and five circuits traveled between JB 7A and JB 8A. The mechanical utilities were placed on native soils and buried with approximately one-half meter of sand before backfilling to grade with beneficial reuse material or imported stone. Mechanical utilities were installed and tested to the appropriate standards and specifications as the excavation for direct buried utilities progressed. Concrete duct banks were formed and poured with embedded conduits for all electrical utilities. The electrical utilities could not be installed or tested until the duct banks between junction boxes were complete. Once the direct buried activities were complete, piping, valves, and other appurtenances for mechanical utilities were installed inside the junction boxes while wires and cables for the electrical utilities were pulled through the embedded conduits. Installation of the new direct buried utilities is shown in Figure 7.

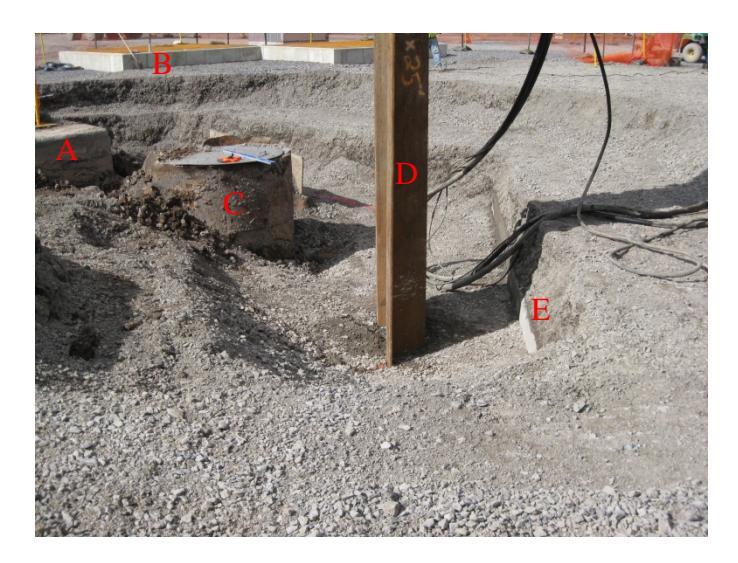
A: JB 7
B: JB 7A
C: Abandoned lift station
D: Sheet piling
E: Active electrical duct bank

Fig. 8. Protecting active electrical duct bank using sheet piling.

The sheet piling design needed to protect the active electrical duct bank and JB 7A while excavating to a depth of approximately five and one-half meters to remove JB 7 and an abandoned storm drainage lift station. The final design specified sixteen linear meters of AZ 26 sheet pile installed to a depth approximately nine meters below grade using a crane and vibratory hammer. Vibration from the hammer was immediately a concern considering sheet pile installation was very near Praxair's electrical substation, electrical vault, electrical duct bank, and JB 7A. Too much vibration from the hammer could greatly weaken the concrete foundation of the substation as well as crack the vault, duct bank, and JB 7A concrete leading to other problems. To ensure vibratory damage would not occur, vibration monitoring was performed at various locations throughout sheet piling installation. The monitoring recorded peak particle velocity and vibration frequency. As long as peak particle velocity remained under five centimeters per second, no damage would occur to the surrounding concrete structures. Monitoring records indicated at no time during installation did peak particle velocity exceed five centimeters per second. Installation of the first sheet pile is shown in Figure 8. With sheet piling installed the final phase of remediation began.
