### Improving Safety and Emergency Preparedness for Storage of Cs/Sr Capsules from Lessons Learned From Fukushima Events – 14022

Connie J. Simiele \*, L. Ty Blackford \*, David Levinskas \*, Jay Lavender \*, Janice L. Pennock \*, Sheila R. Godfrey \*, Lori D. West \* \* CH2M HILL Plateau Remediation Company

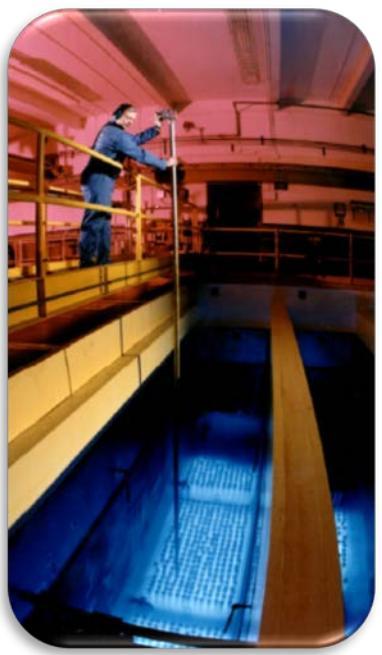
Fig. 1. Radiation from the WESF capsules casts an eerie blue glow called the Cherenkov Effect as the radioactive material decays and loses radioactivity

The Hanford Waste Encapsulation and Storage Facility (WESF) is one of a handful of facilities in the U.S. that is used for wet storage for long-term protection of highly radioactive materials. WESF was designed and constructed to process, encapsulate, and store the Strontium-90 (Sr) and Cesium-137 (Cs) radionuclides extracted from wastes generated during the chemical processing of defense fuel on the Hanford Site. The Hanford Site inventory of cesium and strontium capsules (approximately 100 million curies of total radioactivity) is currently stored in the WESF pool cells (Fig. 1).

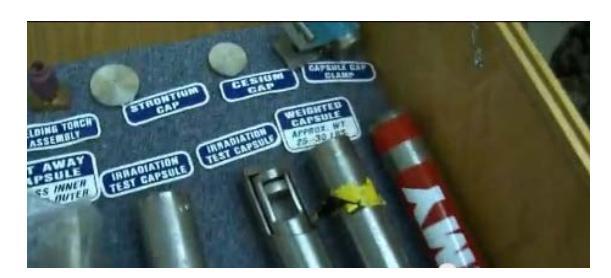
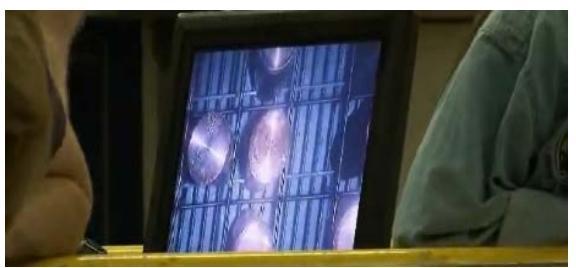
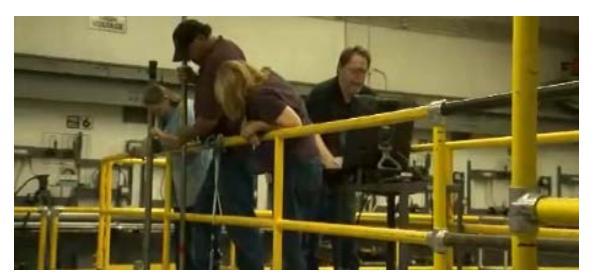
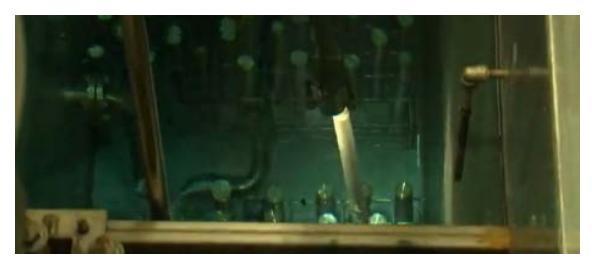
Fig. 2. Workers used long-handled tongs and video cameras to complete the relocation of Cs/Sr Capsules.

Work to relocate more than 800 capsules began in February of 2012 and was completed in June, six months earlier than planned. CHPRC workers standing on walkways above the water used longhandled tongs and "pushers" to reach to the bottom of the water and move the capsules. The team used underwater lighting and a video camera to direct their efforts and verify that the capsules were correctly placed (See Fig. 2). Shortly after the project started, workers assigned to the project suggested ways to redesign the tools and collaborated with engineers to optimize the plan of execution for the project. Two shifts worked on the project every Thursday, with the

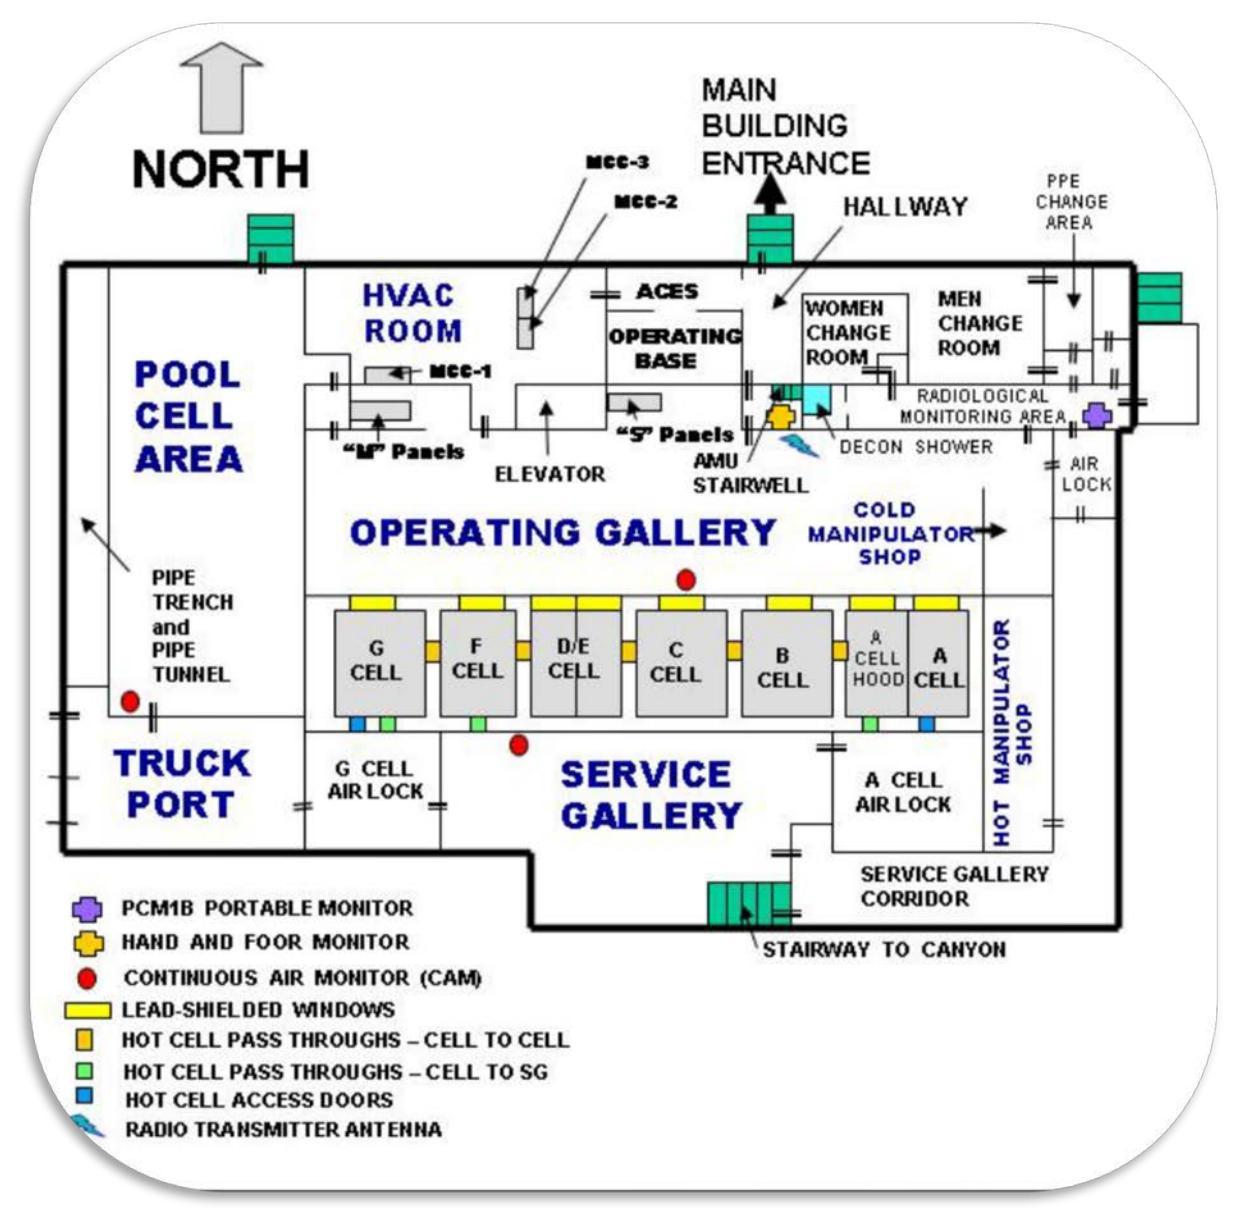
Fig. 3. Main Floor Layout of WESF

The facility (shown in Fig. 3) is a two-story building constructed of steel-reinforced concrete and partitioned into seven hot cells, the hot cell service area, operating areas, building services

areas, and the pool cell area. The hot cells are labeled A through G and activities within the hot cells are performed remotely using manipulators. Waste and drum load out was performed in hot cell A. Hot cells B through E were used to convert strontium nitrate and cesium carbonate removed from the tanks into strontium fluoride and cesium chloride salts. Only hot cells F and G may be used for dry storage of defective Cs/Sr capsules. The pool cell area consists of 12 pools lined with stainless steel. Pool Cells 1, 3 through 7, and 12 are used for underwater storage of Cs/Sr capsules. Each pool has about 4 meters (13 feet) of water that provides radiation shielding and serves to cool the capsules. Each pool has monitoring systems to detect leakage from capsules.
