In Situ Decommissioning Lessons Learned – 14042

Charles A. Negin, Charles S. Urland, Project Enhancement Corporation, and Andrew P. Szilagyi, U.S. Department of Energy

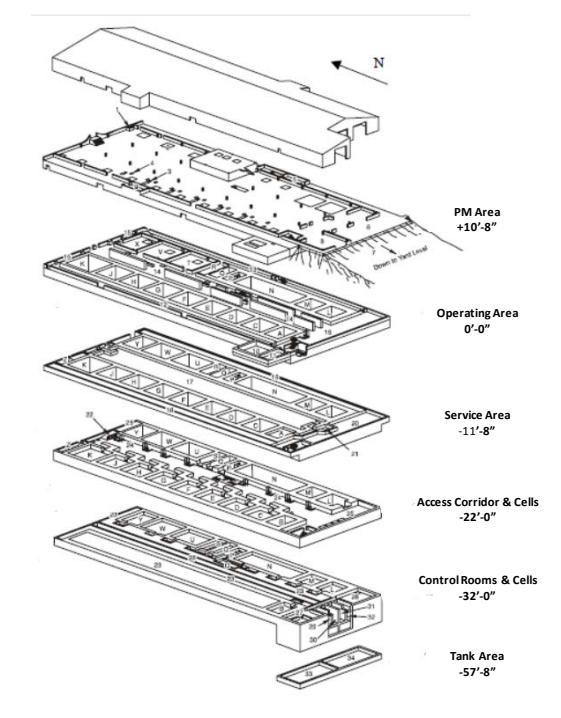
Figure 1 – Isometric View of CPP-601

Among the larger projects, there are significant differences at the three sites for the degree of structure that remains above ground. The differences are related to the initial height and robustness of above ground portions of the facilities. At INL, the structural design of the above-grade portions of the buildings is steel frame construction. It is not expected that such facilities would serve as good confinement over the long term. At INL, these were demolished to grade, with the exception of a small section of heavily shielded concrete process cells that were highly radioactive, with a vertical protrusion of about 18 ft (5.5 m) above grade. An earthen cover, primarily gravel, was placed over this portion; the entombed facilities will eventually become part of a much larger area closure with a permanent cap. See Figures 1 and 2.

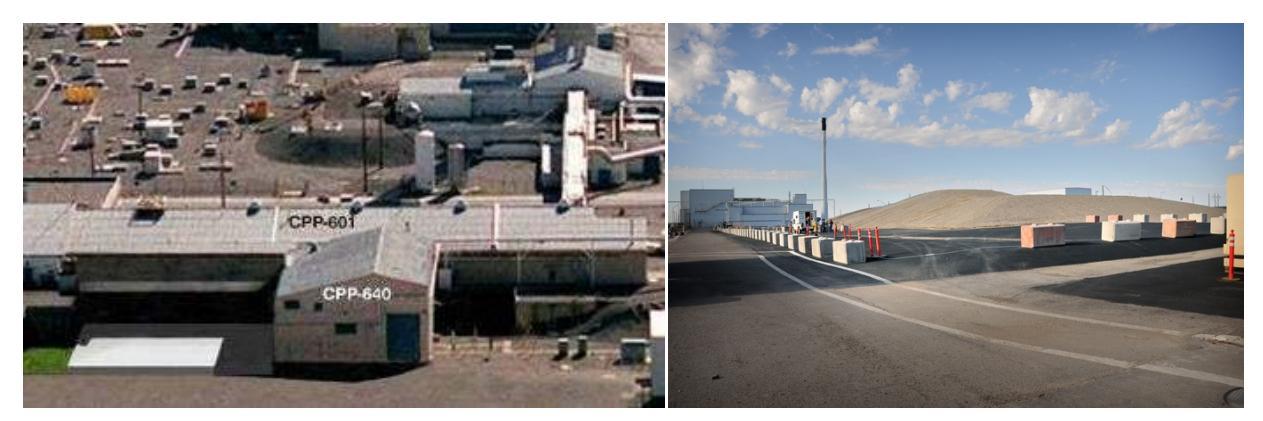
Figure 2 – CPP-601/640 Before and After ISD

The Need for the Change	Change Description/Resolution/Lesson
Above Grade Process Cell Protrusion	The Change
The tops of three process cells that protruded above grade within Building 601 were planned to be demolished. However there were significant safety risks related to cutting equipment in cramped quarters and the associated personnel radiation exposure.	The Citizen's Advisory Board recommended that these cells be left intact to be grouted and integrated into the area cover system. The lesson here is that involved stakeholders with an interest in finding practical solutions can greatly benefit a project. Figure 2 shows the cover system.

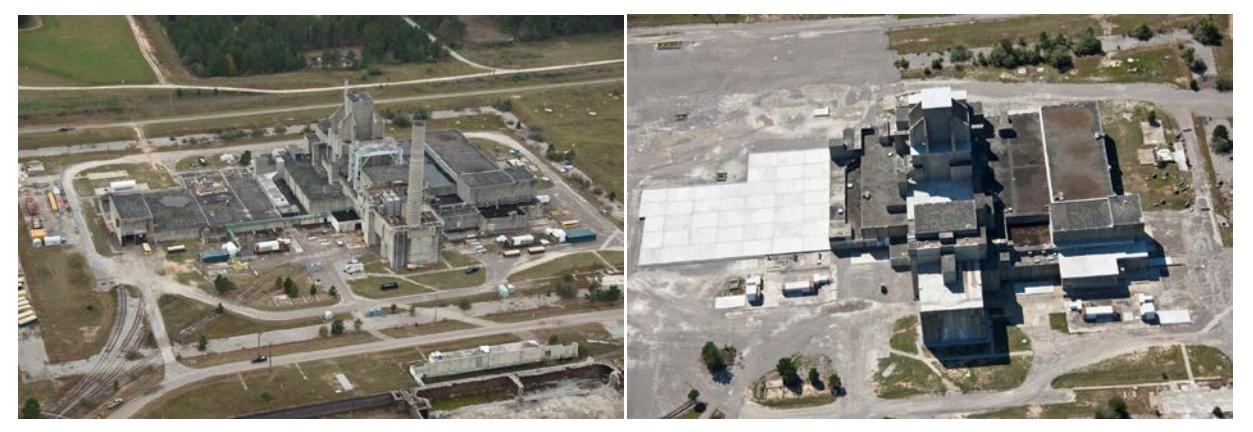
Figure 3 – P-Reactor Area Before and After ISD

At the P- and R- reactors the above grade portion of the reactor building will remain empty, projecting well above the surrounding area. In this case, the primary radiological sources are concentrated with the reactor vessel, which is below ground and has been grouted in place. A permanent cap has been installed above the vessel that is structurally designed to protect the vessel monolith from damage that might be caused by material falling from inside the buildings. The reactor buildings have been sealed and selected roofs have been modified with sloped concrete caps to prevent water intrusion. See Figure 3.

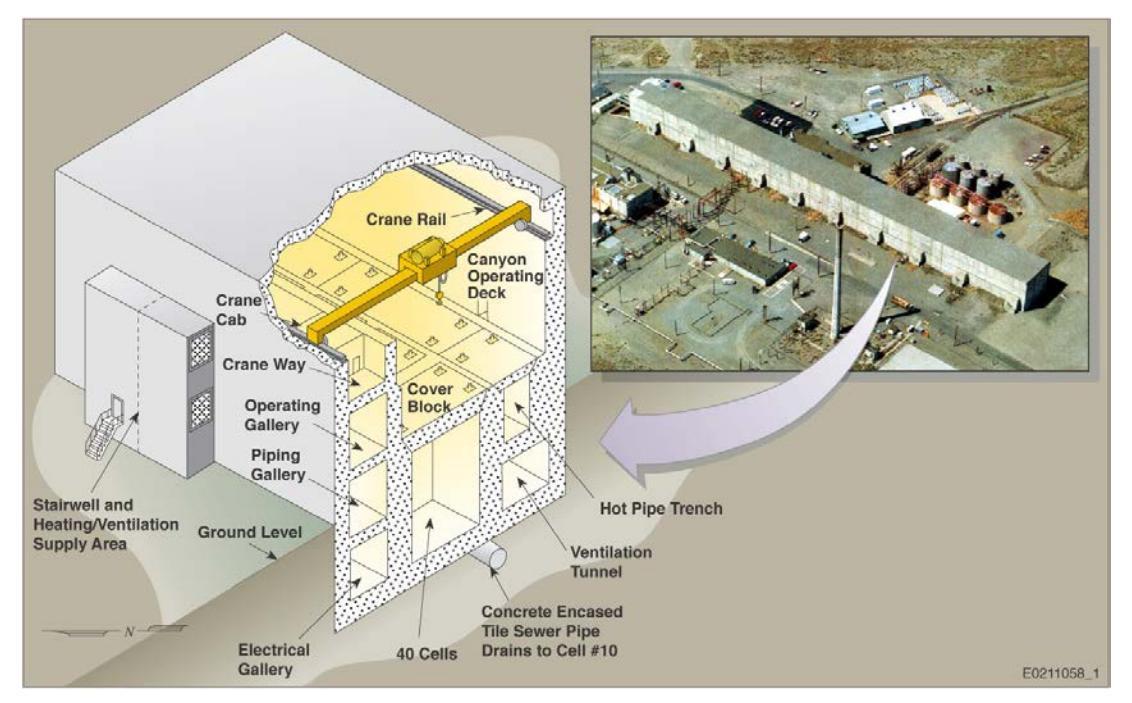
Figure 4 – U Canyon

In contrast, the remaining above ground portion of the U Canyon will be filled with grout and a permanent cap will be placed over the entire area. The primary sources of contamination at the U Canyon is equipment that has been grouted within the below grade process cells. Grouting of the remaining part of the canyon is planned to be conducted as a future project. See Figures 4 and 5

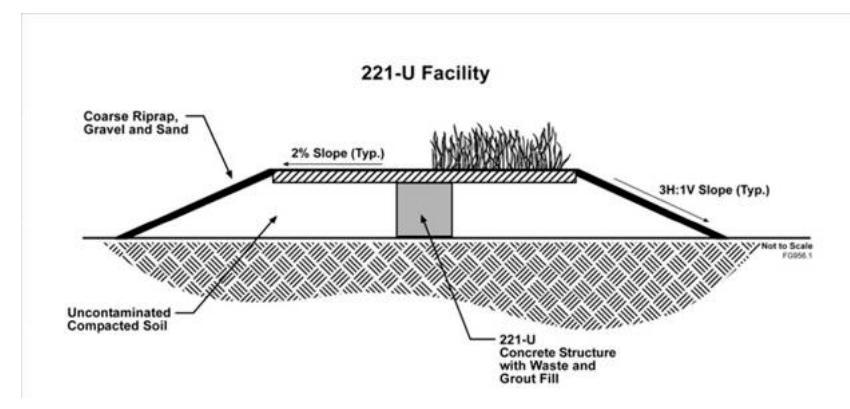
Figure 5 -- U Canyon ISD Concept Engineered Barrier Components

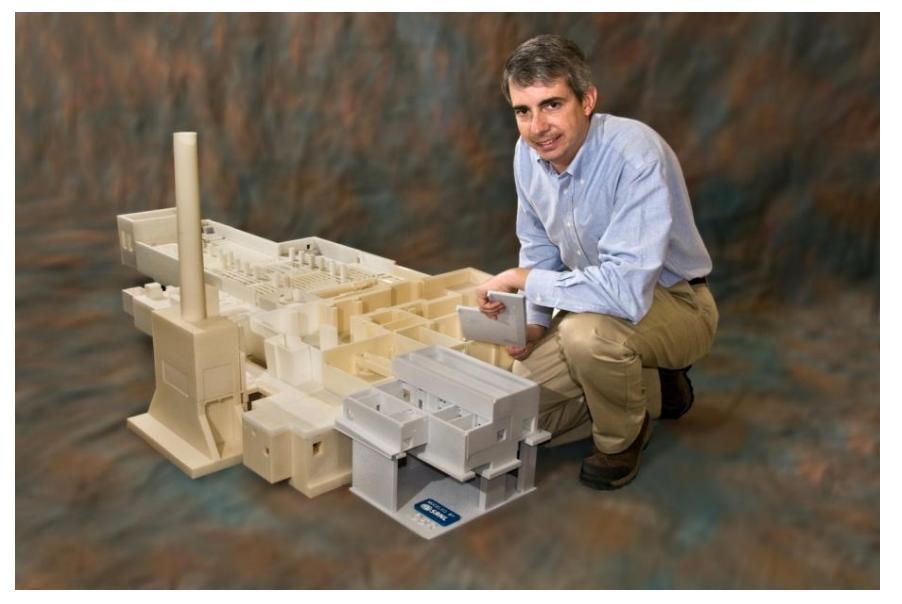
Figure 6 – R-Reactor 3-D Model Credit: Savannah River National Laboratories

- A graphical method of display at the U Canyon displayed the status of grout lifts throughout the facility (which is enormous).
- Sacrificial video cameras used to manage grout fill in selected locations that are difficult to view.
- The use of 3 D physical model at the P and R reactors for sequencing grout placement. The models were also used to familiarize workers with the areas to be grouted. See Figure 6.

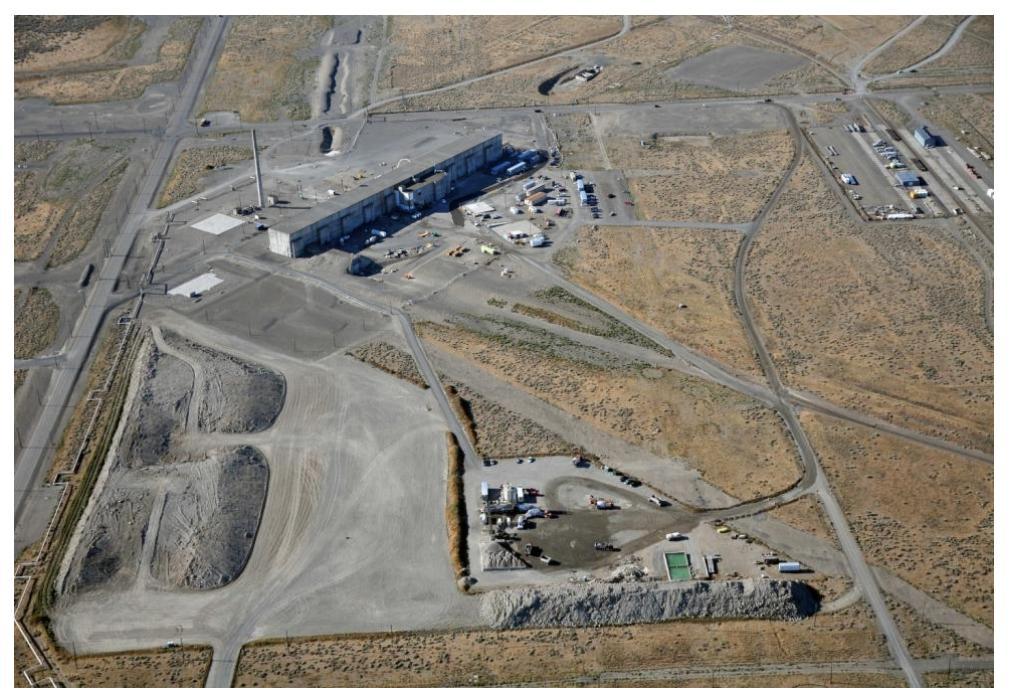
Figure 7 – Placement of the U Canyon Grout Plant

- All the ISD projects benefited from use of on-site batch plants. See Figure 7. Experience at SRS suggests that batch plants be set up on site (even if temporary) should consist of new components to ensure compliance with the latest building codes. Procurement specifications need to delineate all applicable codes that the plant must satisfy.

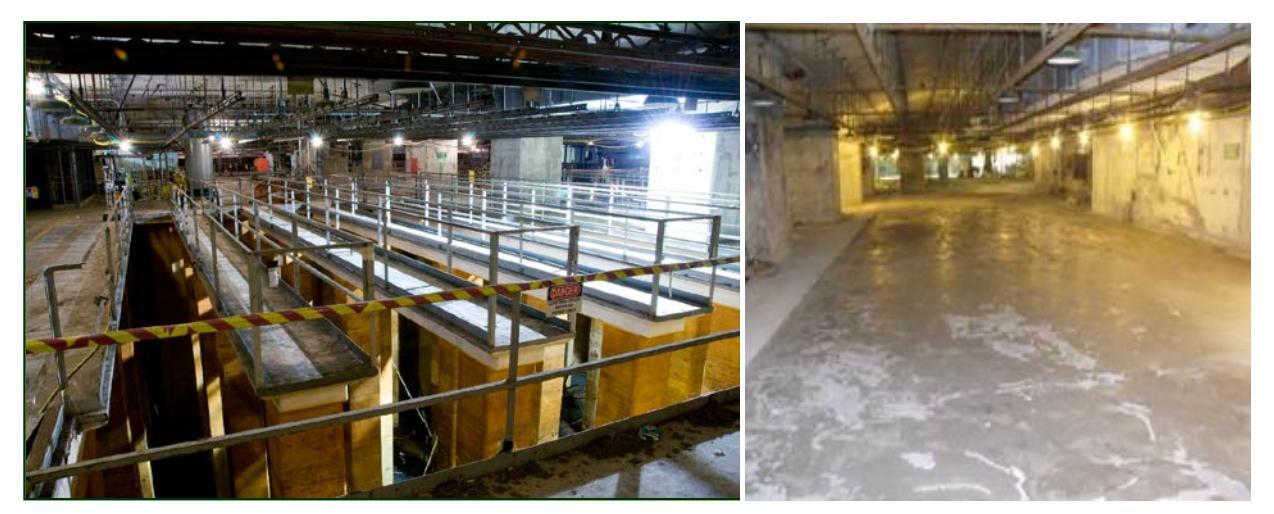
Figure 8 – Before and After Grouting of the P & R Reactor Disassembly Basins

with relative ease into the "nooks and crannies" of most structures. Engineered placement, (i.e., controlled fill in pre-designed lifts) ensured adequate filling of void spaces. Figures 8 and 9 show grout placement examples.

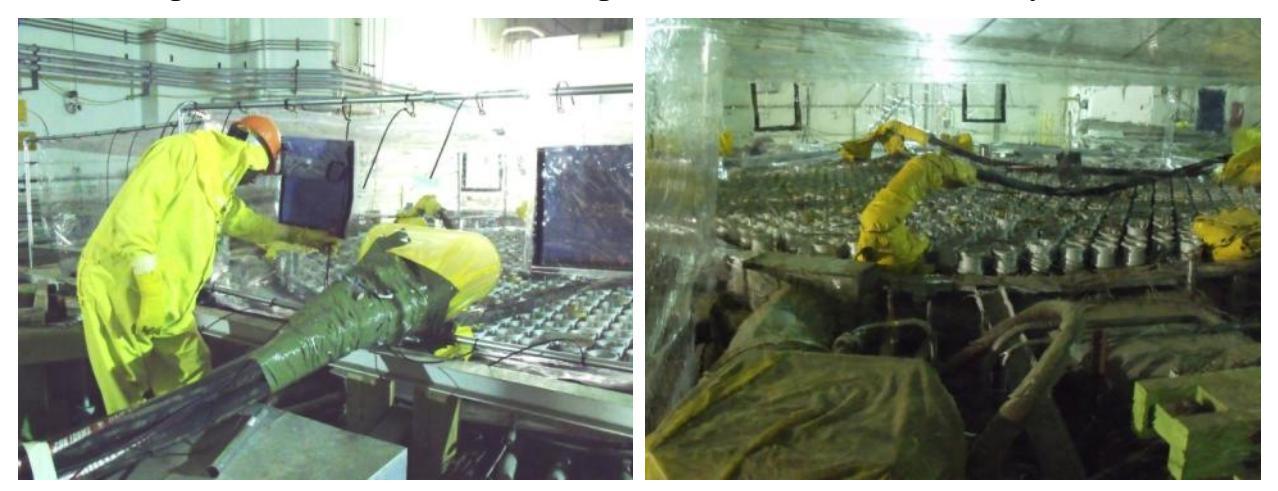
Figure 9 – Reactor Vessel Grouting

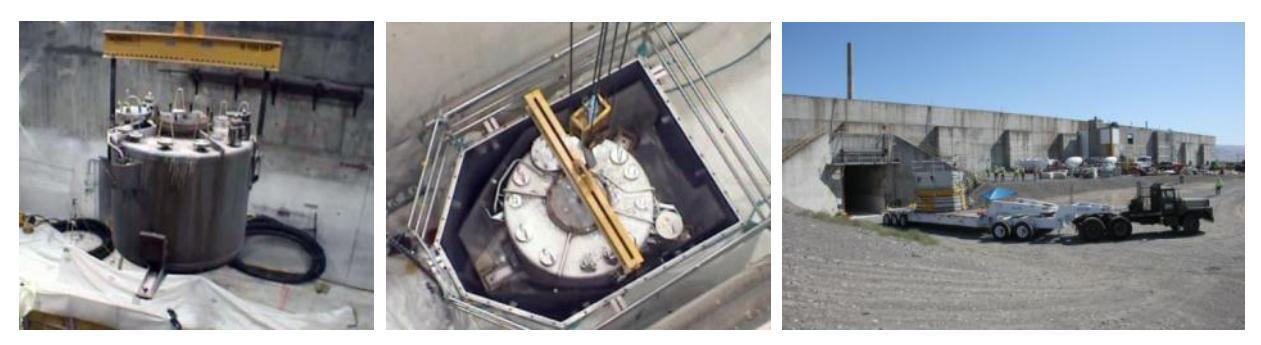
Figure 10 - Removal of Tank D-10 from U Canyon

characterization results that are difficult to obtain prior to the start of work need to be verified as soon as possible.
	See Figure 10.
