# Operational Experience with a Robotic Arm for Wet Waste Retrieval at Trawsfynydd Nuclear Power Plant – 14173

Alan L Smith Magnox Limited

## ABSTRACT

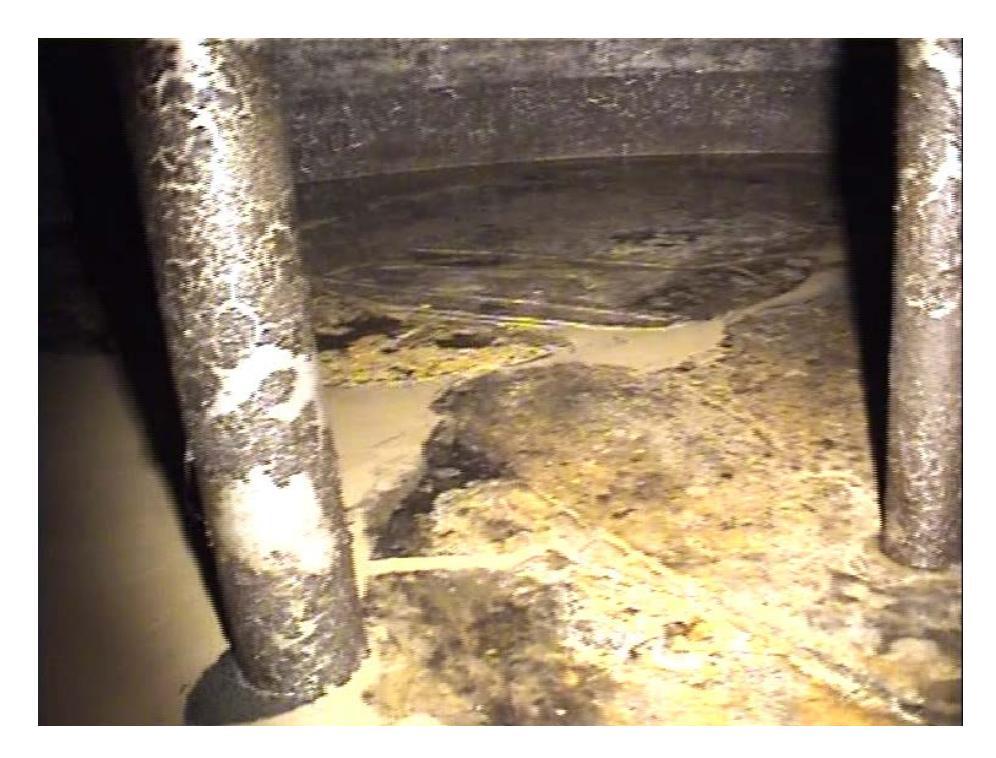
Resin Vault 2 is a cylindrical stainless steel tank approximately 5m diameter x 6m deep and is fitted with internal pipework. The tank has been used for storage of contaminated ion exchange resins throughout most of the operational life of the power plant. A view of the inside of the vault prior to the start of retrievals is shown in figure 1, most of the resin is accumulated in piles on the bottom of the vault covered by about 3m of liquid. Dried and solidified waste can be seen on all surfaces.

Fig 1. RV2 contents before retrieval operations commenced.

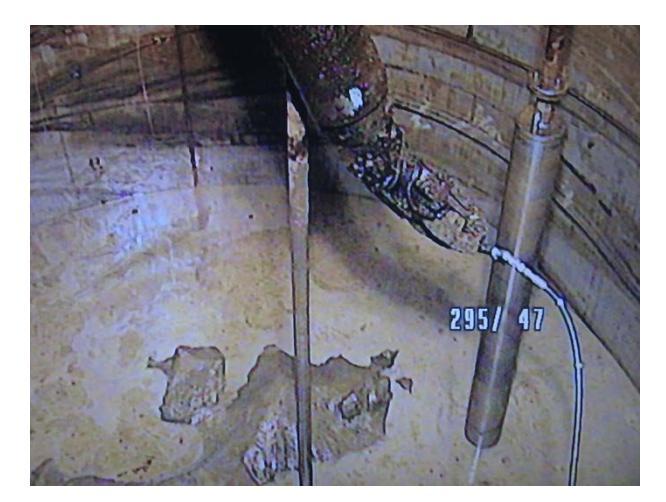
Fig 2. RV2 during retrieval operations.

Instrumentation on the RDA was expected to be crucial to successful and systematic removal of the bulk waste. However a number of challenges arose and retrieval was only achieved because of the skill of the operators and their ability to build on the experience gained during training and early phases of operation. Following removal of the bulk resins the supernate layer could be drained down to reveal residual waste as shown partially in figure 2. A combination of high pressure water and a vacuum tool, both deployed on the RDA, was then able to clear all remaining waste from the tank and from around the numerous items of in-tank furniture.

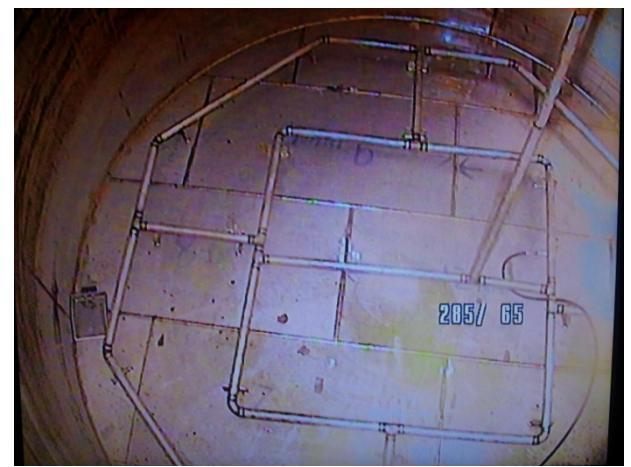
Fig 3. RV2 clean and empty.

RDA1 completed the clean-out of Resin Vault 2 in early 2013, visual (see figure 3) and radiological checks allowed the tank to be declared clean and empty. RV3 is nominally identical to RV2 and is housed in the same building. RDA1 has been transferred to RV3 and at the time of writing has completed retrieval of about half of the bulk resin.

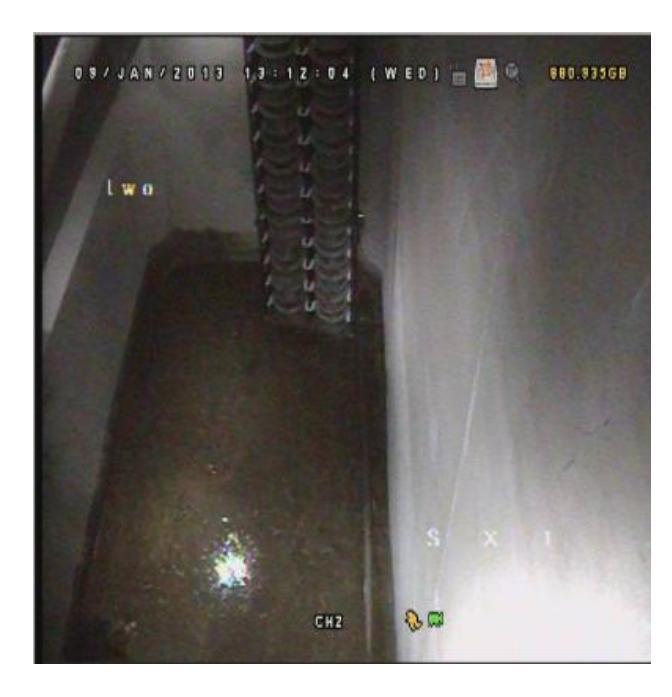
Fig 4. Buffer store installed in PNV.

A key challenge is to separate, in-situ, waste streams that have to be treated and disposed of by different processes housed in different plant areas. Sludges could be disposed of through waste routes that were available at the start of operations. However solid wastes need to be treated differently and that route will not be available until long after bulk wastes have been cleared from PNV and therefore needed to be held in an intermediate store. The retrieval program started with installation of many ancillary components including a buffer store (figure 4) at one end of the vault.

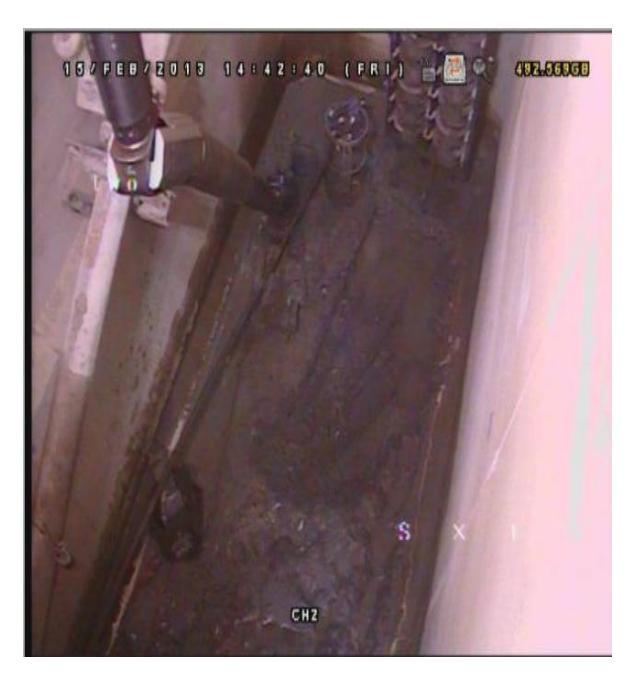
Fig 5. Supernate level lowered in PNV.

The RDA was then used to position a submersible pump after it had been lowered into the PNV through an access hatch. A layer of sludge and supernatant liquor was transferred to another waste tank (the Main Sludge Vault) to improve visibility of the PNV contents (figure 5). Removal of large solid items, including two garbage bins, took place using the RDA. These items had been partially submerged in sludge and so were cleaned using the RDA jet wash tool within the PNV. Once the large solid items had been decontaminated, they were removed from the PNV using a recovery basket and then manually transferred to the appropriate container in an adjacent area on site.

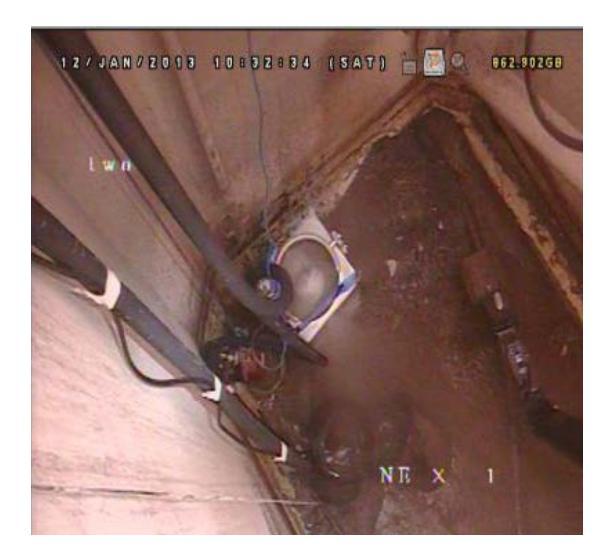
Fig 6. Wash station installed in PNV.

Before their removal from the PNV, these items were subjected to health physics monitoring to determine the container type required. Items of LLW were consigned to the site LLW store whilst ILW was placed in the site's active waste vault. All of the smaller solid waste was then transferred using special tooling, including a grab, scrapers and shovels, mounted on the RDA into specially designed mesh pots. The mesh pots were placed in a wash station (fig 6, 7) for cleaning and removal of sludges before being transferred to the buffer storage area within PNV.

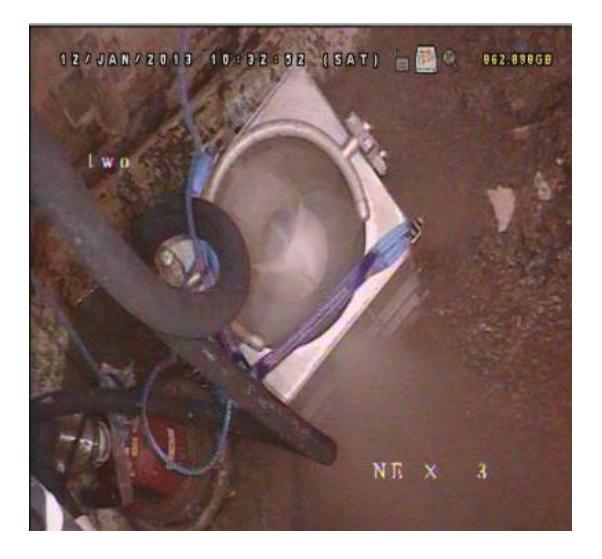
Fig 7. Wash station in operation.

Use of the wash station added water to the tank and assisted in mobilization of further sludge which could be transferred to MSV for final processing. The initial project estimates of the volume of solids indicated that in the region of 25 - 30 mesh pots would be required for storage of this waste stream. The buffer store that was built and installed into the PNV held 38 mesh pots. By the time solid waste retrieval was completed almost 100 pots had been filled, so in addition to the buffer store it was necessary for operators to establish means of stacking pots in other areas within the PNV. Transfer of washed mesh pots containing solid waste from the wash station to the buffer store is shown in figures 8 and 9.

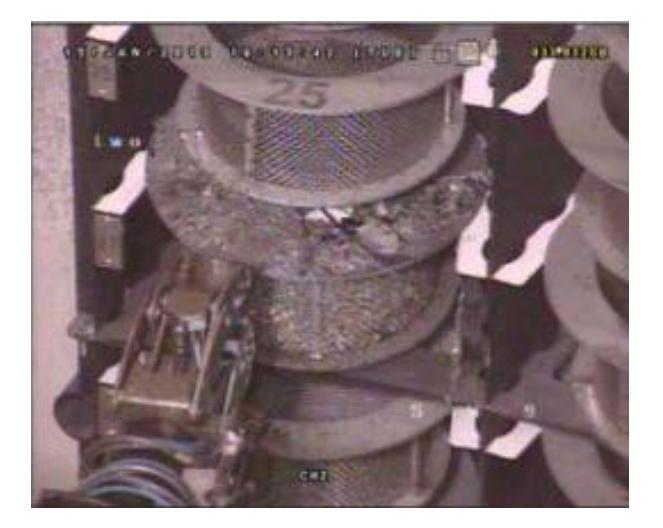
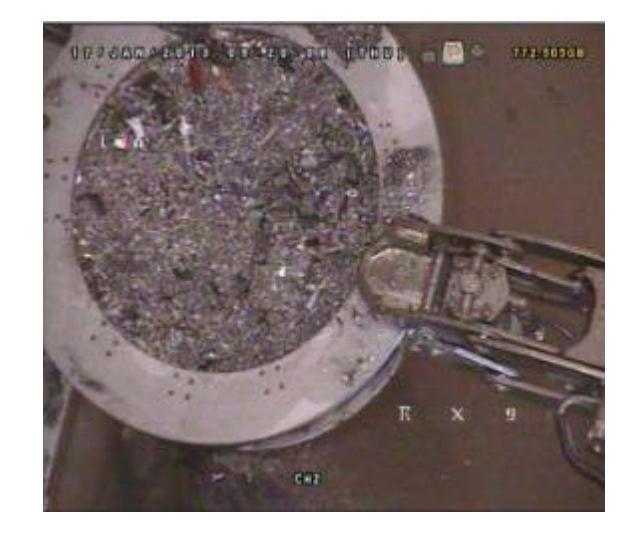
Fig 8. Mesh pot placed in buffer store.
