**A NON-INTRUSIVE METHOD TO DETERMINE THE INTERNAL PRESSURE OF
SEALED WASTE STORAGE CONTAINERS AND SUPPORT WASTE INVENTORY
ACCOUNTABILITY**

ABSTRACT

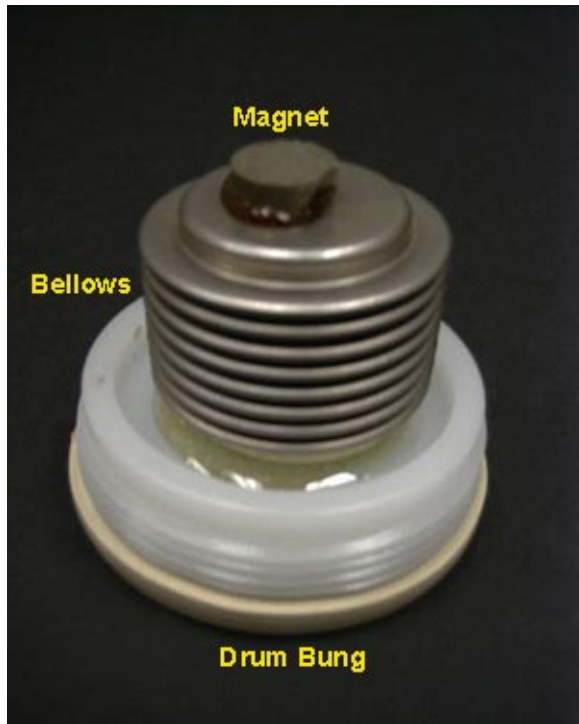
Figure 1. The pressure sensor consists of a magnet and bellows attached to the inside of a drum bung or drum lid.

The DPAD consists of a bellows, which is a sealed metal cylinder with deeply convoluted sides, topped with a permanent magnet. The sensor can be inserted into a bellows guard to avoid contact with the waste and attached to a drum bung (plug), which is inserted into the bung hole of a tight head type drum lid. It can also be attached to the underside of an open head drum lid. Changing pressure inside of a drum causes an expansion or contraction of the bellows, which results in a variation of the magnetic field (flux density lines of the magnet). The variation of the magnetic field provides an external, passive, and non-intrusive method to correlate the pressure/force exerted internally on the drum by using a Hall Effects gaussmeter. A passive contact memory button (part of the AIDC family) is attached to the outside of the drum directly above the DPAD to support this internal pressure monitoring method. An audio/visual alarm can also be attached to the outside of the drum in "high risk" scenarios to provide workers an instantaneous indication of an over-pressurized waste drum.

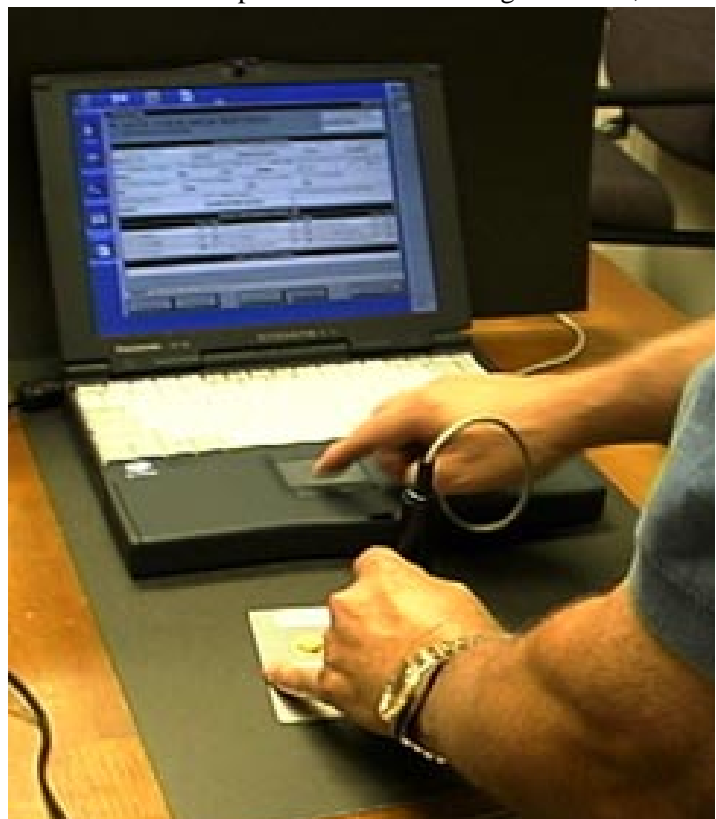
Figure 0. Demonstrating the memory button, associated button reader, and customized software.

The memory button and associated button reader are key components of the DPAD/WIT system. The button reader incorporates a Hall Effects gaussmeter,

and provides a means of verifying the gaussmeter readings by performing a simple calculation based on the ambient temperature at the time of the drum pressure reading. Once the pressure is determined and verified, and any other information required for the inspection is obtained, the date, time, and name of the person performing the inspection can be written to the memory button. This read/write "electronic tag" can be linked to existing waste management databases and its data can be verified via the unique serial number assigned to each electronic button (tag). All of this information can be held in the button reader and then electronically passed to the database without error, providing an audit trail of the inspection, and validation of the container pressure, contents, and location.

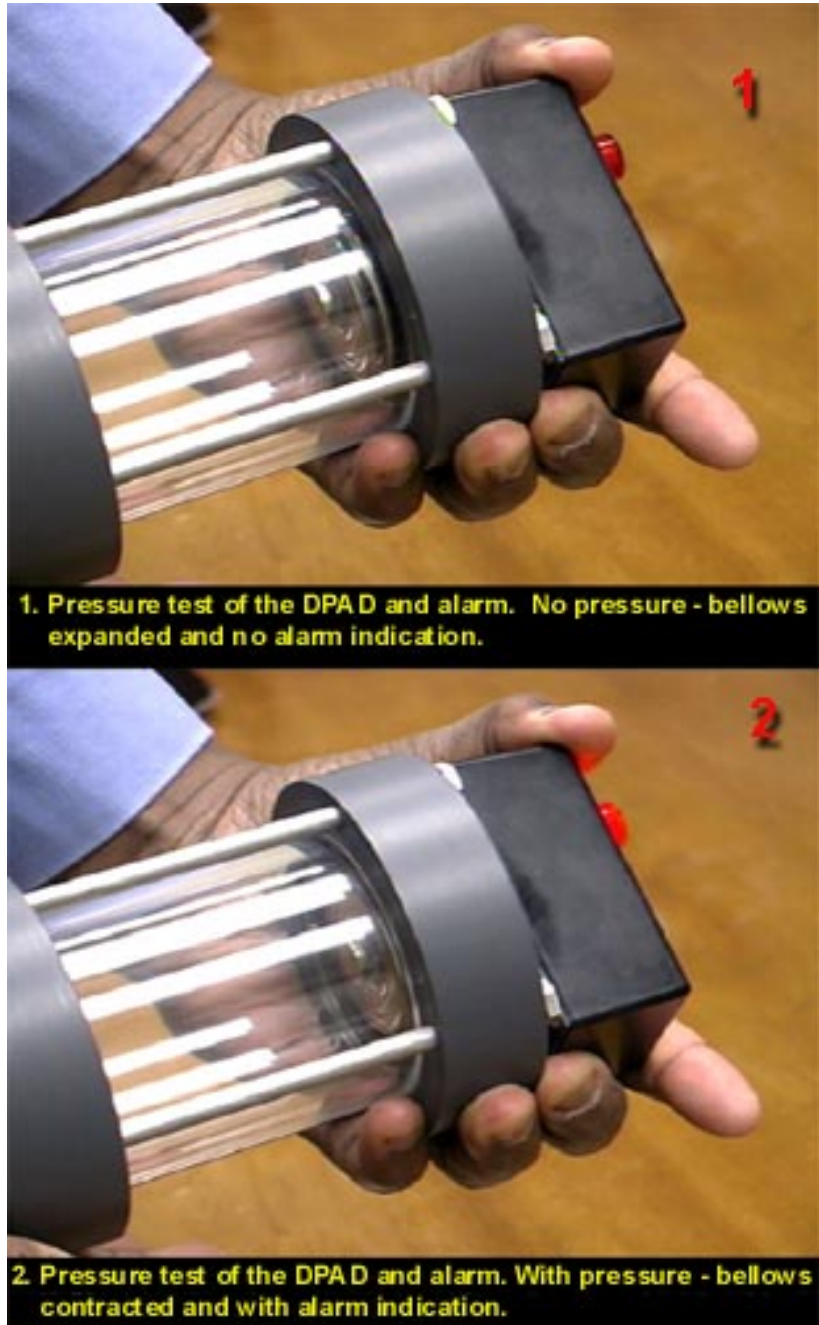
Figure 2. Tests of bellows with attached magnet and pressure alarm.

Four (4) bellows with magnets attached were tested to determine magnetic flux density strength while inserted in test drums of heated and cooled air and water. Test procedures were developed and implemented to ensure the accuracy of the test results.ⁱⁱ Three tight head drum type bung plugs made from poly vinyl chloride (PVC), nylon, and delran materials respectively were fitted with 3 of the 4 bellows with the attached magnets. The last bellow assembly was attached to the underside of a 208 L (55) gal, stainless steel, open head type, drum lid. Memory buttons were attached to the external surfaces of the bung plugs and on the stainless steel drum lid directly over the bellows assembly to complete the DPAD assembly and provide a uniform surfaces for conducting measurements. Two 208 L (55) gal drums were used in the tests; one was sealed with ambient air, and the other was filled with potable water and sealed. Each drum was incrementally heated and cooled to specific temperatures to create a range of internal drum pressures. The drum lids were outfitted with a dial pressure indicator and a thermometer to provide verification of the temperature and the resulting pressure change. A hand held Hall Effects Gaussmeter was used to measure the strength of the magnetic flux line densities, which changed with the increase or decrease of the internal drum pressures resulting from the controlled drum temperature changes.

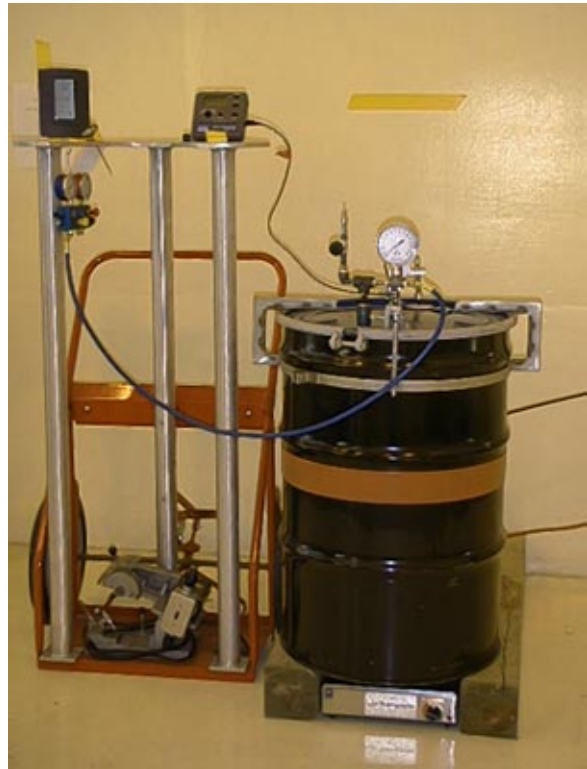
Figure 2. Test setup for the heat variation tests at Oak Ridge National Laboratory.

This test was designed to determine if the strength of the DPAD's magnetic flux lines increased or decreased as a result of changes to the drum temperature and pressure. Each bung plug was screwed into a tight head drum lid after the locking ring had been torqued. The drum restraint was secured and the ambient air in the drum was controlled and heated through a temperature range of 70[®]F to 120[®]F. The tests of all three DPADs attached to the various bung plug materials failed to produce a change in the magnetic flux lines. It was determined that this was due to leaks in the drum lid gasket even though the lock ring was repeatedly tightened to the maximum torque values. Further testing was suspended in order to test the stainless steel lid PAD. Although the test failed to produce the desired results, it is assumed that drum gaskets "seat" over time, and that temperature changes can induce a leak tight seal, which can result in a pressurized drum. The gasket material is closed-cell rubber and glued into the lid. The gasket operating range is -40[®]F to +158[®]F.
