## EMPTYING OF THE STORAGE FOR SOLID RADIOACTIVE WASTE IN THE GREIFSWALD NUCLEAR POWER PLANT

Burkhard Hartmann, Jürgen Fischer  
Energiewerke Nord GmbH  
P. O. Box 1125, Lubmin, D-17507

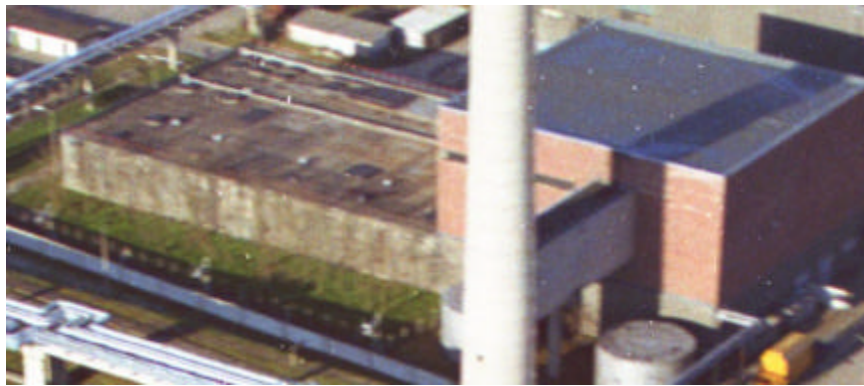
**Fig. 1: Special Building 1**

The storage rooms are located in Special Building 1. The Special Building 1 is situated in the eastern part of the power plant site, in the monitored area of the plant.

The storage building is 90m long and 38m wide. The building consists of a high and a low part below which the seven storage rooms are located. Access to the storage rooms is only possible via the hatches in the roof of the low part.

The walls between the storage rooms and the roof ceiling consist of 300 – 500mm reinforced concrete. The roof ceiling is additionally provided with a multilayered concrete layer.

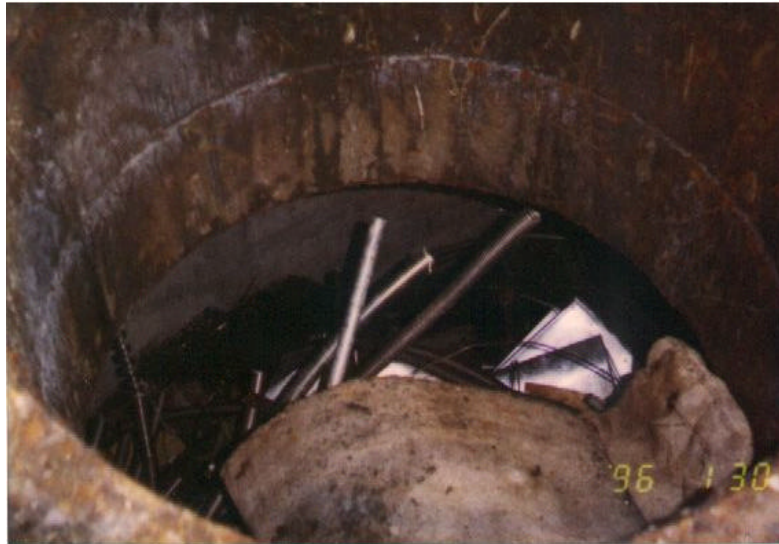
**Fig. 2: View into room BK028/1**

In the result of the inspection, 450m<sup>3</sup> waste was found which consists of metals, different unsorted mixed waste (insulating mats, textiles, foils, paper, etc.), and a large number of 200-l-drums with unknown content. The rooms BK028/1 with 160m<sup>3</sup> and BK028/7 with approx. 280m<sup>3</sup> are the most filled rooms.

Since the roof of the low part of Special Building 1 and thus also the access hatches to the storage rooms were permanently exposed to the weather, water was found nearly in all rooms (water level up to 4m). Analyses showed that rainwater seeped into the rooms. This water was immediately pumped off to the controlled area.

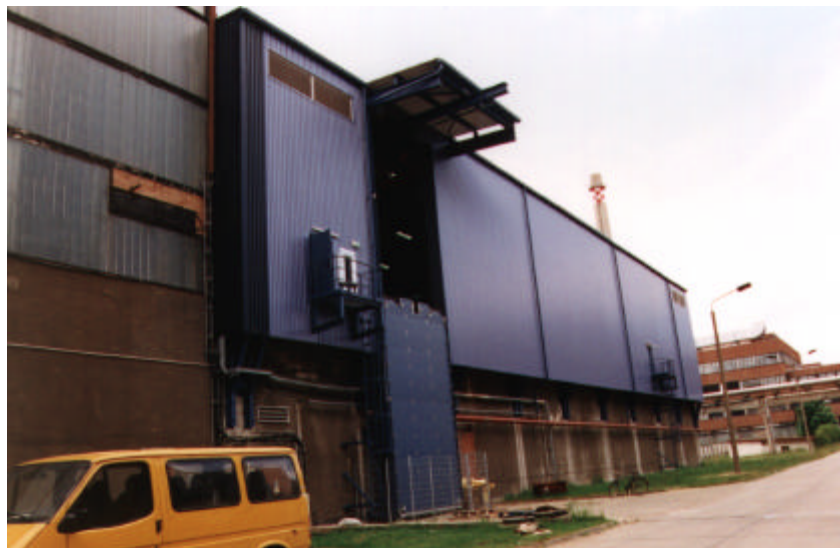
**Fig. 3: Weatherproof construction**

The weatherproof construction is designed as a steel lightweight construction. The wall lining consists of cassettes with heat insulation and metal sheets.

The construction was mainly fastened on the building walls and supports of the ceiling plates. The individual supports are equipped with cams and fastened with anchors on the roof of Special Building I. The result was a hall with three open sections in which two central metal supports are arranged above of load-bearing reinforced steel walls (west/east direction).

length	ca. 54m
width	ca. 38m
lower clear height	ca. 8.00m (up to ridge ca. 10m)

- north side (8500mm x 15000mm) for putting the disposal caisson in,
- southwest side (6000mm x 5930mm) as an additional opening.

Due to the complete covering, the existing loading bridge had to be removed. Alternatively, a cat carriage with cantilever to the outside and electric wire rope (lifting capacity 5t) was installed. In both, the northern and the southern hall section, a suspension crane with a lifting capacity of 5t was installed.

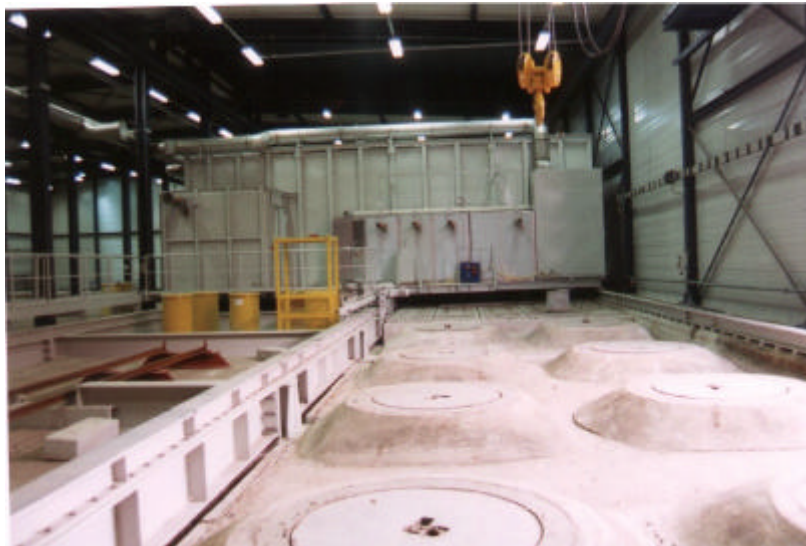
**Fig. 4: Caisson on the rail carrier construction**

The caisson is a steel construction. The caisson bottom, the inside walls and the roof consist of 6 or 5mm steel sheet, which is fastened on steel supports and tightly welded. The inside surfaces of the caisson are provided with decont-paint.

The caisson is self-supporting deposited on 3 rail carriers (surface of polished high-grade steel). There is a mounting hatch in the bottom area for taking of the operational waste. The clear dimensions of the mounting hatch in the caisson bottom are 4.22 m x 5.60m.

On these 3 rail carriers, which rest on the reinforced concrete walls of Special Building I and overstretch the ceiling construction of the building, the caisson is horizontally moved to the individual caisson and disposal places.

Before the caisson is moved into working position over the storage room, which has to be emptied or cleaned, the additional concrete layer has to be removed except of the statically constructive concrete of the reinforced concrete ceiling. This is necessary to hermetically connect the caisson with the reinforced concrete ceiling. For this, a compensator is used.

For the disposal of the rooms in Special Building I, eight different working positions of the caisson are needed to which it is pulled or pressed on the rail carriers by hydraulically operated spindles after the corresponding preparatory work. Before starting the work, the caisson is pushed to working position, all supply and disposal lines will be connected, the compensator installed between caisson bottom and ceiling plate of the building, and the ventilation system put into operation after hermetical sealing to the environment. The filter facility is located in the caisson
