LIFE EXTENSION OF AGING HIGH-LEVEL WASTE TANKS

D. Bryson, V. Callahan
U.S. Department of Energy, Office of River Protection
P.O. Box 450, Richland, WA 99352

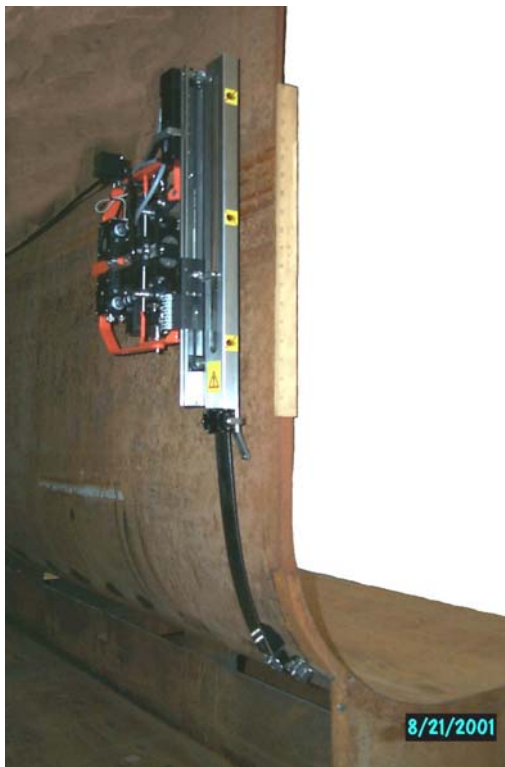
Small video cameras with pan and tilt extension arms (designed to fit through a 4" tank riser) are used in the tank interior and annulus regions. The cameras are capable of extended operation in a 250 R/hr. radiation field, and have provisions for cooling and minimization of contamination. Robotic crawlers have been developed to carry UT (plus a video camera for positioning) equipment into the annulus through 24" and 12" risers, and then to traverse horizontally and vertically along the vertical tank walls. A magnetic wheeled robotic crawler carrying a UT instrument, with a recently deployed strap extension, to reach the bottom curved portion of the tank (knuckle), is shown in Figure 1 below:

Fig. 1. Crawler Robot with P-Scan Ultrasonic Tester and Transducer Extension Arm.

However, several challenges still remain for implementation of a comprehensive tank UT inspection: a) the magnetic crawler P-scan transducers cannot reach the predicted highest stress region of the lower knuckle, b) there is very limited access (slots in the cement base) for tank bottom UT inspection, c) walls with severe corrosion cannot be inspected, and d) pit depth on the annulus side can not be readily measured. Solutions to these problems are well underway as described below.

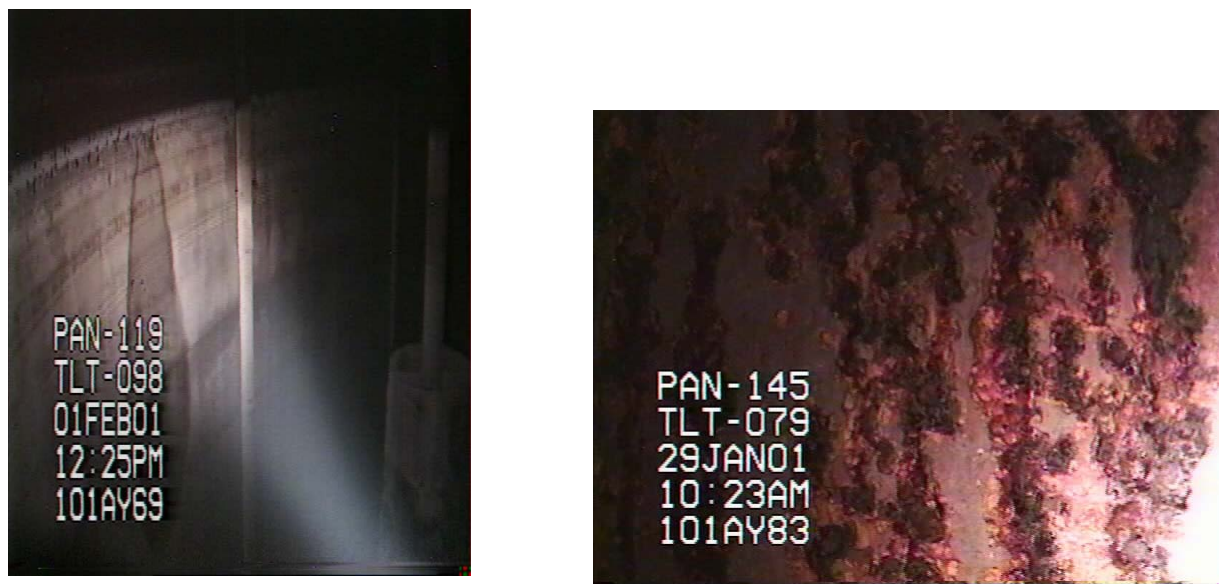
The DST visual and UT technical baseline efforts are well underway and when completed, will be repeated on a 5-year cycle. At the end of FY 2001, 12 of the 28 DSTs had been UT surveyed, and 8 DSTs were video inspected. The UT inspections have detected four instances of notable localized pitting or crevice-like corrosion at previous waterlines (AN-102, AN-105, AP-108 and AY-101), along with the detection of a significant original construction defect (a crack-like indication in AP-108) that will be periodically re-inspected to assess if there is any growth. The video examinations have shown notable corrosion on the inner tank dome surfaces, as well as significant annulus corrosion in AY-101 along with an interior stain that potentially could be the result of a pinhole leak. The interior stain and the annulus corrosion are shown in Figure 2.

Fig. 2. Interior stain (left) and Annulus Corrosion (right) in DST AY-101.

A recent engineering study of DST annulus ventilation, and recent video inspection results on tanks with long-term inoperable annulus ventilation systems (e.g., 7 year outage in AY-101), confirm the importance of maintaining operational annulus ventilation systems to avoid significant tank wall corrosion and prolong tank life. A change is being made to the Hanford Tank Farms Technical Safety Requirements (TSR) to incorporate an administrative control requiring an operable DST annulus ventilation system. The UT and visual inspection results show notable interior tank wall pitting and thinning from waterline corrosion, also highlight the importance of maintaining DST waste chemistry within specification; which will be discussed in more detail in the next section.

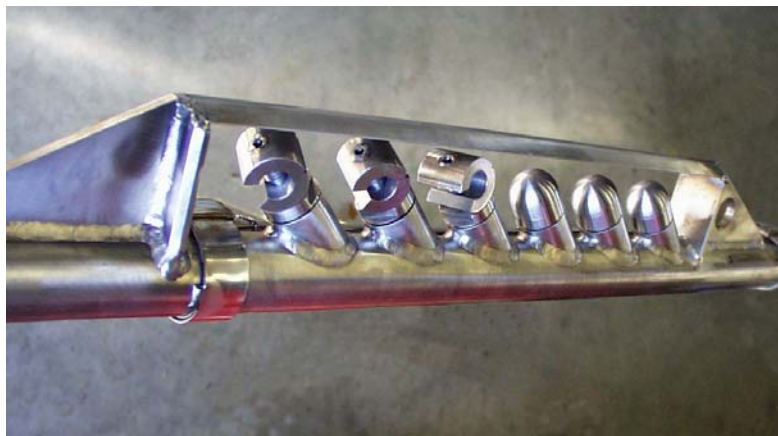
- Continued development of Electrochemical Noise (EN) probes for direct, real time, detection of in-tank corrosion. [This is an EM-50 TFA project that has already had several in-tank EN probe assemblies in place at Hanford (see Figure 3).]
- Develop DST repair technologies and options, such as weld repair, epoxy patches, and mechanical plugs. This is also an EM-50 TFA sponsored program being led by the Savannah River Site.
- Develop a waste heel lay-up procedure to ensure that pumped down tanks remain free of corrosion.
- Evaluate the modifications necessary to inhibit dilute additions (e.g., condensate return water, piping flush water, etc.) to the DST waste.
- Continue development and deployment of T-SAFT and EMAT (as discussed in the UT section above).

Fig. 3. Third generation EN probe design used in DST AN-105.
