## **RESULTS OF HAZARDOUS AND MIXED WASTE EXCAVATION FROM THE CHEMICAL WASTE LANDFILL**

### **ABSTRACT**

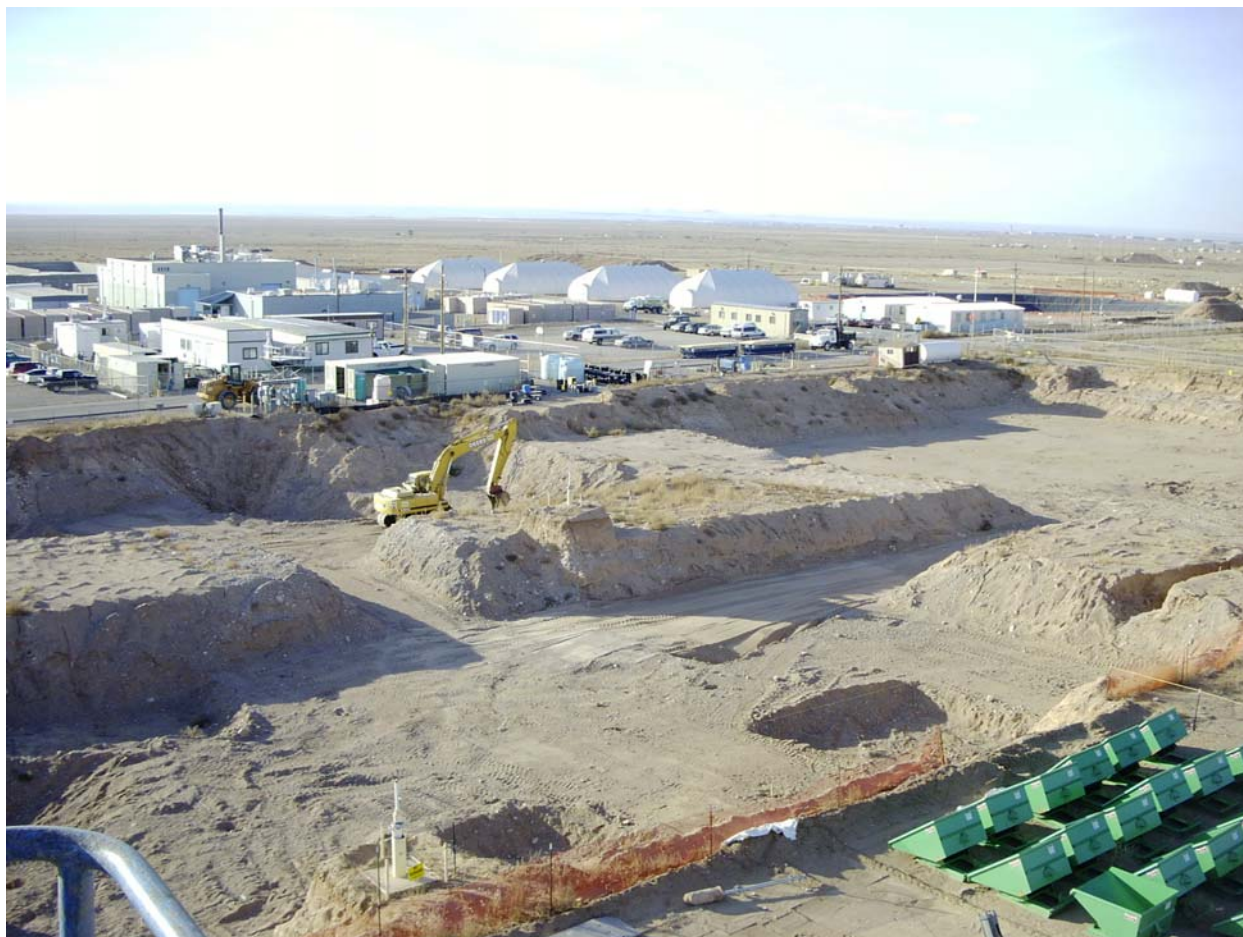
Fig. 1. Excavation of the Buried Debris from the 1.9-acre Chemical Waste Landfill was Completed in June 2001

In June 2001 the last of the buried debris from the Chemical Waste Landfill (CWL) was removed (Figure 1). Over 50,000 cubic yards of material was excavated and safely managed during this process. This included approximately 50,000 cubic yards of soil, 1,000 cubic yards of rocks, and 500 cubic yards of debris, chemical containers, and other buried waste material. Approximately 25,000 cubic yards of the excavated soil is at the CAMU and the remainder is either waiting for final characterization data or earmarked for backfill.

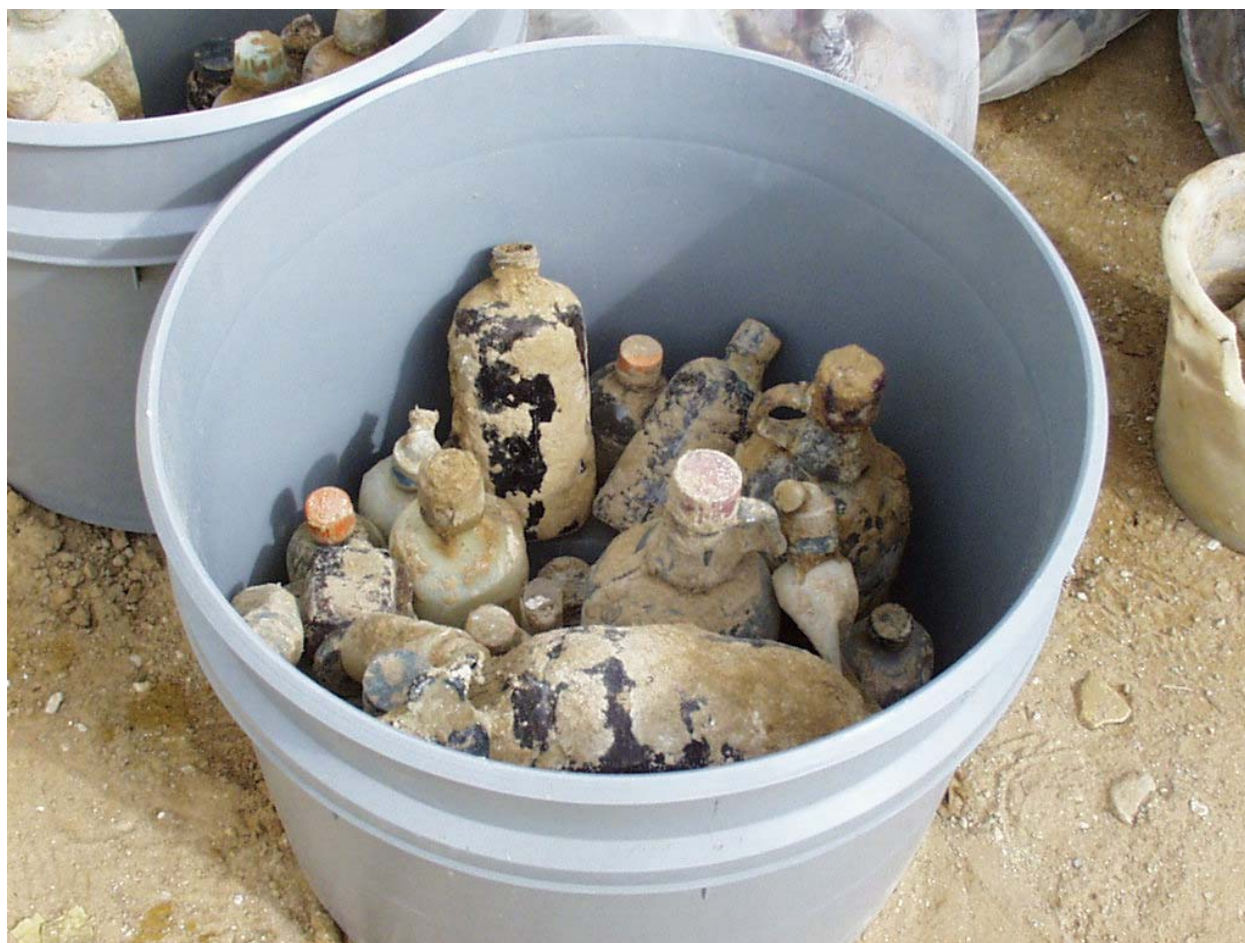
Approximately 2,000 chemical containers with unknown contents were recovered intact. To date, about half of these have been identified at the on-site mobile laboratory and these included laboratory reagents, acids, solvents, oxidizers, carcinogens, water reactive materials, pyrophoric materials, inert salts, plasticizers, darkroom chemicals, epoxies, oils, paints, and other industrial products. The remainder of these chemicals were characterized to allow for proper storage according to material compatibility until final identifications can be completed (Figure 2).

Fig. 2. Excavated chemical containers with unknown contents

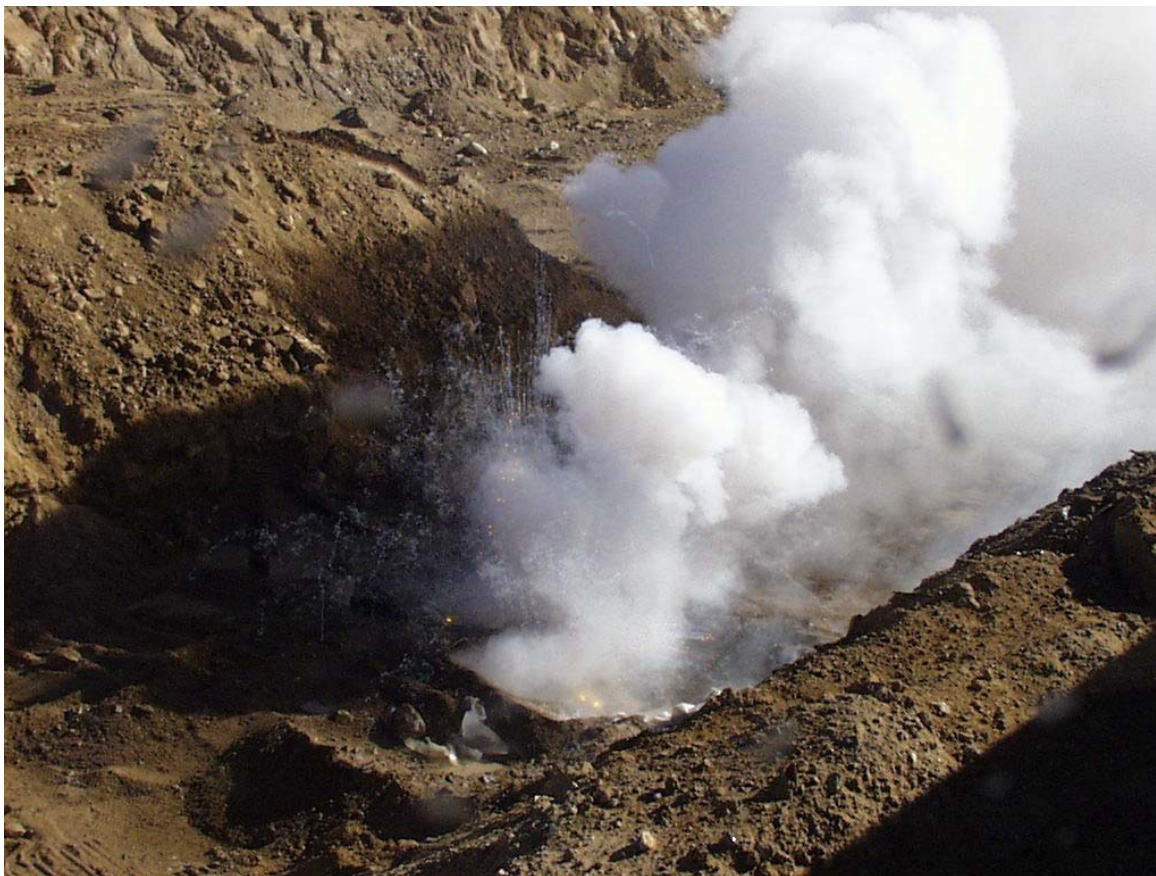
Fig. 3. Reaction of sodium-potassium compound with water

The RCRA emergency treatment exclusion has been necessary on two occasions (11). First, in December 1999 a breached container of a sodium and potassium-containing compound was removed from the excavation. Upon attempting to collect a sample, the material began to spontaneously react with the humidity in the air. Flames and smoke resulted in the debris segregation tent where the sampling was attempted. Hazardous material response team members placed type D fire extinguishing powder on the can of material, then placed the can into the fully shielded wheel loader bucket used during excavation. Site personnel reacted the compound with water in the bottom of the 12-foot deep excavation per the RCRA emergency treatment exclusion (Figure 3). Secondly, the contractors managing the compressed gas cylinders identified an intact container of solid sodium-containing material. This material was reacted by successively removing small quantities of the material from the container and fully reacting each small piece of sodium material in water.
