DISMANTLING OF THE REACTOR BLOCK OF THE FRJ-1 RESEARCH REACTOR (MERLIN)

B. Stahn, K. Matela, C. Zehbe
Forschungszentrum Jülich GmbH
52425 Jülich, Germany

This report describes the past procedure in dismantling the reactor block of the FRJ-1 research reactor (MERLIN). Furthermore, it gives an outlook on future activities up to the final removal of the reactor block. MERLIN is an abbreviation for **Medium Energy Research Light Water Moderated Industrial Nuclear Reactor**.

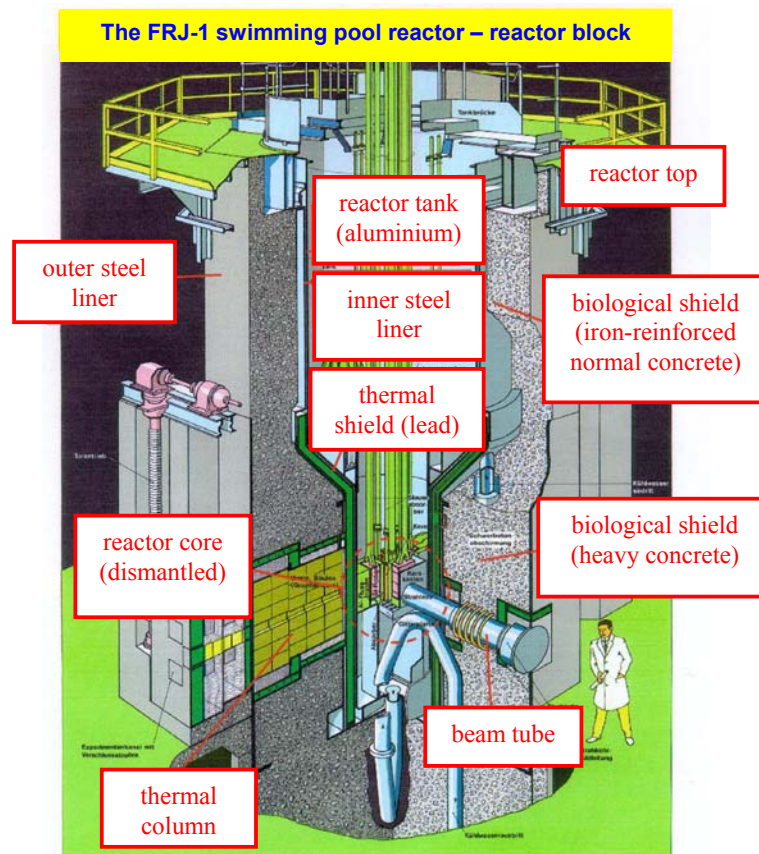
Fig. 1 Reactor block of the FRJ-1 (MERLIN) research reactor

The reactor block (see also Fig. 1) was the central component of the reactor plant. With an overall height of approx. 11 m the block represents an octagon with a spacing of 5.65 m between the parallel surfaces. The reactor tank of up to 13 mm thick aluminium, into which the reactor core had formerly been integrated and which was filled with light water for cooling and moderation purposes, is surrounded by a biological shield of concrete over the complete height. In the upper region, iron-reinforced normal concrete with a density of approx. $2,350 \text{ kg/m}^3$ was used with a thickness of approx. 1 m. In the bottom region, which formerly accommodated the reactor core, heavy concrete with a density of approx. $4,200 \text{ kg/m}^3$ was used. The biological shield has a thickness of approx. 1.80 m here and is internally and externally surrounded by steel liners (12 to 25 mm). In the bottom region of the reactor block a thermal shield was additionally provided. It consists of aluminium-clad lead segments with a thickness of approx. 100 mm.

Following this, the dismantling of the reactor block was started. As the central component of the Merlin reactor plant, the reactor block exhibits the highest activity and contamination level. For this reason, prior to actual dismantling various protective measures had to be realized which primarily serve health physics purposes. For the structural implementation of these measures, first of all, preparatory work was carried out at the reactor block. The reactor extensions, especially the gates of the thermal columns including the associated supporting columns of heavy concrete and the steel platforms surrounding the reactor block (reactor top) were dismantled (see Fig. 1).

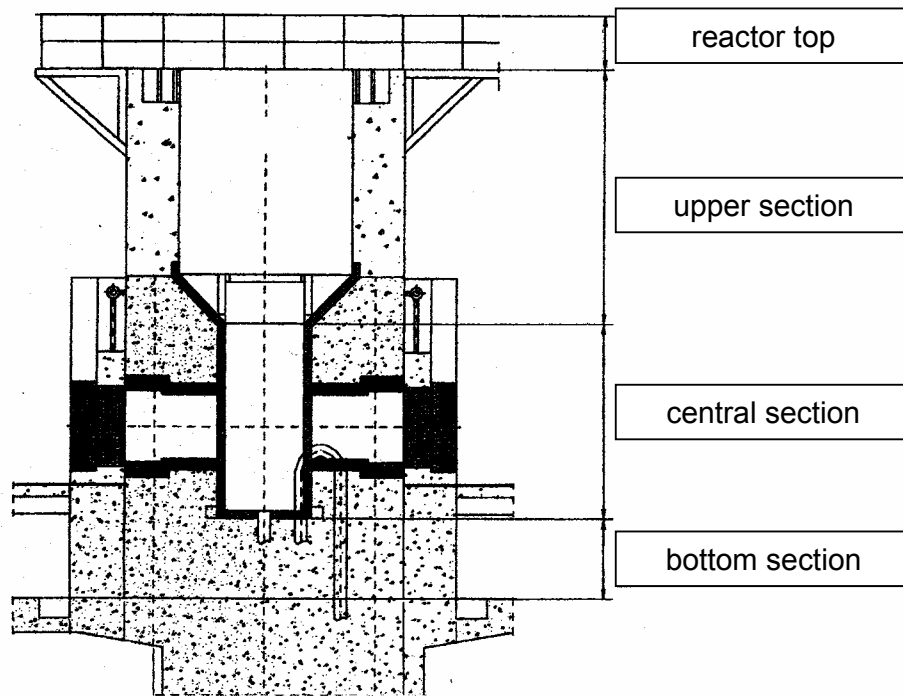
Fig. 2 Dismantling sections of the reactor block

The reactor block is being dismantled in several steps from top to bottom and from inside to outside. These steps are divided into upper, central and bottom section (see Fig. 2).

Dismantling the upper section of the reactor block started in August 2002. This section comprises the upper cylindrical part of the reactor block with a wall thickness of approx. 1 m including the conical part of heavy concrete. It is being assumed that almost 100 % of the dismantled materials from this region can be measured for clearance. Up to the present, about half of the upper section has been dismantled and disposed of (see Fig. 3).

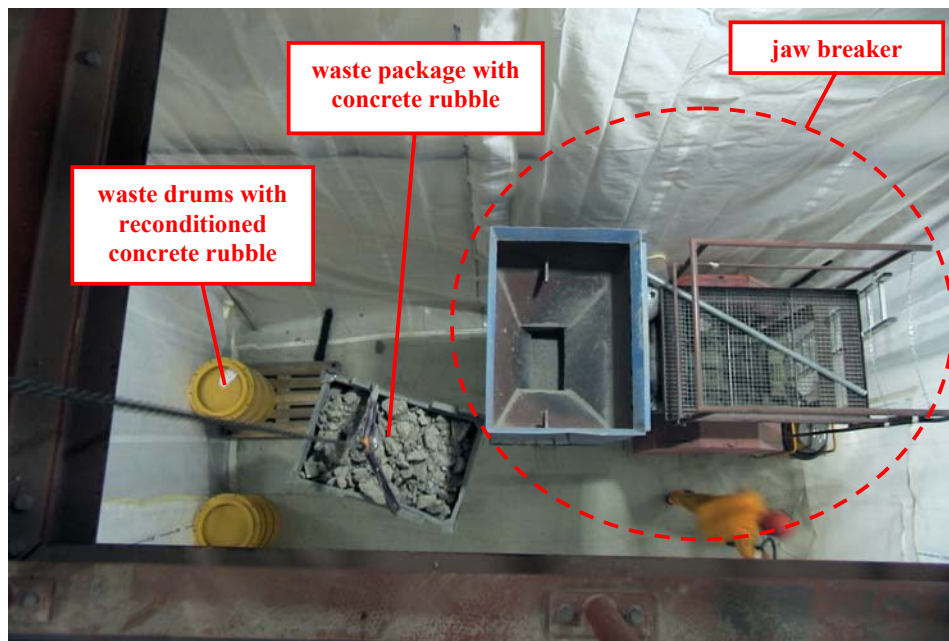
Fig. 4 Position of the jaw breaker in the casing

For the dismantled concrete, the homogenization step was realized in the form of a toggle jaw breaker modified for use in MERLIN. Special measures were required for filling and discharging the concrete rubble. After the jaw breaker had been installed, it was provided with a casing, which is exhausted by a separate ventilation system generating a directional flow from the reactor hall into the casing. After the jaw breaker had been put into operation, the concrete rubble from dismantling the reactor extensions could be reconditioned and measured for clearance. After the reactor extensions had been dismantled, the jaw breaker was moved from its original position on the ground floor of the reactor hall into the casing of the reactor block. This measure serves to optimize waste logistics, since the concrete structures measurable for clearance can now be conditioned immediately after dismantling and filled into the waste drums required for the clearance measurement device (see Fig. 4).

The jaw breaker will remain in this position until the dismantling of contaminated or activated structures can no longer be excluded. Since a contamination of the breaker exclusively provided for concrete structures measurable for clearance must be avoided by all means, repositioning will be necessary at this point in time, at the latest. The breaker will then be moved to the former position of the storage block on the ground floor of the reactor hall. This position was also selected to optimize waste logistics operations since there is a direct access from the ground floor to the reactor level. The waste packages loaded with concrete rubble can thus be directly unloaded into the jaw breaker with the aid of the hall crane.
