**The Use of Ecological Restoration Principles To Achieve Remedy Protection  
At the Fernald Preserve and Weldon Spring Sites**

J. Powell, F. Johnston, J. Homer  
Fernald Preserve  
10995 Hamilton-Cleves Hwy. Harrison, Ohio 45030

WM2008 Conference, February 24-28, 2008, Phoenix, AZ

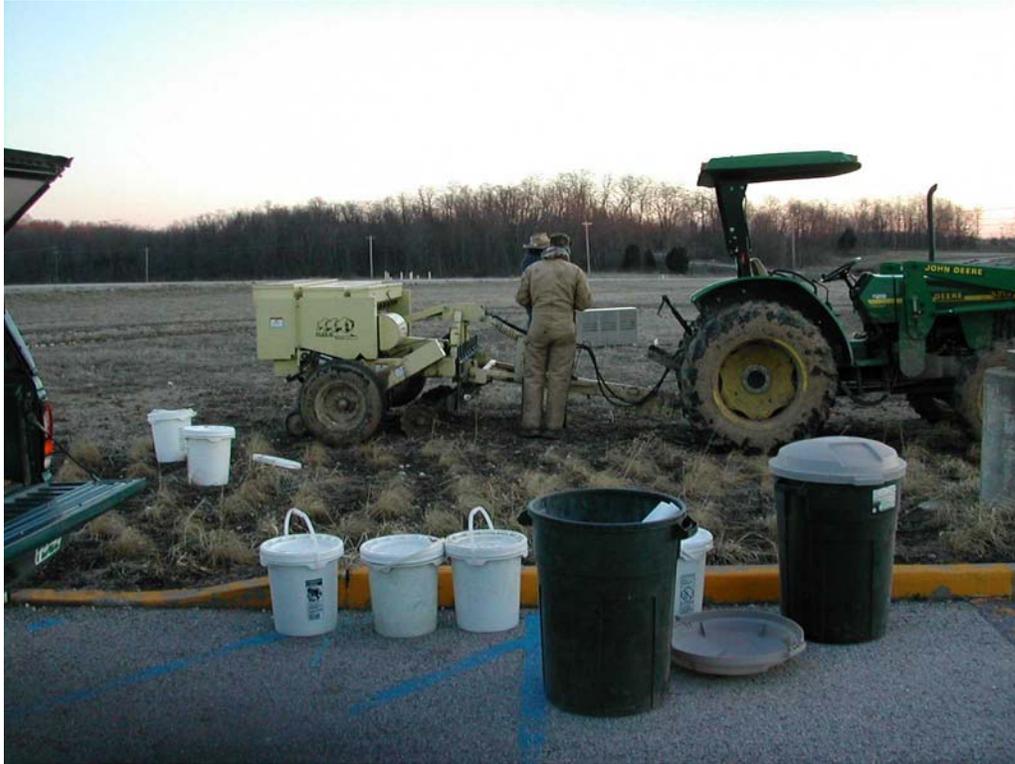
Fig.1. A seed drill was utilized at the Fernald Preserve and Weldon Spring Site for seeding operations.

Additional seeding was performed in January of 2003 and 2004 utilizing a seed drill (Fig. 1). Seed mixes consisted primarily of forbs supplemented by grasses. In 2004, a micorrhizal inoculant was utilized as a seed coat to enhance root development. Limited spot-seeding of harvested and donated seed was performed in 2005, 2006, and 2007.

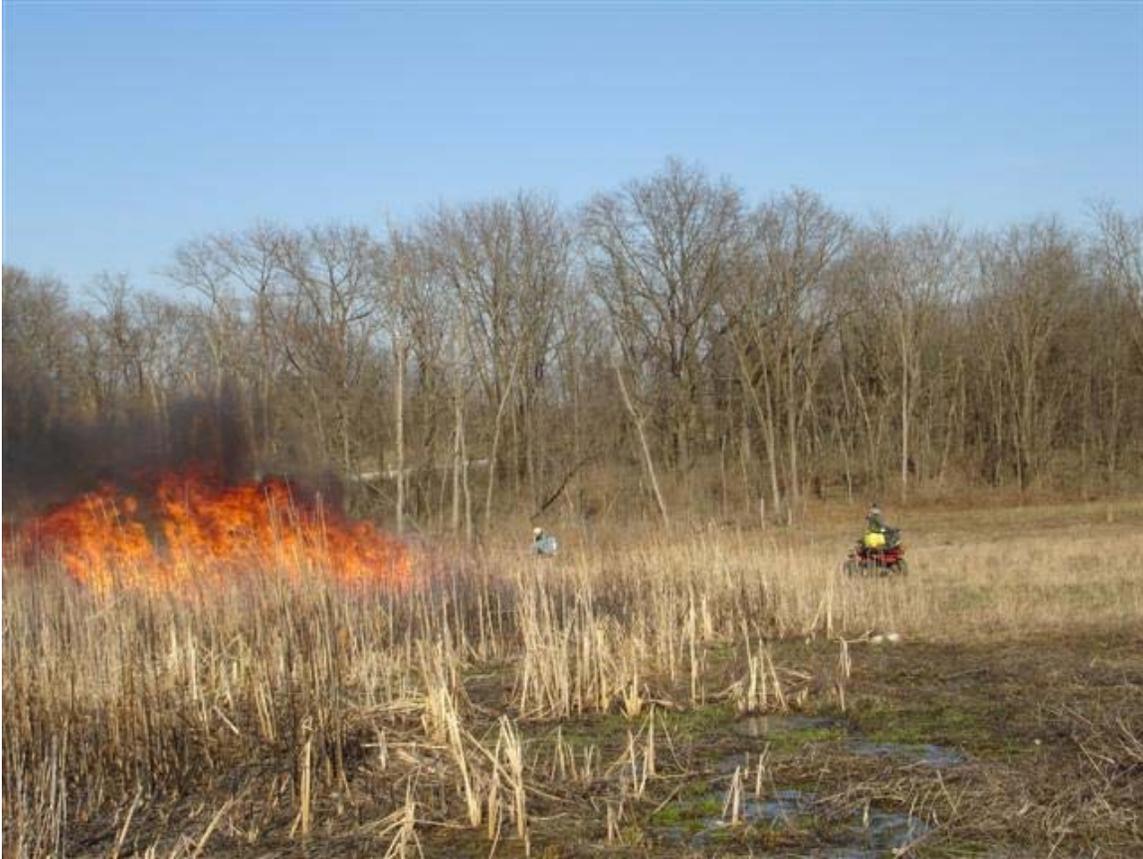
Fig. 2. Prescribed burning is being performed in the drainage outlet area of the Weldon Spring Site in February, 2006.

High mowing was performed from 2002 – 2005 to limit annual weed establishment and encourage natives. The prairie was mowed to a height of approximately 30 centimeters (12 inches) during early summer. Prescribed burning was performed in limited areas with greatest fuel load in 2006 and it is expected that this will be the primary long-term management tool. (Fig. 2)

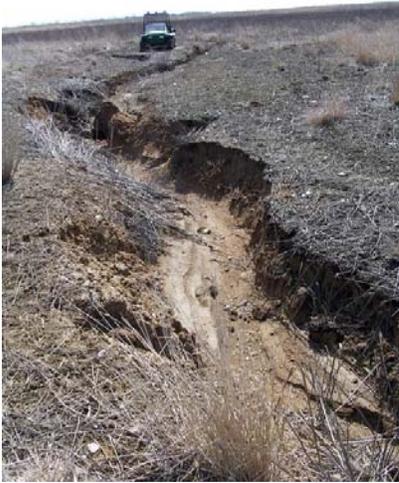
Fig. 3. Erosion channel observed in late winter, 2007. Significant plant establishment has since occurred along the sides and bottom of the channel.

In 2004, a more aggressive strategy was employed for controlling erosion in the worst gullies. Erosion in two areas of the site was repaired by performing limited excavation, applying geo-fabric, digging rock boxes, and then filling gullies and boxes with rock. An extensive summer drought hampered further plant establishment for the season. In 2005, new erosion channels were noted and repaired by digging rock boxes and filling channels with rock. Summer drought conditions continued to hamper plant growth and establishment. In 2006, all erosion areas were monitored and appeared to be stable. However, by late winter of 2007, erosion in one portion of the site appeared to be increasing rapidly and areas repaired with rock were observed to be silting in and new erosion channels starting to cut around the sides. (Fig. 3)
