**D&D (System Closure) Mockup Testing Demonstration—Remediation of Legacy Radioactive Piping and Tank Systems at the Reactor Technology Complex (RTC) (2007) – 8397**

**ABSTRACT**

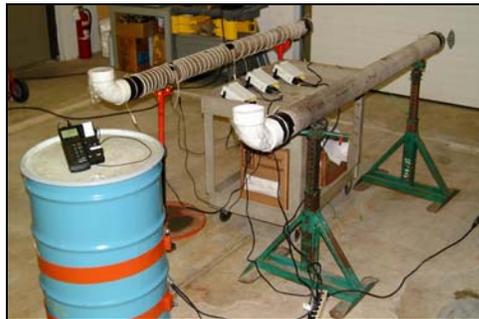
Fig. 1. Duriron pipe and WAXFIX test setup.

The purpose of the temperature testing was to determine the effect of cold piping on wax placement. Previous testing had been performed on piping heated to above the melting temperature of the wax. This test addressed pouring the wax into a cold pipe, to test both the self-sealing properties of the wax in a cold pipe and amount of piping that could be addressed without pre-heating. The two sections of Duriron pipe were prepared by taping bored PVC fittings on the pipe ends using Gorilla tape. Twine was tied around the Gorilla tape close to the fittings at each end of the pipe to prevent wax leakage. One end was capped, and the other end had a 90-degree fitting that was used for wax introduction. The 10% moisture surrogate waste was then placed into the pipes. One of the Duriron pipes was heated to 60 °C (140 °F) using fiberglass heat trace while the other piece of pipe was maintained at room temperature. Temperature controllers were used to control the heated pipe temperature and to monitor the pipe temperatures before, during, and after wax introduction. Figure 1 shows the test setup before wax introduction. The Duriron pipe shown at the top of the picture was the heated piece of pipe. The blue 200-L (55-gal) drum contained the WAXFIX that was kept at approximately 60 °C (140 °F) using two drum heaters. The temperature was monitored using a temperature probe as shown in Fig. 1 [on top of the 200-L (55-gal) drum]. The ambient temperature of the test facility and the unheated pipe was approximately 29.4 °C (85 °F).

The WAXFIX was introduced into the unheated piece of Duriron pipe. No leaks were detected coming from the unheated piece of Duriron pipe. Approximately one-half hour later, the unheated pipe temperature was 32.7 °C (91 °F) and dropped to 29.4 °C (85 °F) 3-1/2 hours later. After 4 hours and 20 minutes, the pipe had cooled to 28.8 °C (84 °F) and remained at that ambient air temperature for the remainder of the day.

The temperature of the heated piece of Duriron pipe ranged from 58.8 to 60.5 °C (138 to 141 °F) before the wax [at approximately 60 °C (140 °F)] was introduced. The pipe began to leak from each of the pipe sections at the taped fittings. Burlap was wrapped around the taped pipe and fitting sections and was tied down with twine. (Twine proved better than rope to fix the burlap in place since it could be tied tighter to the pipes.) The wax continued to leak out of the taped area that was covered with burlap. The heat was maintained between 57 to 60 °C (135 and 140 °F) for one-half hour after the wax was placed into the pipe, and the wax continued to leak during that time. The pipe temperature ranged from 39.5 to 50 °C (103 to 122 °F) after 1 hour and dropped to a range of 28 to 39 °C (83 to 100 °F) after 6 hours. At approximately 6 hours and 25 minutes, additional wax was added to the pipe, and the pipe temperature rose to a range of 35 to 38 °C (95 to 100 °F) within 15 minutes. The pipe did not leak at this point, which shows the wax does self-seal and provides a hardened interface for hot wax introduction after initial wax cool down.

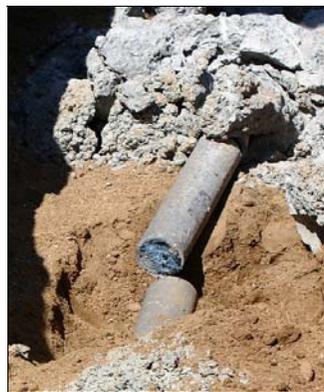
Two pieces of Duriron were placed into the trench for the trench piping Mockup after wax was placed into the pipes. The heated piece of Duriron pipe was cut during the first Trench Mockup, and the unheated section of Duriron was cut during the second Trench Mockup. Figure 2 shows the heated piece of Duriron pipe after the Brokk cut it into two pieces during the first Trench Mockup. Notice that the WAXFIX product has encapsulated the 10% moisture surrogate waste in the pipe instead of coating the bentonite grains as it did in the clear PVC pipe. Also, the wax and the surrogate waste stayed in the pipe after it had been cut.

Fig. 2. (5-11) Cut Duriron pipe.

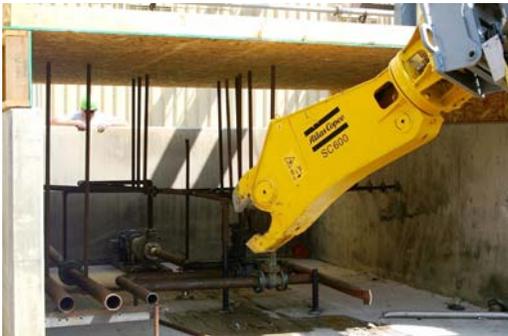
Fig. 3. Pipe shear moving into the vault for cutting piping.

An existing, not in use, concrete structure measuring approximately 4 m (13 ft) wide by 5.5 m (18 ft) deep with 1.5 m (5 ft) high cement walls on three sides and an open front was selected to replicate a typical pipe vault. The cement walls of the concrete vault were extended to 2.13 m (7 ft) high using a wood frame and sheathing. The vault was then covered with a flat wood frame and sheathing roof to simulate the headspace of a typical RTC pipe vault. Pumps and piping systems were installed by MSE personnel in accordance with CWI instructions that were designed and installed to replicate a typical RTC pipe vault as shown in Fig. 3. Following the wax fixative demonstration, one pipe filled with wax fixative was installed in the vault mockup.

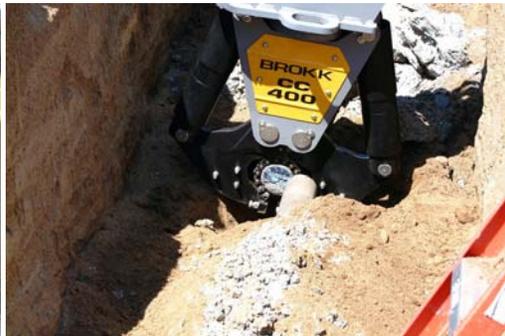
MSE personnel excavated a 1.5 m (5 ft) wide by 1.2 m (4 ft) deep trench approximately 9 m (30 ft) long and installed cast iron and Duriron pipe as specified by CWI. A section of Duriron pipe filled with wax fixative was also installed. Pipe joints were covered with concrete to simulate conditions that will most likely be encountered at the CTS as shown in Fig. 4.

Fig. 4. Pipe joints covered with concrete in the trench mockup.
