Employing Interim Water Management Barriers at Waste Disposal Area – 9255

Daniel Sullivan, U. S. Department of Energy, West Valley Demonstration Project;
David Garber, Environmental Chemical Corporation;
Scott Chase, Cynthia Dayton, KK Gupta, Emil Selent, West Valley Environmental Services;
10282 Rock Springs Road, West Valley, NY 14171-9799

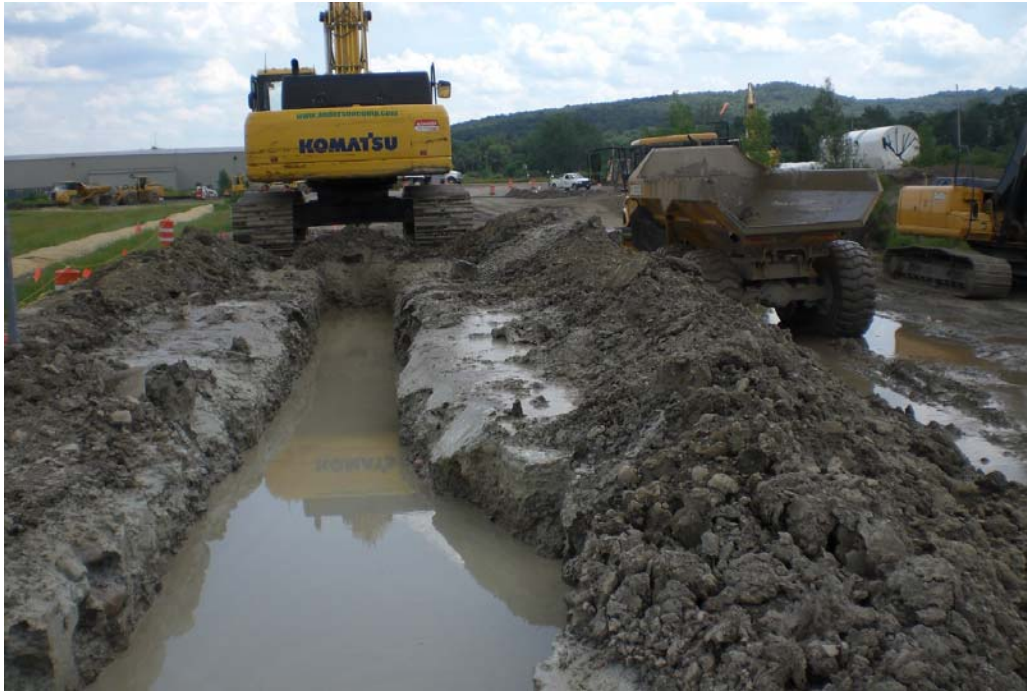
Figure 1. Excavation for the slurry wall.

A working platform was established to prepare for excavation of the slurry wall and excavation for the slurry wall began in mid-June 2008. The 4.3 meter (14 foot) wide earthen platform enabled the excavator to safely straddle the slurry wall trench during excavation. The slurry wall construction was performed by excavating soil, filling the excavation with bentonite slurry, mixing the excavated soil with bentonite and water, and backfilling the trench with the soil bentonite mix. The bentonite slurry was displaced and maintained in the excavation for trench stability.

The slurry wall was excavated in a continuous line, with the excavator gradually reaching the depth of 5.5 meters (18 feet) through a series of simultaneous digging and backfilling evolutions. This method of installation was selected to provide a uniform, continuous and homogenous slurry wall that is free of joints with a permeability rate of 10⁻⁷ cm/sec.

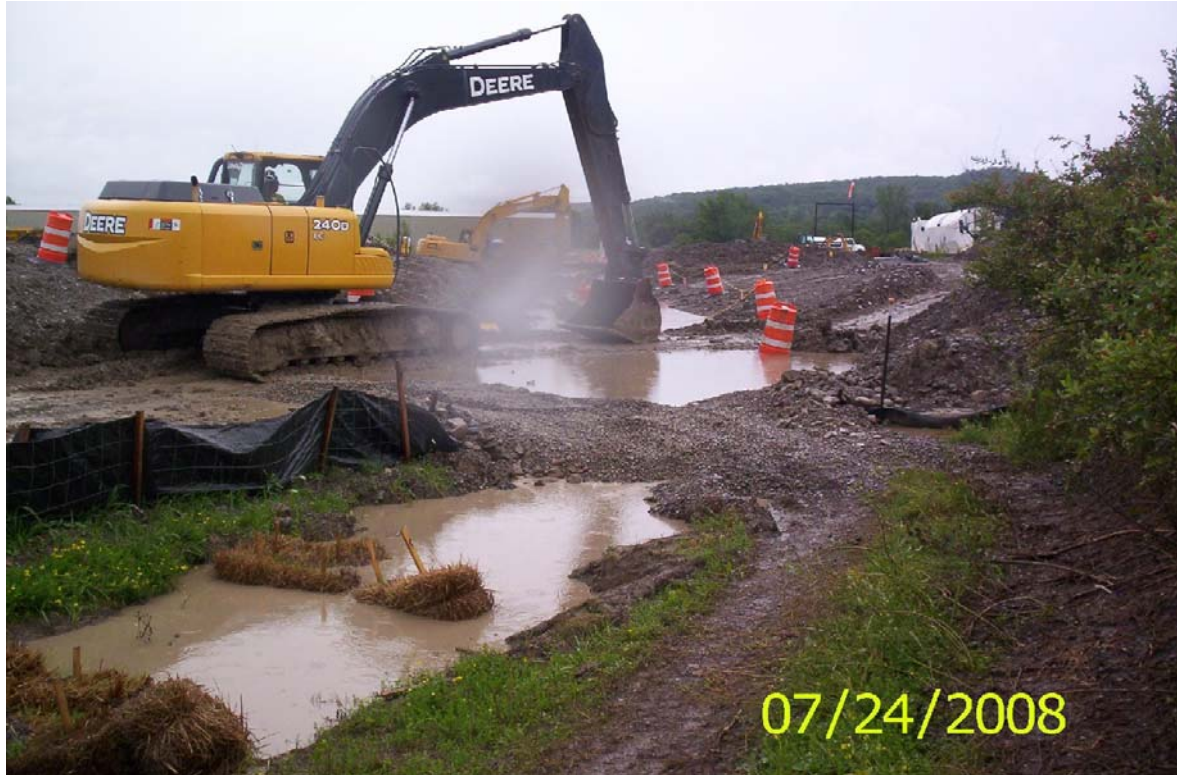
Figure 2. Stormwater pollution prevention barriers -- repairs and maintenance in progress after a heavy rainfall event.

Storm water controls were established in accordance with the project's storm water pollution prevention plan. Key components include a construction perimeter silt fence backed with straw bales in areas of extreme slope, earthen dikes to direct anticipated runoff in a controlled path, and water control check dams to slow water and confine any silt associated with the construction.

Geomembrane placement began September 22 and was completed November 8, 2008. The work was generally routine and progressed according to the plan, however, exceptionally wet weather impacted the installation schedule and resulted in excessive amounts of runoff from the NDA during cap installation. While runoff was managed in accordance with all stormwater pollution prevention requirements, additional resources were required to address runoff issues.

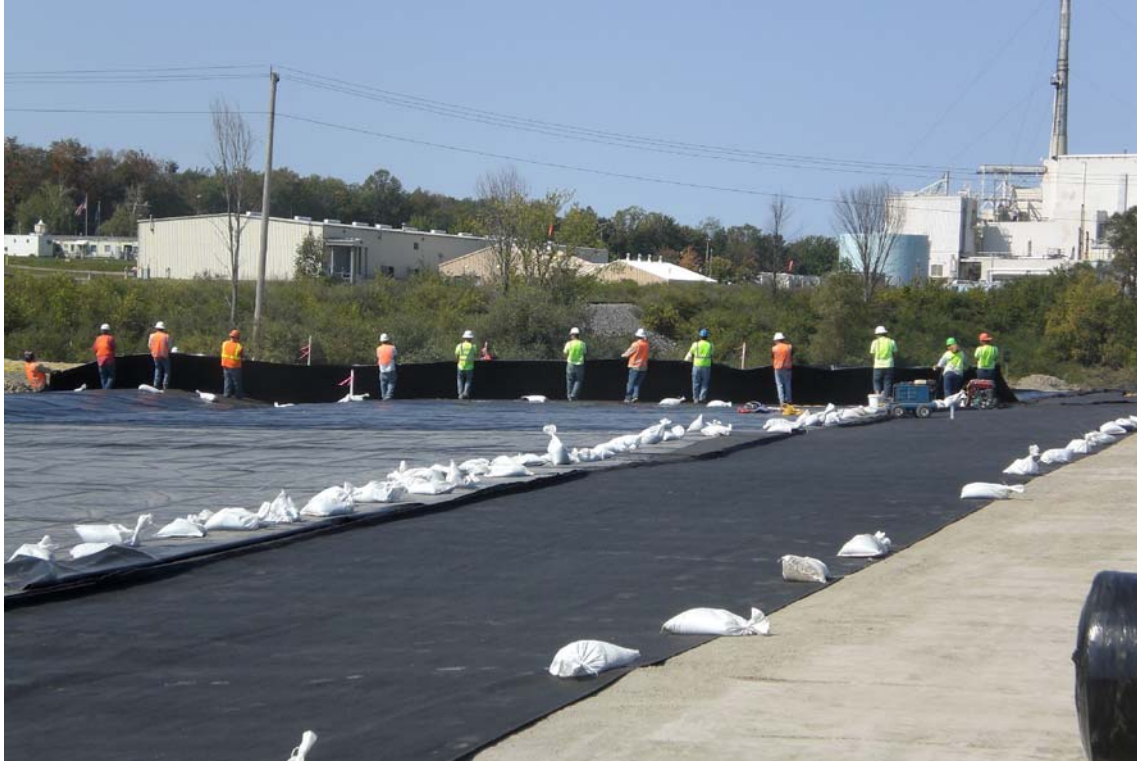
Figure 3. Panel installation in progress.

Geomembrane was fabricated by Lange Containment of Denver, CO. Lange fabricated the 29 panels in August 2008. The panels were constructed from 3-mil thick XR-5™ ethylene polymer alloy (envaloy). The panels were irregular in length and configuration due to existing the features and contours of the NDA, necessitating a number-matched delivery and installation pattern to ensure proper placement of each panel. The first panels began arriving at the WVDP during the first week of September 2008.
