**Management and Beneficial Reuse of Overburden Material - Linde Formerly Utilized Sites
Remedial Action Program (FUSRAP) Remediation Project – 9319**

J. D. Boyle
U.S. Army Corps of Engineers – Buffalo District
1776 Niagara Street, Buffalo, New York 14207

M. Schwippert, W. D. Lorenz
Shaw Environmental & Infrastructure
175 East Park Drive, Tonawanda NY 14150

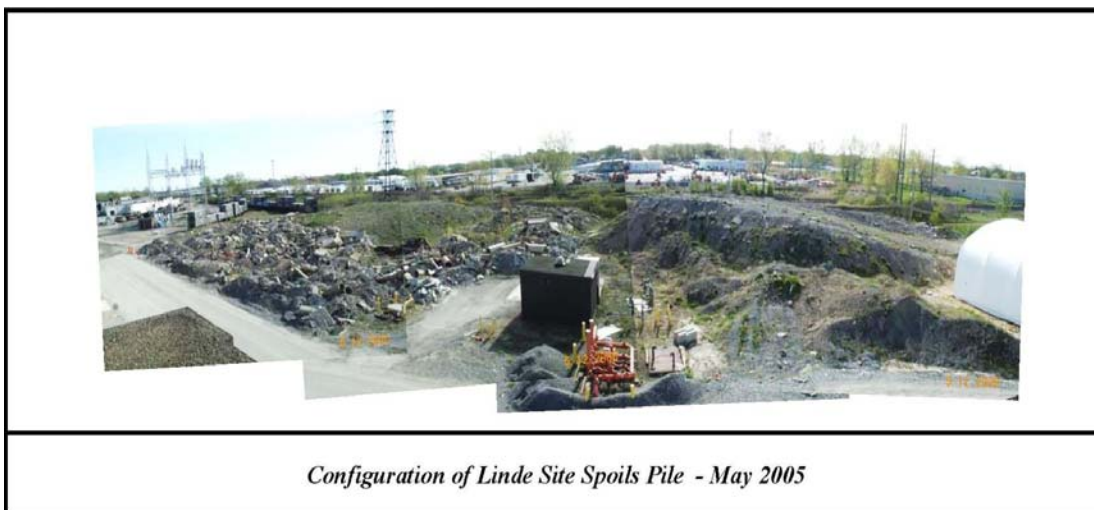
The spoils pile was located in the southeastern portion of the Linde site. In 1990, the Owner initiated facility expansion and improvement work that involved construction of a new building and site parking lots on the west side of the property. Excess materials that were removed during construction of these facilities were relocated within the area that became known as the spoils pile. From 1990 through the spring of 2005, all excess material generated from landscaping, construction, demolition and excavation activities by the Owner or its subcontractors were placed in the pile. These materials included soil and soil-like material, concrete, steel, wood and asphalt. The in-situ volume of the spoils pile was estimated at 14,000 cubic yards as surveyed in 2003. Development of the property by the owner between 2003 and 2005 resulted in additional material being added to the spoils pile.

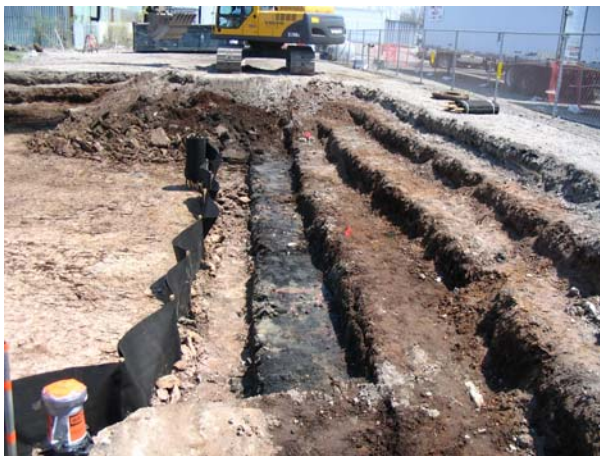
Figure 1 – "Black Lens"

The radiological contamination was predominantly in a black colored lens (Figure 1) located at various depths below the ground surface. A characterization activity to confirm the extent of MED-related radiologically contaminated "lens" was an initial step to the operation.

contamination was concentrated in a two to thirty inch thick black colored lens located at various depths below the ground surface.

Excavation challenges were met by evaluating gamma count rates relative to background in the area of the dark lens. Elevated count rates and the presence of the black lens provided sufficient evidence to support the existence of MED material in excess of subsurface ROD criteria. This effort resulted in time and cost savings because the excavation of the area could proceed as guided by the Health Physics Technician, while confirmatory alpha spectrometry analytical results were being processed. To support documentation of this effort, daily photographs of the dark lens material were taken, GPS coordinates of its location, thickness, count rate, and overlying material count rate were also recorded. This methodology proved to be extremely successful during the remediation of this area.

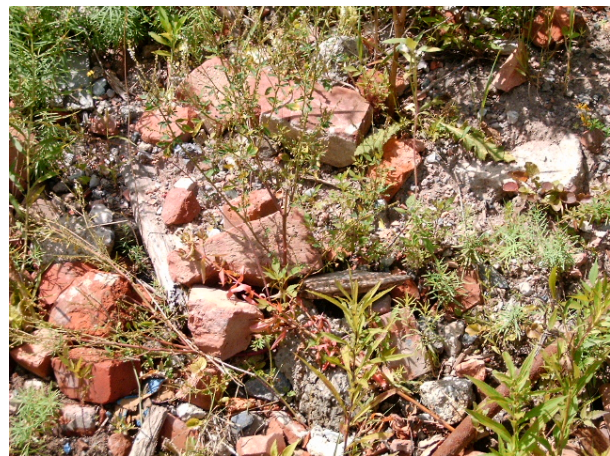
Figure 2 - Heterogeneous Hard Fill

A modification of the existing Class 2 sampling protocol was required due to the irregular land surface, mixed hard-fill, and building demolition debris within the property area (Figure 2).

The modified protocol employed a combination of sampling techniques including test pits, split-spoon sampling, and hollow-stem auguring methods as opposed to exclusive use of split-spoon sampling. Due to the presence of the commingled contaminants the analytical results provided by on-site high purity germanium detector gamma spectroscopy and previously developed investigation levels were determined to be inconclusive.

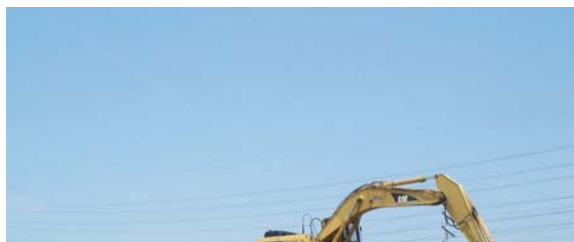
Relocation of spoils pile material commenced in May 2005. Field operations relied on conventional excavation techniques using hydraulic excavators and articulated haulers to excavate, segregate, load and transport soil, soil-like material, concrete and debris from the spoils pile to designated staging areas. Staging areas for each type of material were established near the northeast corner of the Linde site where removal of radiologically-impacted soils and subsequent backfilling had previously been completed. Materials were transported along a prescribed route with each load being escorted to its destination to ensure safe passage.

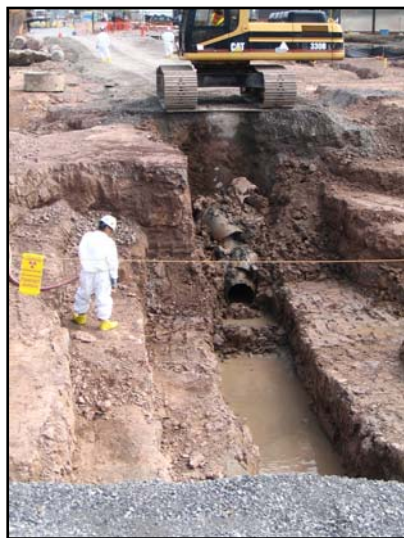
Sewer Line Remediation

The second phase of operations focused on removal of contaminated soils and sewer line infrastructure associated with 12” sanitary and 24” storm sewers. This effort required excavation to depths of 17’ below grade and required extensive benching of excavation sidewalls to maintain safe working conditions. Benching operations involved removal of non-impacted clay overburden material and placement of the clay in on-site stockpiles.

The final phase of work focused on restoration of the 12” sanitary and 24” storm sewer lines, backfilling of the excavated area and restoration of surface structures.

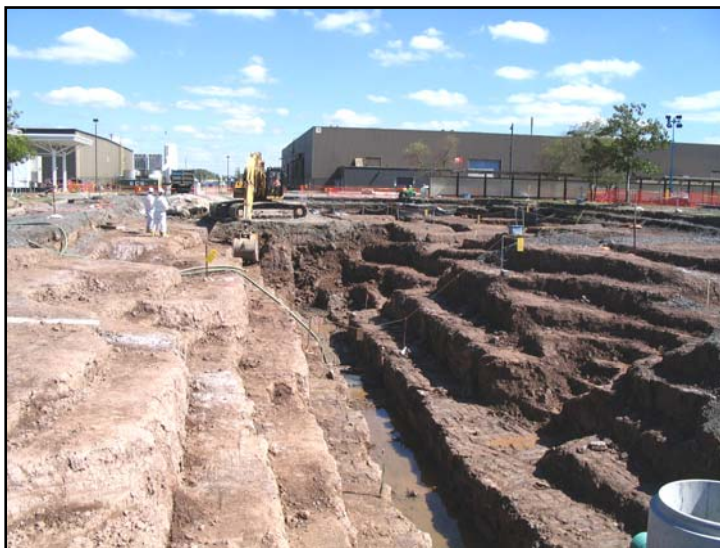
Benching of Excavation Sidewalls

In order for site personnel to safely access the base of the excavation once remediation was complete, extensive benching of excavation sidewalls was required to ensure adequate stability. Due to the depth of the excavation, a large volume of material would require removal during formation of the benches. The native clay that comprised the "benched material" was designated for future use as post-excavation backfill and was staged in on-site stockpiles for interim storage.

During benching operations in EA-I, native clay material was removed using conventional excavation techniques and was placed in clean intermodal containers (IMCs) of known volume. The IMCs were transported to the stockpile area by roll-off trucks where the contents were dumped. The material was configured using a bulldozer and compacted in lifts using a smooth drum vibratory compactor. The number of IMCs was recorded to establish a daily volume as the stockpile was constructed. Once excavation and restoration were completed in EA-I, the native clay stockpile was surveyed by a licensed land surveyor. Based in the findings of the volume survey, it was estimated that the clay stockpile contained approximately 3000 tons of material.
