**Fernald Preserve Aquifer Restoration Extraction Well and Pump
Maintenance Improvements – 9427**

W.A. Hertel, C. Glassmeyer
S.M. Stoller Corporation
10995 Hamilton-Cleves Highway, Harrison, OH 45030

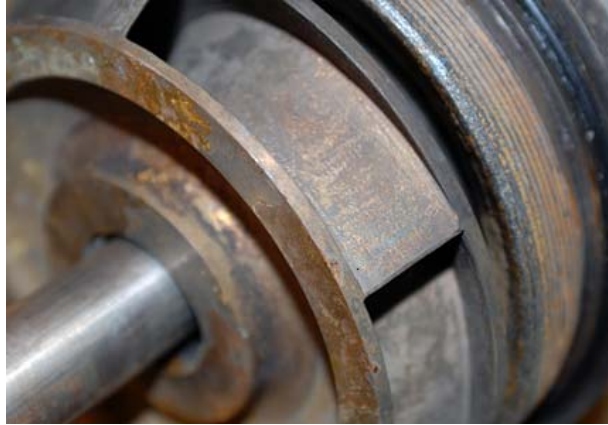
Fig. 1. Clean Pump Impeller

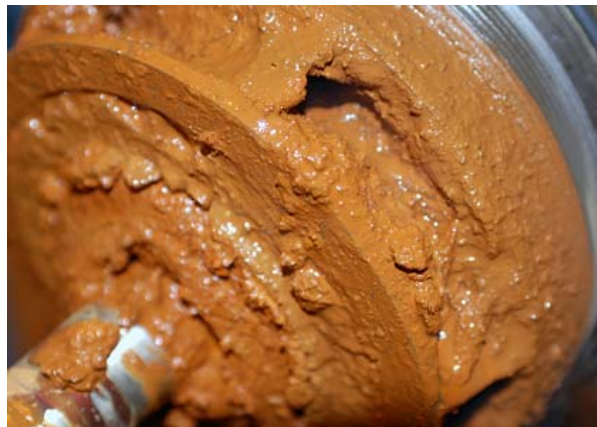
Most of the extraction wells are screened across the water table. The pumped water has high concentrations of iron, manganese, and carbonate, which in the past have precipitated out of solution and clogged the well screens, the pumps, and the discharge pipes. The precipitate appears to be held together by filamentous bacteria. The clogging is so severe that the output from some pumps was reduced by over 50 percent in less than 1 year. Figure 1 shows a clean pump impeller, and Figure 2 shows a clogged pump impeller.

Fig. 2. Clogged Pump Impeller

In the past, site personnel typically alleviated the clogging by removing the pump, motor, and discharge pipe from the well; rehabilitating the well with hundreds of gallons of concentrated hydrochloric acid; disinfecting the well with concentrated sodium hypochlorite; and replacing the clogged pump with a new one. A new pump typically costs between \$8,000 and \$10,000. Cleaning the well was a 2- to 3-week process that cost \$20,000 to \$30,000. All work was performed by a well maintenance subcontractor. The subcontractor made several unsuccessful attempts to use sodium hypochlorite to clean the pumps in the wells. After the pumps were removed from the wells, they were torn down and cleaned with hydrochloric acid on site to remove residual uranium contamination before being shipped to the well maintenance subcontractor for rebuilding at a cost of \$4,000 to \$5,000 each.

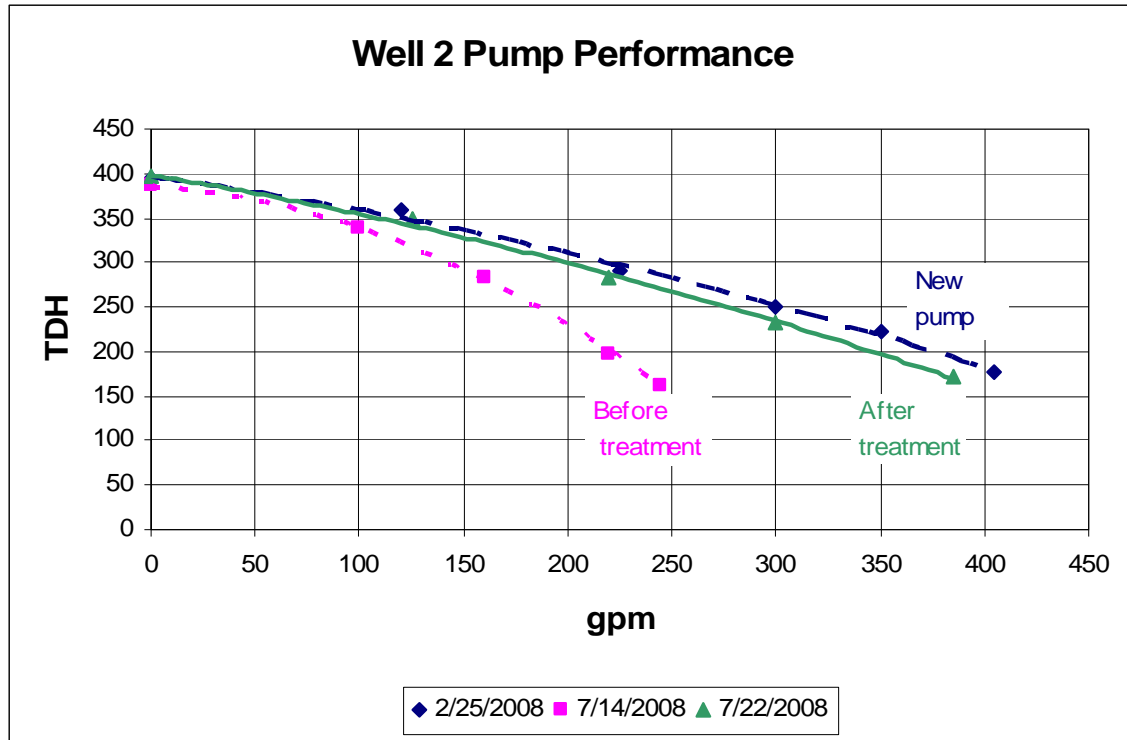
After surging for several hours manually or overnight using the control system, the pH of the solution in the discharge pipe was checked. If the pH was less than 4, pump surging was continued. When the pH reached or surpassed 4, the solution was pumped to a portable tank, using the well pump. The color of the solution being pumped was observed, and the pH was tested after about 200 gallons had been pumped. Pumping was continued in approximately 200-gallon increments until the pH of the solution was between 6 and 7 and the discharge water was clear. The pump was restarted, with its variable frequency drive or flow control valve set to allow the maximum possible flow rate. The pump was allowed to run at maximum capacity for at least 2 hours, and then the controller was reset to the desired set point. After a day or 2 of routine operation, another performance test was conducted. The results of the before-and-after performance tests were compared to the performance test conducted when the pump was new. Figure 3 below shows the results of cleaning Well 2 with the hydrochloric/glycolic mixture. Treating the well restored its performance almost completely.

Fig. 3. Performance of Well 2 Pump Before and After Treatment

In order to focus the cleaning on the inside of the pump, the chemicals needed to be added to the discharge pipe at the top of the pump. Minor modifications were made to some of the discharge pipes to allow a hose to be placed at the desired location. The chemical was added through the hose, using a drum pump. Originally, the amount of chemical used was based on maintaining approximately a 10 percent solution in the water column above the pump. Based on the results of initial testing, the concentration of the chemical solution has been increased to about 50 percent. The cleaning chemicals were allowed to sit in the pump for approximately 3 hours; then the pump was operated for about 5 to 10 seconds before it was stopped. This brief surging allowed the chemicals to circulate throughout all stages of the pump and made it easier to remove the material that constituted the clog, which had been loosened by the treatment solution. The surging was performed manually for some of the wells and through the automated control system for others. Since all of the cleaning chemicals used were acid-based, pH was used to determine when the cleaning ability of the chemicals was exhausted and when to pump the solution from the well.

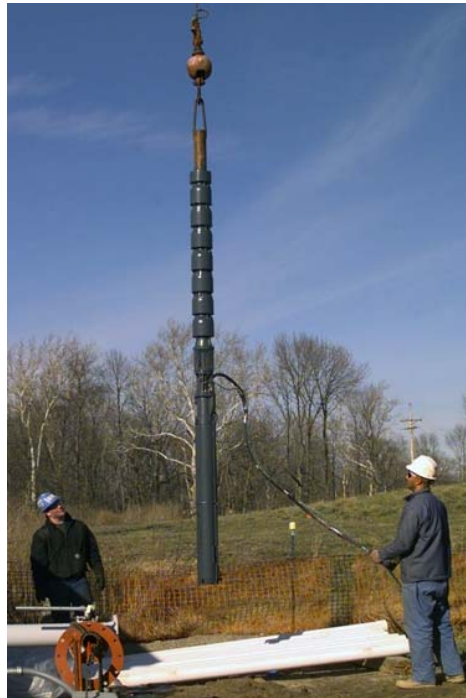
Three main safety improvements have been realized by using the new treatment chemicals. The first is that the pump is treated while still in the well. This eliminated all hazards associated with the use of a crane to pull the discharge pipe, pump, and motor from the well and then reinstall the new pump with the old motor and discharge pipe. Figure 4 below shows workers installing a new pump and motor in a well. The discharge pipe, pump, and motor assemblies typically weigh over 2,000 pounds. The types of hazards eliminated are falling objects from a failed crane or an improper lifting, back injuries from disconnecting discharge pipes, crushed hands from handling discharge pipes, and electrical injuries from improper disconnection or reconnection of the motor.

Fig. 4. Installing Pump & Motor in Well
