# PACKAGING AND TRANSPORTATION OF DEPLETED URANIUM FOR DISPOSITION FROM THE SAVANNAH RIVER SITE

#### ABSTRACT

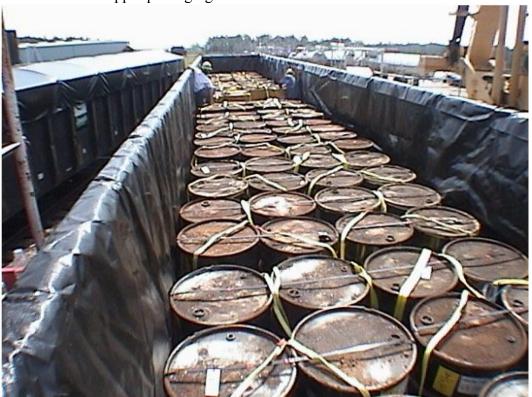
In FY03, the pilot project included the 3,270 55-gallon drums from F-Area that were in poor condition that required packaging into IP-1 compliant packaging. Three different attempts to use polyethylene soft-sided wrappers as the packages for this material were made before it was determined that several layers of protective materials were needed to meet the IP-1 packaging requirements. Package failures were significant in the first two attempts before the packaging vendor was able to meet the requirements. The poor performance of the soft-sided package for use under very heavy drums has been a prime decision factor in determining packaging for subsequent campaigns. Figure 1 shows a gondola railcar that is loaded and ready to close using the soft-sided wrapper packaging.

Figure 1. Loaded gondola railcar that is ready to close during Campaign 1.

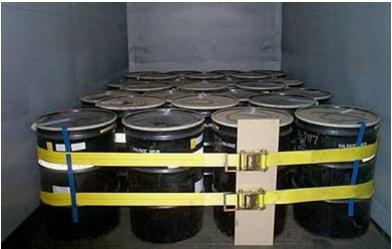
shipping package and the boxcar as the conveyance in FY04/05. Figure 2 shows the interior of a boxcar loaded with drums.

Figure 2 – One end of loaded boxcar with 85-gallon overpacks during Campaign 2.

Of the approximately 33,000 remaining DUO drums, about 7,000 had been historically overpacked into 85-gallon drums for on-site handling purposes. These overpack drums are wider than the 55-gallon drums such that four overpack drums would not fit across the width of a standard railcar. Therefore, other options were needed. The overpack drums were relatively new and in excellent condition but the weight exceeded the DOT limits for a non-bulk, "strong, tight" package (i.e., IP-1 package). Since this was a significant quantity of drums, SRS decided to perform a drop test to qualify the overpack drums as Industrial Package 2 (IP-2) packages (IP-2 packaging was required due to the weight of the material, not due to the radioactive content). The overpack drums passed the testing and thus did not require additional packaging. SRS shipped these drums in wider-than-standard boxcars to the Clive Facility with the drum as the

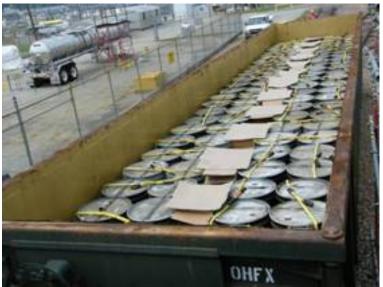
Figure 3 shows a railcar fully loaded, including required B&B materials, and ready for lid replacement.

Figure 3 – Fully loaded railcar during Campaign 3.

- Placing the pallets into the railcar in two rows of 13 pallets each (extremely tight fit less than ½ inch per pallet excess space),
- 9) Installing the B&B materials between the two rows of drums,

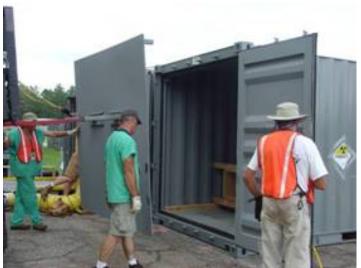
As the DUO drums were being removed from the facility, several drums were found to be damaged. The damaged drums were individually overpacked into 85-gallon drums to reduce the possibility of contamination spread during loading operations and were then loaded into the cargo containers for disposal. Figure 4 shows a bulkhead being installed on a cargo container. This is the bulkhead that was added to the cargo containers to ensure powder would be contained if a drum were to breach in transit.

Figure 4 – Installation of bulkhead to seal door during Campaign 4.

After the determination of the P&T approach was made for Campaign 4, the M&O decided that the doors of a standard cargo container would not contain the powder if a drum breached. Modifications to the containers were made to ensure the powder could not escape the bottom of the door. There were debates as to the extreme levels that were being required by the M&O and the associated cost (lower cost alternatives were possible but were not fully considered by the M&O), but the modified containers functioned well above requirements. Once these decisions were made, the loading became simple. The drums were removed from the facility, swiped, labeled, and loaded into the container. The drums were blocked and the container was sealed. The containers were loaded onto the flatbed trucks and the trucks sent to NTS. The fully loaded containers were placed in the disposal unit at NTS (they were not unloaded at NTS).
