**Remediation of Potentially Pyrophoric Mixed Wastes  
at the 618-7 Burial Ground, Hanford Site – 10399**

**ABSTRACT**

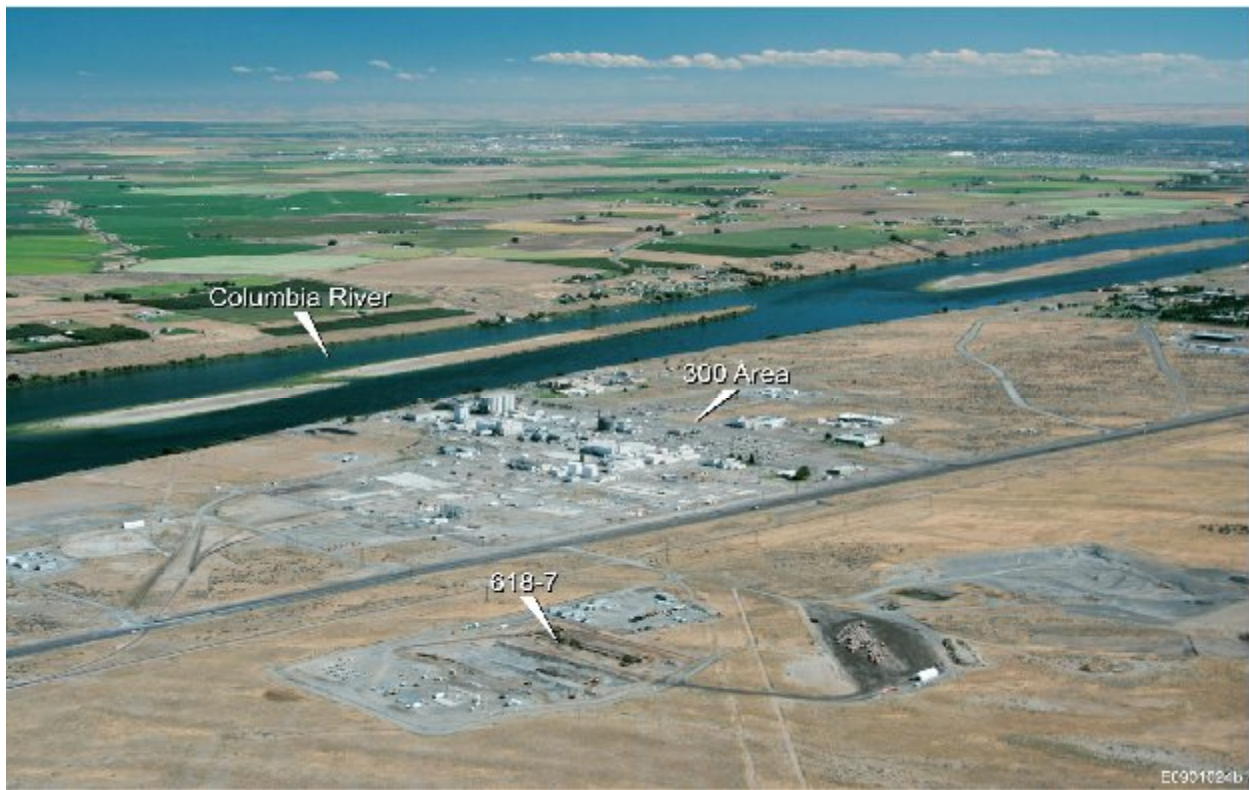
The 618-7 Burial Ground, located west of the Hanford Site 300 Area complex (see Figure 1), was a general purpose burial ground operated between 1960 and 1973. The original burial ground consisted of

**Fig. 1. 618-7 Burial Ground and the 300 Area Complex, Hanford Site**

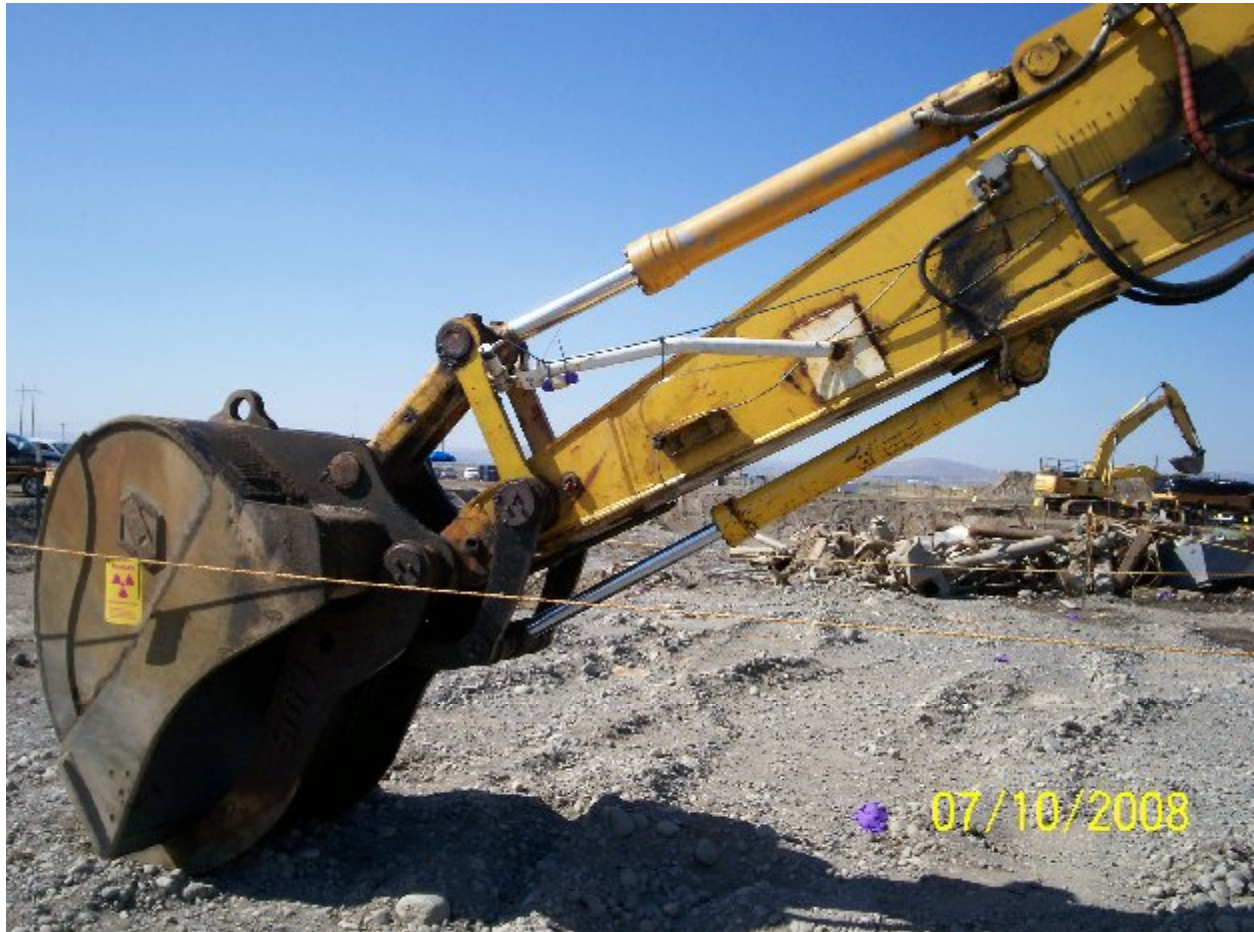
Excavated materials and anomalies were initially monitored using radiation detectors and a photoionization detector (PID) mounted on the arm of the excavation equipment. These instruments were connected to remote readouts via radio telemetry. An infrared thermometer was also mounted on the excavator arm with a readout that could be seen by the operator to monitor for elevated temperatures of drums and other anomalous materials to provide an early indication of a pyrophoric reaction (Figure 2).

**Fig. 2. Excavator bucket and arm showing infrared thermometer and radiation meter mounted on end of white metal pole and photoionization detector intake tube running along length of arm.**

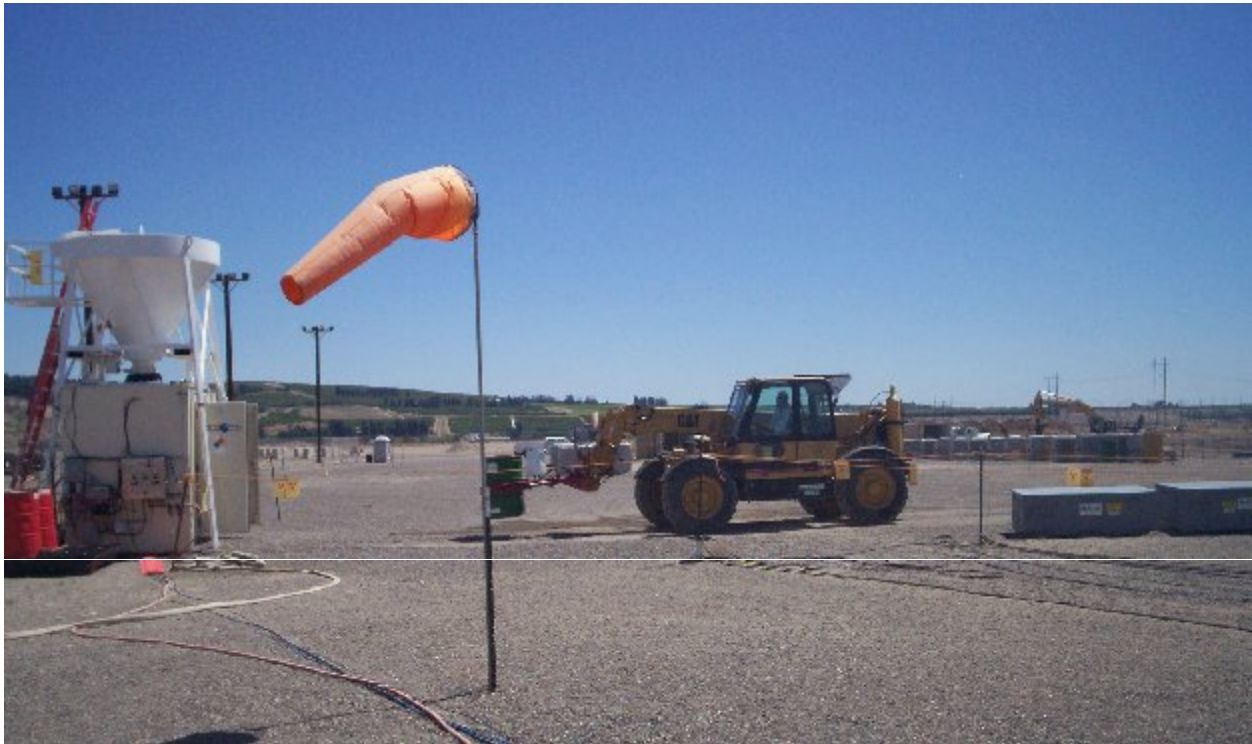
The last stage of drum characterization was to puncture the top of the drum; remotely evaluate the stability of the drum contents; and, if the drum was determined to be safe to approach, to sample the contents. The design of the drum punch facility (DPF) was a product of the pre-project workshops. The DPF consisted of a Hazmat building with a hydraulic lift table and a brass-tipped punch attached to the ceiling. A negative pressure ventilation system with a HEPA filter was connected to the building. The pneumatically-operated doors of the DPF could be opened and closed remotely to allow drum placement and removal by the blast-shielded, long-reach forklift (see Figure 3).

**Fig. 3. Blast-shielded forklift transporting overpacked drum into drum punch facility.**

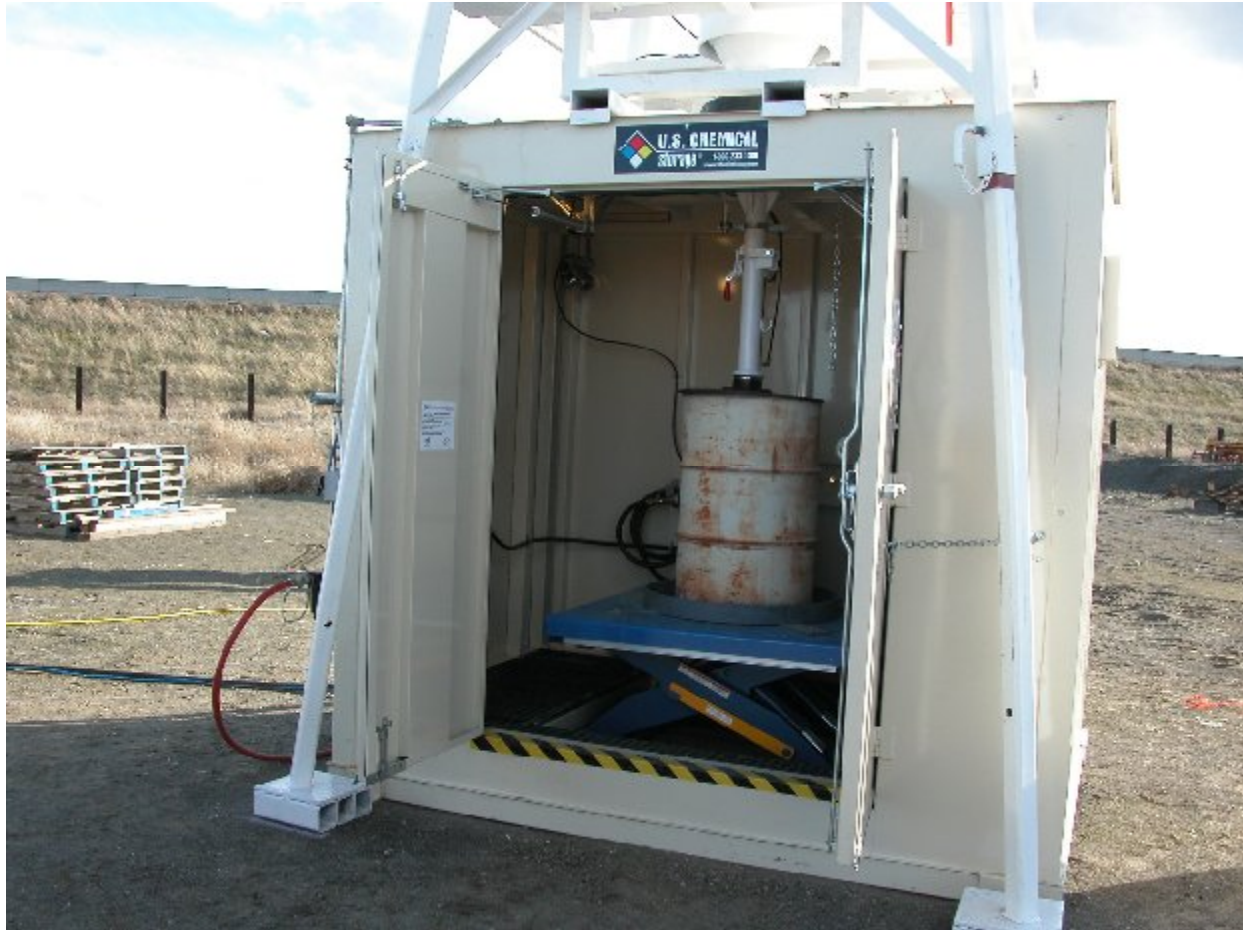
To open a drum, the non-sparking brass punch created a 4-inch diameter opening in the top of the drum. A flexible rubber skirt was mounted near the tip of the brass punch to deflect any liquids or splash down onto the lid of the drum during opening (see Figure 4).

**Fig. 4. Pre-project testing of the drum punch facility using an empty drum.**
