**Idaho Closure Project Integrated Waste Treatment Project Construction and Startup
Status and Lessons Learned - 10433**

Raymond M Geimer
CH2M•WG Idaho, LLC

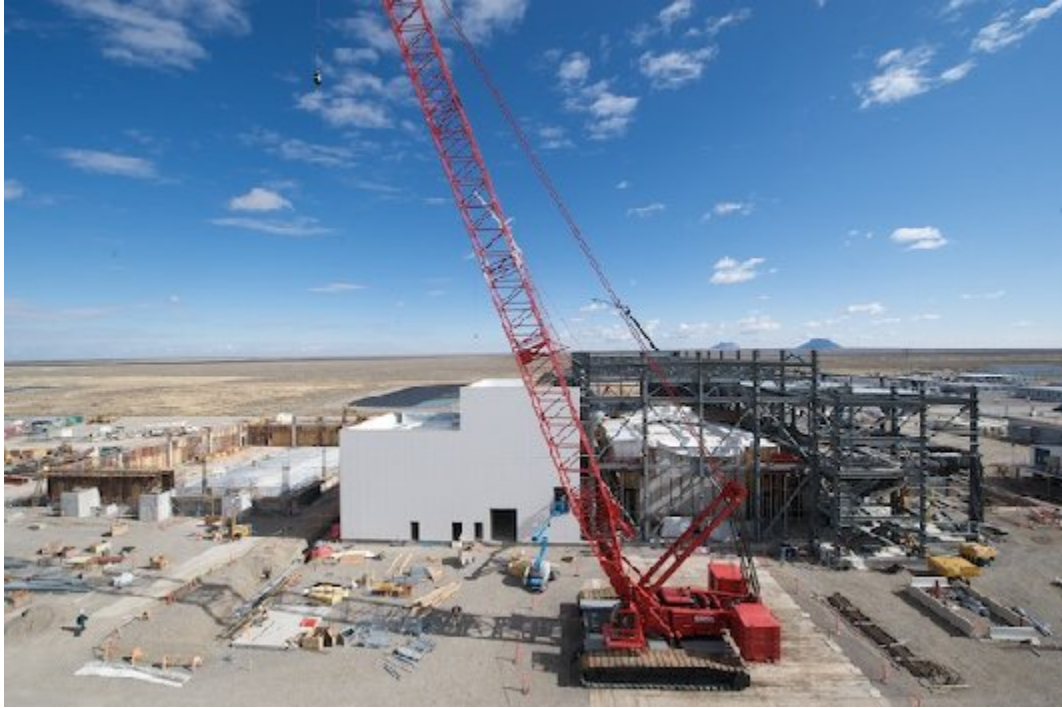
Figure 1. IWTU treatment building and product storage building under construction in the fall of 2009.

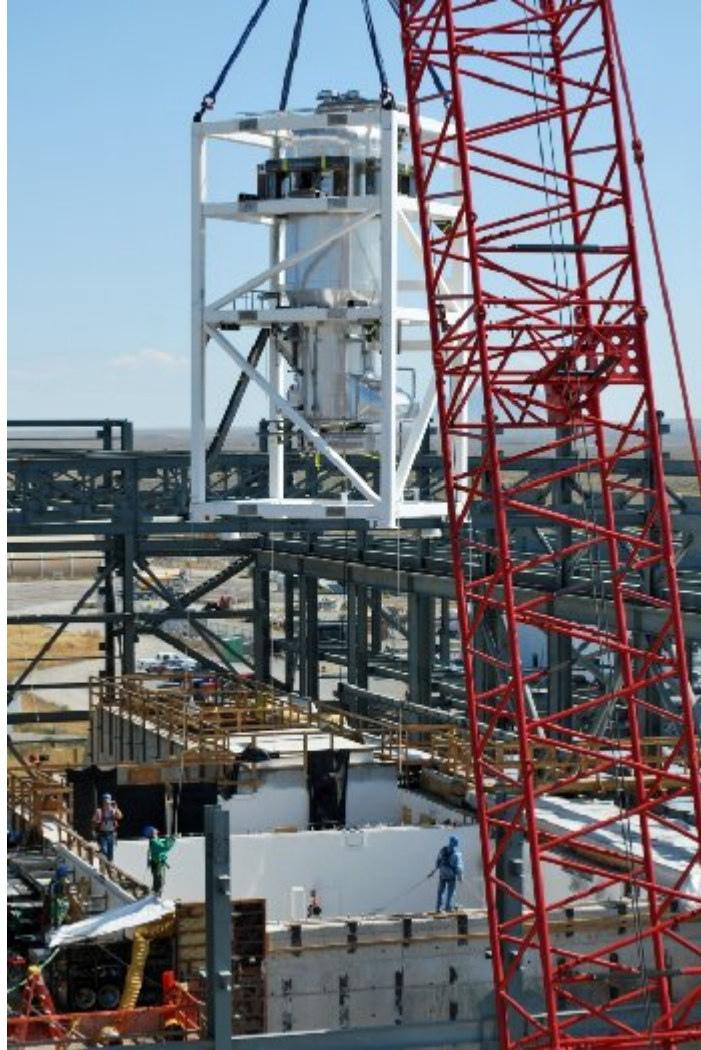
Fig. 2. The DMR vessel being lowered into place in the IWTU facility.

The steam reforming process to be used for treatment of the SBW consists of two steam reformers that are integrated into a single process system. The system converts the SBW into a dry, solid, carbonate product. The steam reforming process includes a feed collection and transfer system through which waste from the Tank Farm is transferred into the first of two steam reformers, the Denitration and Mineralization Reformer (DMR). The DMR contains a moderate temperature (~640 °C) fluidized bed. The bed particles are fluidized by low-pressure, superheated steam. The superheated steam and a small amount of added oxygen react with carbon (a process additive) to produce process heat and a chemically reducing environment. The liquid waste is sprayed into the fluidized bed where it evaporates. As the waste evaporates in the DMR, the dissolved constituents form additional bed material that is removed as solid product.

The DMR destroys organics, nitrates, and nitrites in the feed, and converts the bulk of the dissolved chemicals into a solid, granular product. The DMR converts organics in the waste into

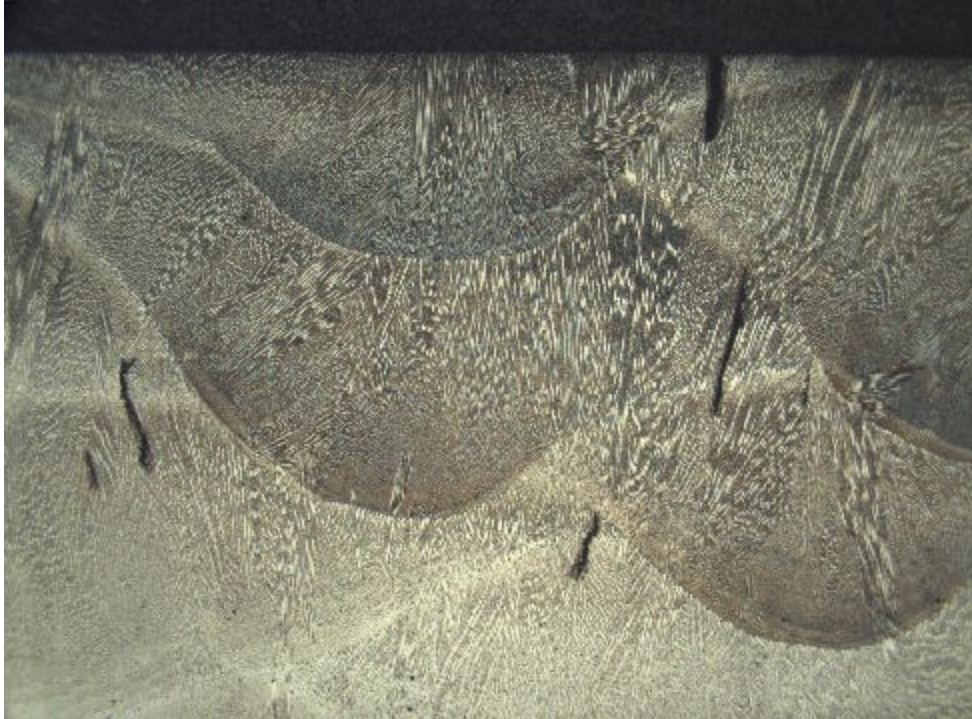
Fig. 3. Magnified cross section of a Haynes 556 weld coupon showing microfissures.

subsequent to the discovery of the initial surface cracking and the initial repair process showed that the weld process, even though performed as recommended by the material supplier and within the approved weld procedure, can produce the formation of very small cracks on and below the weld surface (See Fig. 3). The vessel fabricator was directed to perform an extensive set of weld coupon examinations using different weld techniques to explore the issue. In all examinations performed, the microfissures:

- Are not produced within 9.5 mm of the root of the weld (the typical weld preparation is a 30/70 double V configuration)
- Were randomly located and were no greater than 0.2.7 mm using the GMAW-P weld process
- Were isolated (i.e., not contiguous, or occurring in groups of several closely spaced flaws).

Structural Integrity Associates, an industry recognized expert in this field, was retained to perform calculations to estimate the acceptable flaw size for the Haynes 556 material under the expected operating conditions [1]. The report concluded that the crack propagation rates in the low-stress welds of the vessel shell are negligible and the seam and girth welds of the DMR vessel upper and lower cylinders can tolerate weld fabrication flaws with through-thickness depth that are roughly 50% of the shell wall thickness (approximately 1.5 cm). The results from the nozzle-to-shell connections that are the most highly stressed indicated higher expected crack-growth rates, and thus smaller allowable crack size. The maximum allowable flaw size for the worst-case nozzle weld was determined to be 0.70 cm, which is larger than any flaw size encountered in the test coupons examined, even using the less effective weld techniques. It also should be noted that the worst-case value of 0.70 cm is based on 32,760 hours of operation (nominally 5 years of operation with 75% in-service use). For the expected duration of the IWTU operational period for carbonate product of 17,500 hours (approximately 24 months of hot operations), the critical flaw size would be larger (approximately 1.0 cm).
