“ECOMET-S” JSC Experience in the Remediation of the former Balkanabat Iodine Plant NORM Contaminated Territory - 11451

“ECOMET-S” Joint-Stock Company, Russian Federation, 188540, Sosnovy Bor, Leningrad Region

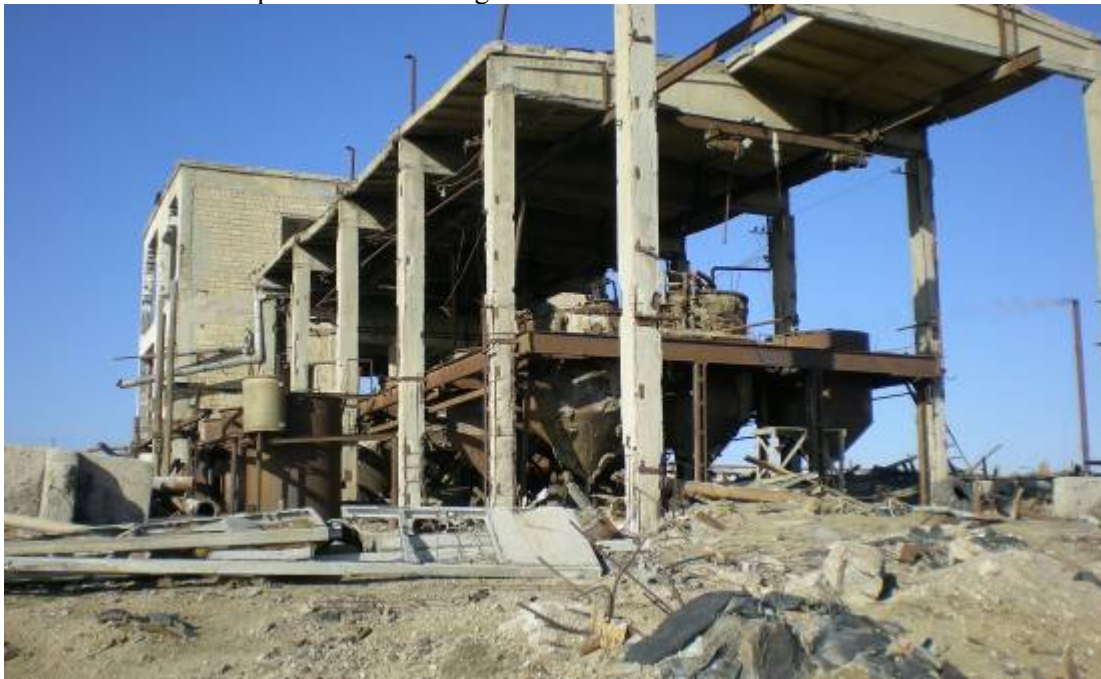
The iodine and bromine have been extracted by the adsorption technology from the underground mineral water at Balkanabat (Nebit-Dag) Iodine plant since 1970 and till 1983. Because of radionuclides' presence in water the adsorption technology implementing caused their simultaneous accumulation in the adsorption units and adsorbents [1, 2]. Generally Ra-226 (U-238 series), as well as Ra-224 and Ra-228 (Th-232 series) define the natural radioactivity of the mineral waters and precipitate on the adsorption media. As the result, the significant amounts of the radioactive waste mainly in the form of charcoal, were accumulated at the territory of the Balkanabat Iodine plant. The waste is referred to the NORM contaminated production waste according to Sanitary Rules of the Russian Federation (SP) 2.6.1.1292-03 [3]. According to the process, the charcoal after 10 cycles was off-loaded to the storage site, which is a main temporary storage at the present time. The minor part of charcoal is situated in the adsorption tanks and air separator. There are some contaminated areas in the close proximity to the adsorption shop. The absorption building consists of 3 pavilions. The absorbers have been installed in two of them (48 units totally). The major part of the third pavilion was used as the washing department. Two reinforced concrete decanters are situated there. The rest of the building is occupied by the crystallization and pressing department, pumps, iodine warehouse and other auxiliary facilities. The shop was out of operation for more than 20 years. The building is destroyed. The adsorption shop appearance before remediation works is presented on the fig. 1.

Fig.1. The Balkanabat Iodine plant adsorption shop.

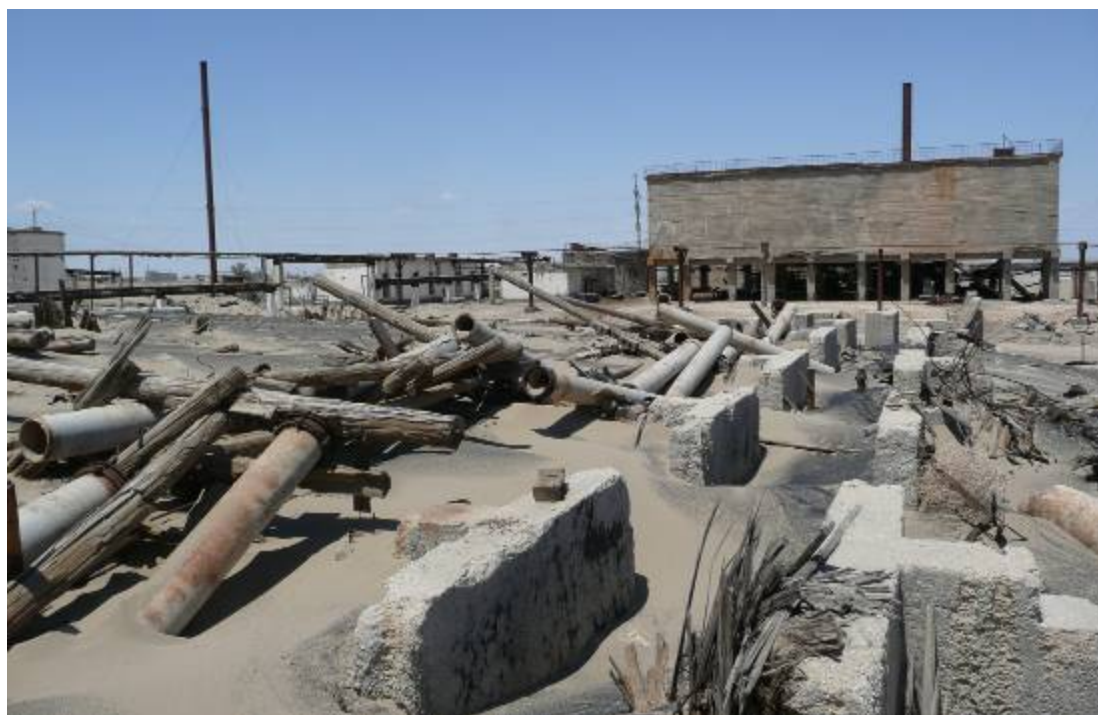
Fig.2. The adsorption shop site of the Balkanabat Iodine plant.

The radioactive elements composition in the waste is the following: Ra-226 – 80% including associated decay products (U-Ra series); Ra-228 – 19.99% including associated decay products (Th series); K-40 – 0.01%. The dose capacity over the waste (charcoal absorbent) was 1 – 5 $\mu\text{Sv}/\text{hour}$, at the depth of 0.5 m – 5 $\mu\text{Sv}/\text{hour}$. The dose rate over the other NORM contaminated production waste was 0.5 – 1 $\mu\text{Sv}/\text{hour}$. The estimated maximum charcoal specific activity was 7.63×10^4 Bq/kg.

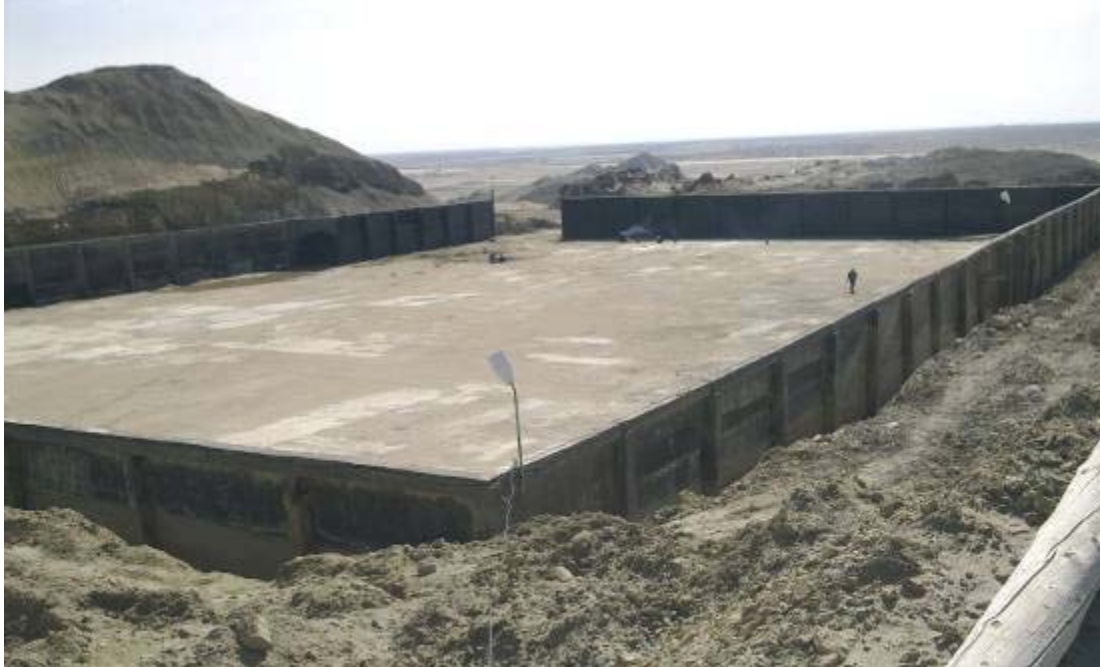
A reinforced-concrete tank is used as storage facility, its dimensions are 81.8 x 106.8 m. The depth is from 5.44 to 11.44 meters. The tank bottom dimensions are 80.0 x 105.0 m. The square is 8,400 sq. m. The volume is 42000 cu. m. Repository appearance is presented on the fig. 3.

Fig. 3. The TENORM repository.

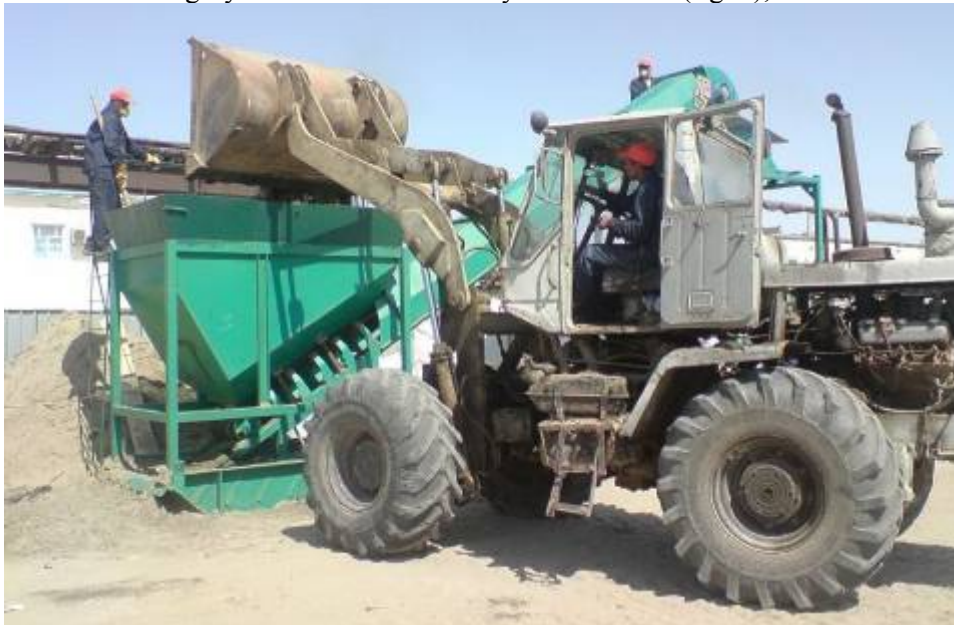
Construction debris, as well as grounds, soils, sands, charcoal (II category) and charcoal / soil mixture with the soils domination (III category) resulted from the remediation activities and categorized as II and III category waste was collected by wheel loader (fig. 4),

Fig. 4. The wheel loader.

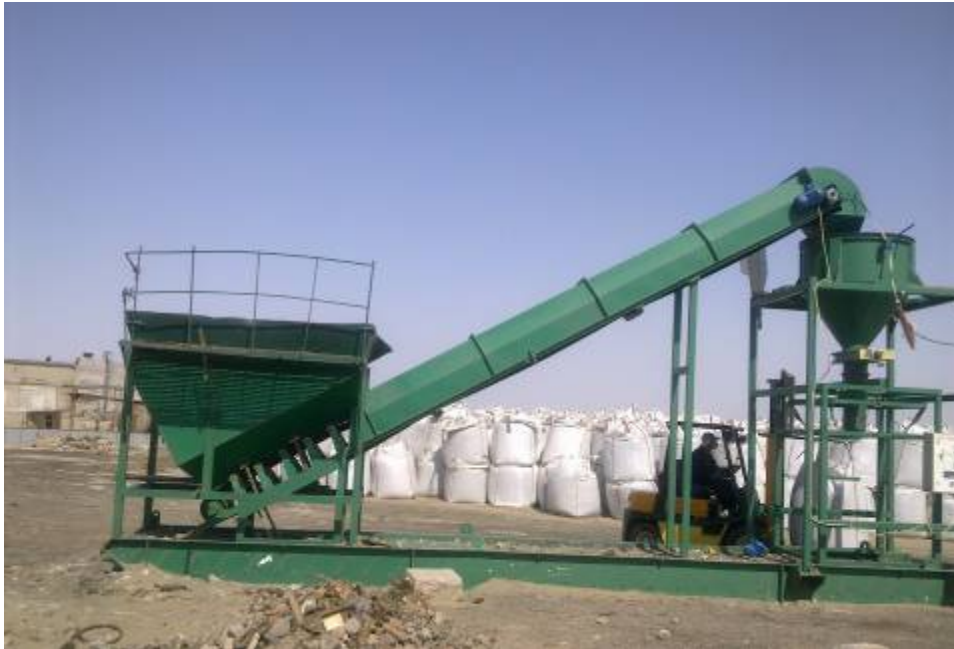
belt conveyor and Big-Bags' filling station, which is represented at the fig. 5.

Fig. 5. Big-Bags' filling station

After being filled the Big Bags are passing the radiation inspection and characterization (weighting and marking). Then they are placed into UKTN-24000 container and directed with the accompanying documents to the repository. At the repository transport container is being discharged. The Big Bags with the II and III category waste are disposed.

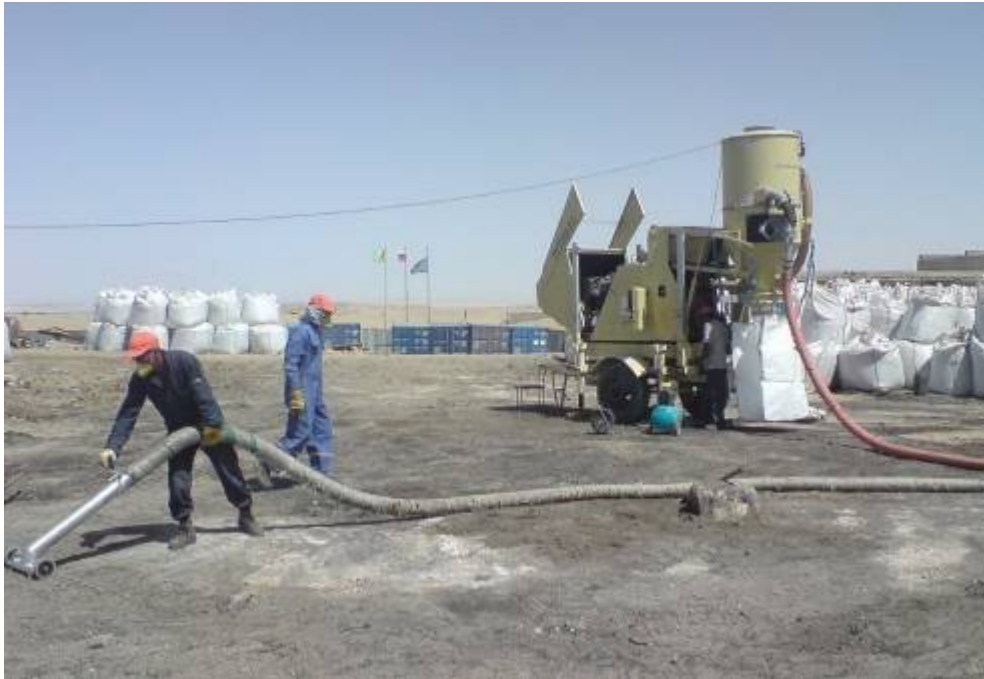
II, III category metal industrial waste was collected into KTBN-3000 transport containers, which were placed into UKTN-24000 and directed to the repository after radiation inspection and characterization. Spent adsorbent charcoal was collected by the industrial vacuum cleaner into 1.5 cu. m Big Bags. Charcoal collection using VacTrailer S-4 industrial vacuum cleaner is represented at the fig. 6.

Fig. 6. Waste collection with the industrial vacuum cleaner.

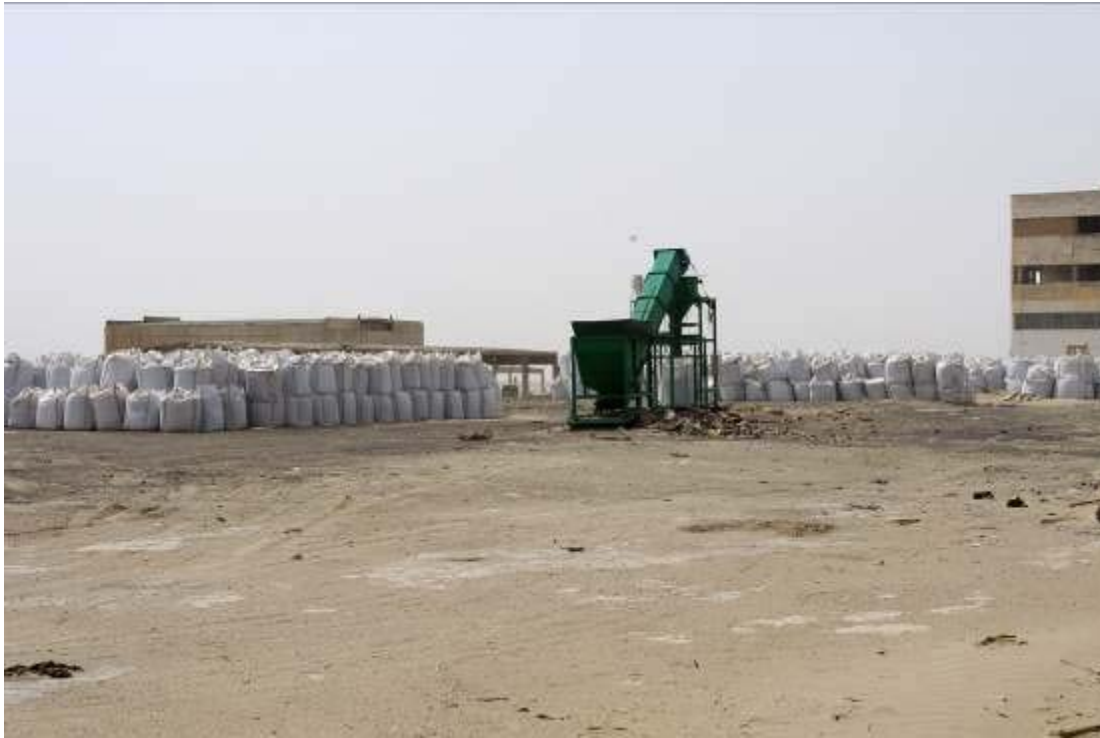
Altogether 3888 Big-Bags (4138 cu. m in total) with II category waste were packed and prepared for the transportation to the repository. III category waste volume amounted 15 cu. m (10 Big-Bags with adsorbent charcoal).

Fig. 7. Charcoal adsorption shop site after main remediation works finishing.

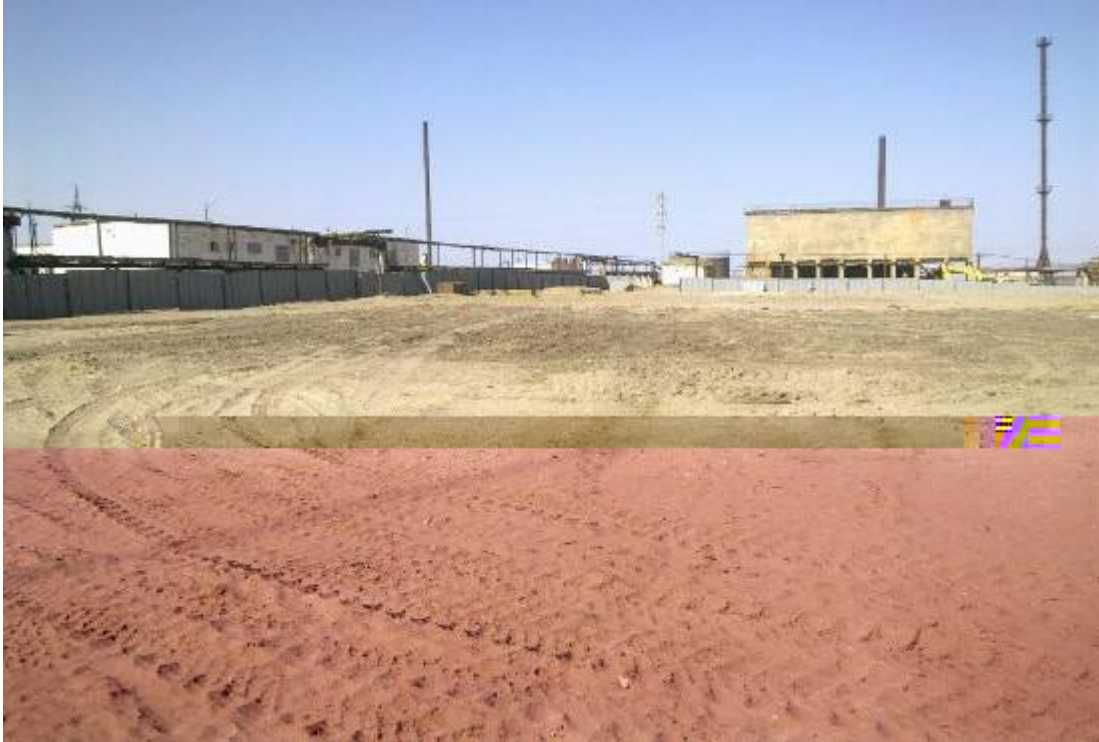
Fig. 8. Balkanabat Iodine plant charcoal adsorption shop site appearance after remediation.

Post-remediation radiation inspection has confirmed that the average equivalent gamma-radiation dose capacity doesn't exceed $0.15 \mu\text{Sv}/\text{hour}$, radon discharge rate from the ground is less than $100 \text{ mBq}/(\text{sq. m} \times \text{sec})$. Thereby the desired remediation criteria were significantly overfulfilled. This means, that the effective dose for the enterprise staff working at this site will not exceed $1 \text{ mSv}/\text{year}$ which corresponds to population dose limit.
