Lessons Learned from a Complex FUSRAP Site - Sylvania Corning FUSRAP Site - 12269

Ann Ewy*, David Hays*

*United States Army Corps of Engineers, Kansas City, Missouri, 64106

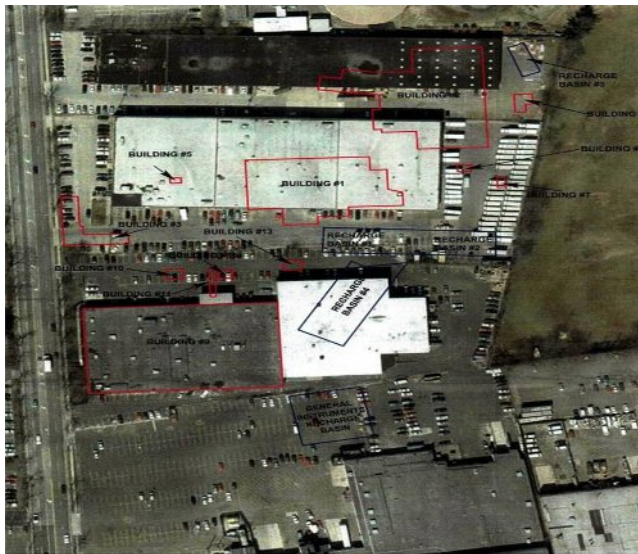
Fig. 1. Sylvania Corning FUSRAP Site layout aerial with historic building footprints [1].

The Sylvania Site operated from 1952 to 1967 for the research, development, and fabrication of nuclear elements. Some of this work was performed under Atomic Energy Commission contracts, leading to the Site's eligibility in FUSRAP. However, work was also performed for other government and commercial contracts. The Sylvania site is a 4.25-hectare area located in Hicksville, Nassau County, New York, in the west-central portion of Long Island, approximately 48 kilometers east of lower Manhattan. It is currently divided into three separate but contiguous properties: 140 Cantiague Rock Road (140 property), 100 Cantiague Rock Road (100 property), and 70 Cantiague Rock Road (70 property; [1].
