LL/ILW: Post-Qualification of Old Waste through Non-Destructive Extraction of Barrels from Cement Shields – 13535

ABSTRACT

Currently there is a large number of radioactive waste drums entombed in cement shields at German nuclear power plants. These concrete containers used in the past for the waste are not approved for the final repository. Compliance with current acceptance criteria of the final repository has to be proven by qualification measures on the waste. To meet these criteria, a new declaration and new packing is necessary. A simple non-destructive extraction of about 2000 drums from their concrete shields is not possible. So different methods were tested to find a way of non-destructive extraction of old waste drums from cement shields and therefore reduce the final repository volume and final repository costs by using a container accepted and approved for Konrad. The main objective was to build a mobile system to offer this service to nuclear plant stations.

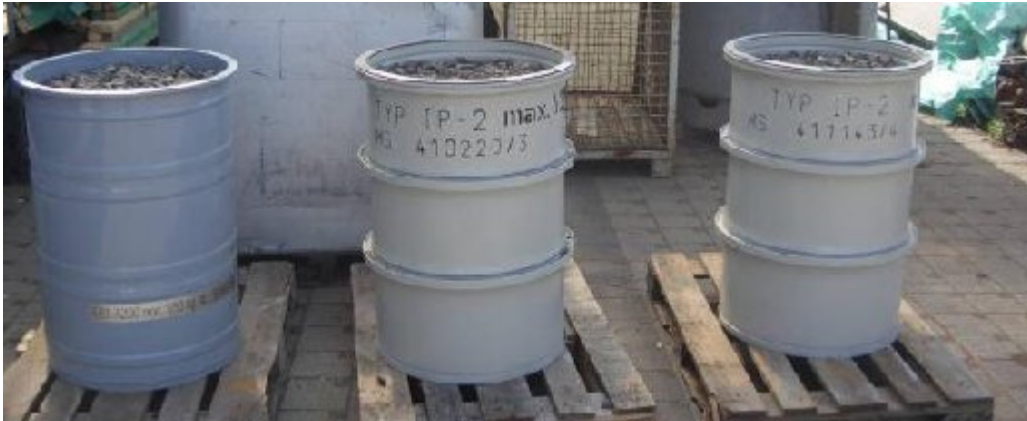
The first step was to produce three samples of concrete shielded drums. The intent was to create an exact copy of real concrete shields that can be used for the Mock-Up trials with the drilling process. Two concrete shields were produced with the Type IP-2 drum as the most common and one concrete shield was produced with the Type EB1 A200 drum. The barrels were filled with commercial gravel with a weight of round about 300 kg per drum.

Figure 1: different type of drums to produce the concrete shields

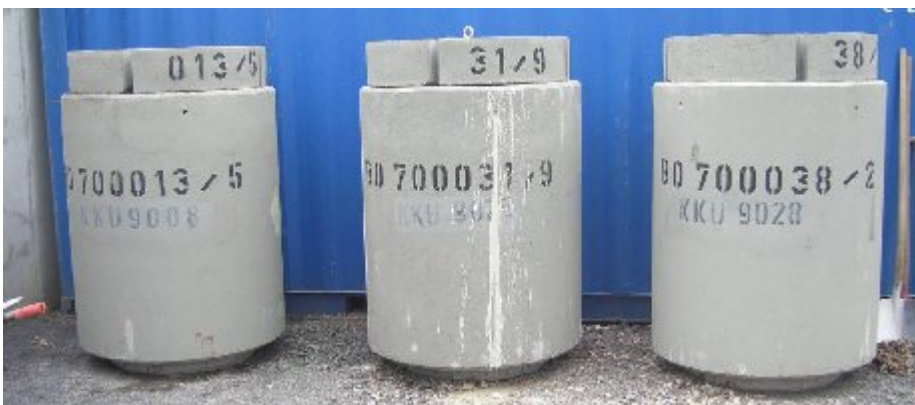
Two different methods of filling were used. In the first case the concrete was produced with C25 and a reversing-drum mixer. To reach a better flow behavior 6 liter instead of 4 to 5 liter water were used. By poking in the four existing notches and so compacting the concrete, the drums placed themselves a bit and got coated with concrete. Afterwards the inner lid was insert and secured with the provided rebar after 2/3 of the concrete backfill height. The filling got finished and smoothed over the inner lid. The second method of filling was the same procedure as the first one only without poking in the notches. The cement curing process took more than 29 days.

Figure 2: concrete shields

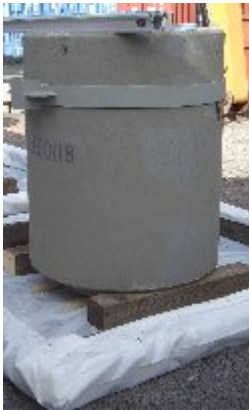
To prepare the concrete shields for drilling, a horizontal standing area for the drill stand and drill machine was constructed. This includes a horizontal placement for the concrete shields with an intermediate restraint for the drill stand to shorten the lever. To collect the falling drill water and

mud the ground was covered with foil. The concrete shield horizontal and plumb were checked to ensure proper alignment.

Figure 3: prepared concrete shield

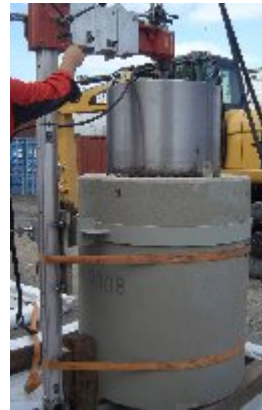
Figure 4: first trial with diamond core bit

The first trial was made with a diamond core bit. The process was divided into two different steps. The bit had to have a size of 700 mm to be bigger than the drum and smaller than the concrete shield. In the first step, a 500 mm long bit was used to create a guidance channel for the 1400 mm long bit. After about 37 cm of drilling, the bit locked up and only got removed after several tries and the use of a 20 ton hydraulic shovel. The first trial was stopped. The inner lid was not really connected to the top of the drum as expected, the removing was easily done. A part of the drill core split near the cover of the drum (1 cm of concrete) and so locked up the bit.

In the first trial, the real position of the drum was not known with certainty. The surface geometry of the drum causes four weak points: lid, upper and 2 drum hoops. After blocking the first time with the 500 mm bit a second blocking with the longer bit would have guided to a loss of the drum. Therefore, a different solution was necessary.

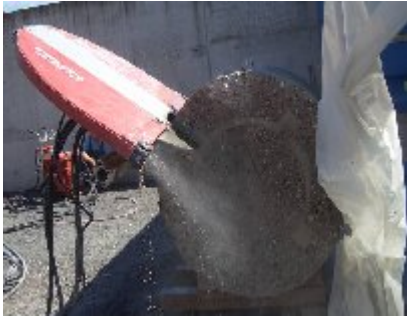
The second trial was extracting the drums by using diamond saw technology. The first two cuts were made to separate the head and base of the concrete shield. It was simple to determine how to conduct these cuts without damaging the drum. Cut 1 was 26 cm above the bottom edge of the concrete shield. Because of the concrete stone on the bottom of the concrete shield damage to the drum was not possible. The bottom part had a weight of about 441 kg. The cut-off had about 3 cm tolerance to the first ring of the drum. The second cut was approximately 3 cm under the lower armoring stick of the inner lid of the concrete shield, easy to see in the open space from outside. The head of the concrete shield had a weight of about 293 kg. Between cut and drum was more than 5 cm space. The next two cuts with the diamond saw were made for splitting the outside in two different parts. The cuts were only 12 cm deep and ended in the armor less slots. By placing steel wedges in the saw cuts, a gap was formed that followed the inner form of the drum. The effect of the wedges was limited and the use of a hydraulic splitter after using a core drill was necessary. The core drill had a diameter of 50 mm and was done by hand. The use of the hydraulic splitter took place in two diagonal spots on the concrete shield. As a result the upper part could be removed from the base.

Figure 5: cuts to separate the outside

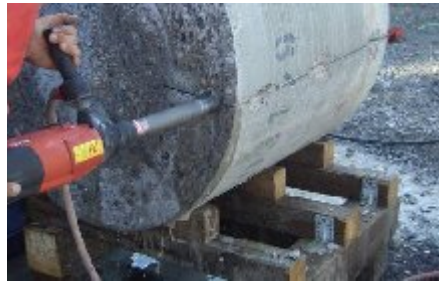
Figure 6: use of the hydraulic splitter

With the second method the drum was extracted from the concrete shield without any damage. As expected there was little binding between drum and concrete. Only the barrel hoops were stuck in the concrete. By using a hydraulic splitter and wedges, the concrete shield was removed from the drum. With the last concrete part the wedges on the drum hoops were driven tangential with light hammer beating. The use of wedges did not damage the drum or drum hoops. The trial was considered successful. The blocking of the concrete with the drum hoops in combination with damaged or rusted drum as a worst case is with this method still in discussion. Through filling the drums with humid material, restricted corrosions ability could be assumed. A permanent moisture penetration through outside was excluded. The alkalinity of the concrete would prevent damage of the drum.

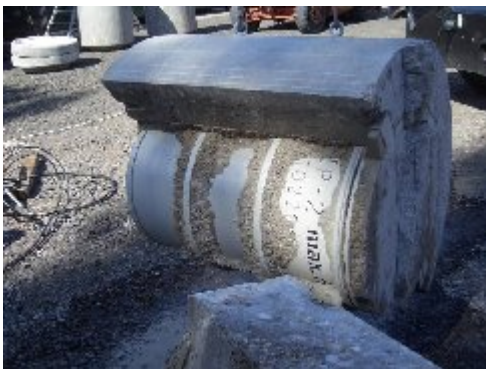
Figure 7: concrete shield without upper part

After removing one half part of the concrete shield the drum was still stuck in the other part. The smooth coated drum surface had no bond to the concrete.

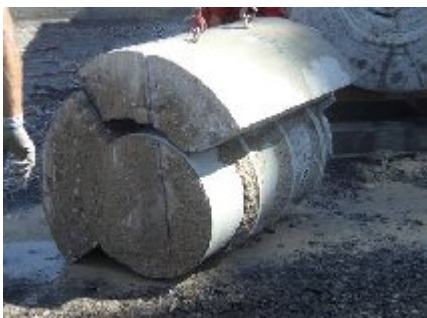
The fifth cut was made to half the half-shell concrete again. The last concrete section was removed by using wedges. Since now no more concrete was more available as a support, the wedges were used along the hoops and the drum was removed from the last part.

Figure 8: removed third part

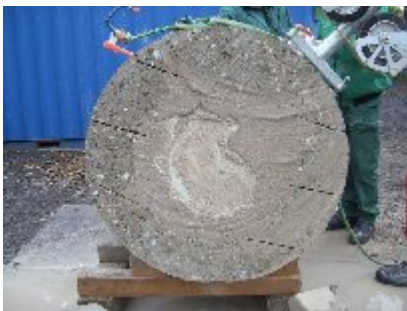
The order of cuts, tools and change of position of the concrete shield were necessary to optimize the result. Six different cuts around the concrete shield with the diamond saw were done. The concrete coat of the shield was separated into two quarter parts and four eight parts. All cuts were about 20 cm deep and split the armoring. The concrete body around the drum is still closed. Then two cuts in the concrete shield were done. The head and bottom part got removed with a diamond wire saw in the same position. Before the first cut all preparations for the second cut were made. Only the wire saw had to change position. The concrete shield was only moved one time during the whole process. After removing the head and bottom, the drum can be evaluated and measured. A damaged drum could be stabilized with polyurethane foam or similar by an injection. The cuts on the sides generated smaller segments. These segments got removed by using different wedges. Because of the big counterweight the wedges had no effect on the drum.

Figure 10: different cuts in the third trial

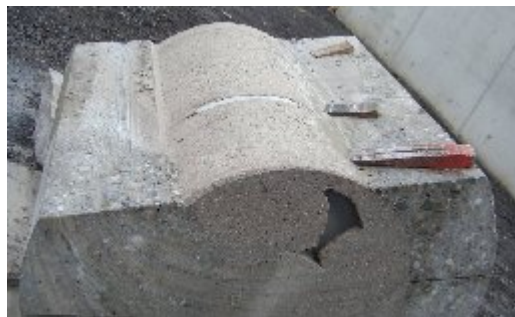
Figure 11: first wedged part

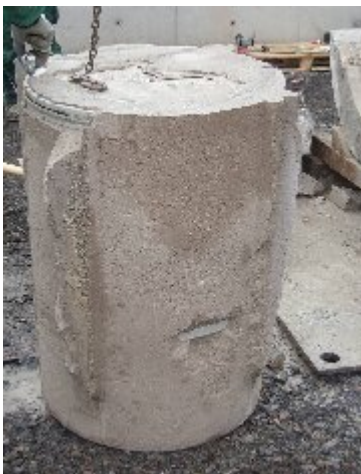
As expected the separation happened between the concrete shielding and the grout. The thickness of the grout up to the barrel skin was approx. 22mm at the weakest place and really solid. Removing the drum from the last concrete segment was possible without problems because of the circumferential gap between drum and cement. The removal was possible with the use of eyebolt instead of the lid screws.

Figure 12: freed drum with concrete
