**Waste Management Lessons Learned
from the Paducah C-340 Metals Reduction Complex D&D—14300**

Myrna Redfield*, Robert Seifert**, Brad Montgomery*

*LATA Environmental Services of Kentucky

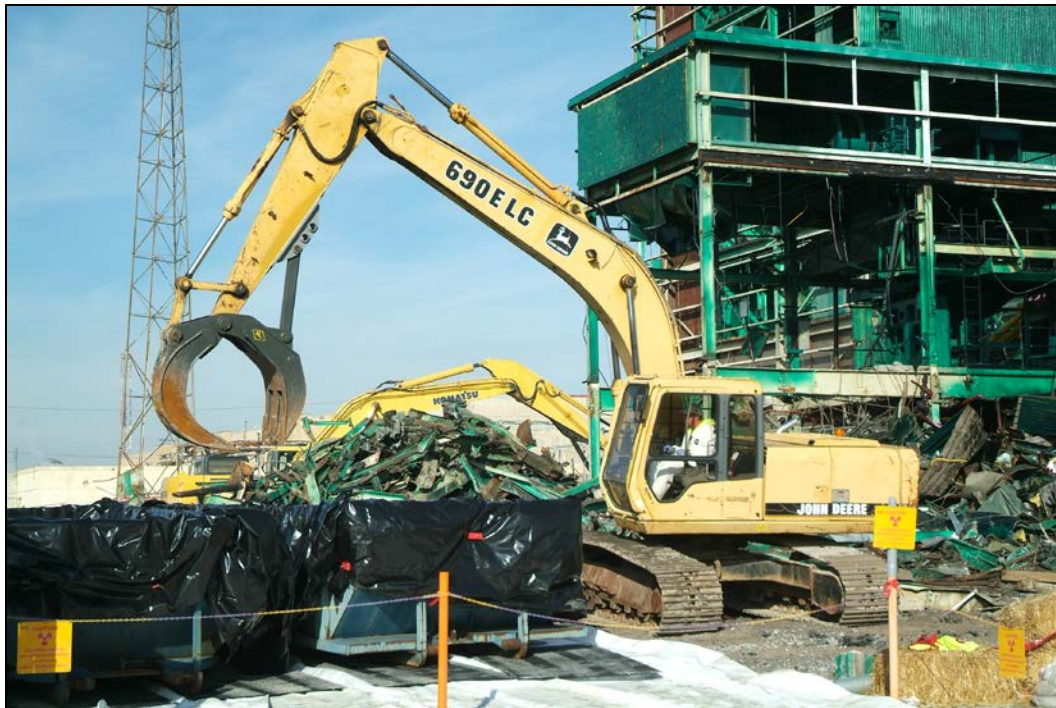
Figure 2. Waste is Loaded Directly into Shipping Containers in Areas Adjacent to C-340

Waste materials were sorted and segregated on-site, size reduced, packaged, and/or staged for disposal in accordance with applicable or relevant and appropriate requirements (ARARs). Most waste was loaded directly into shipping containers in areas adjacent to the C-340 Complex (Figure 2). Staging areas were used for storage of loaded containers prior to loading containers onto conveyances (e.g., railcars or trucks) for shipment. Figure 3 depicts staging of transite after removal from the C-340 Complex in preparation for disposal in the on-site C-746-U Landfill.

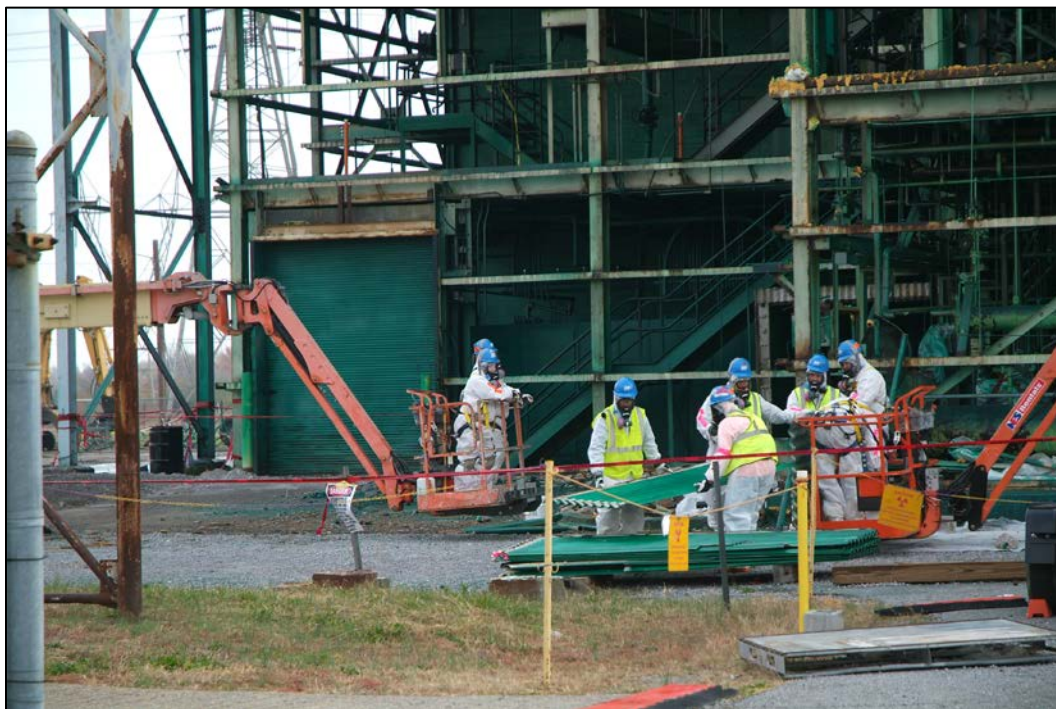
Figure 3. Staging of Transite after Removal from the C-340 Complex

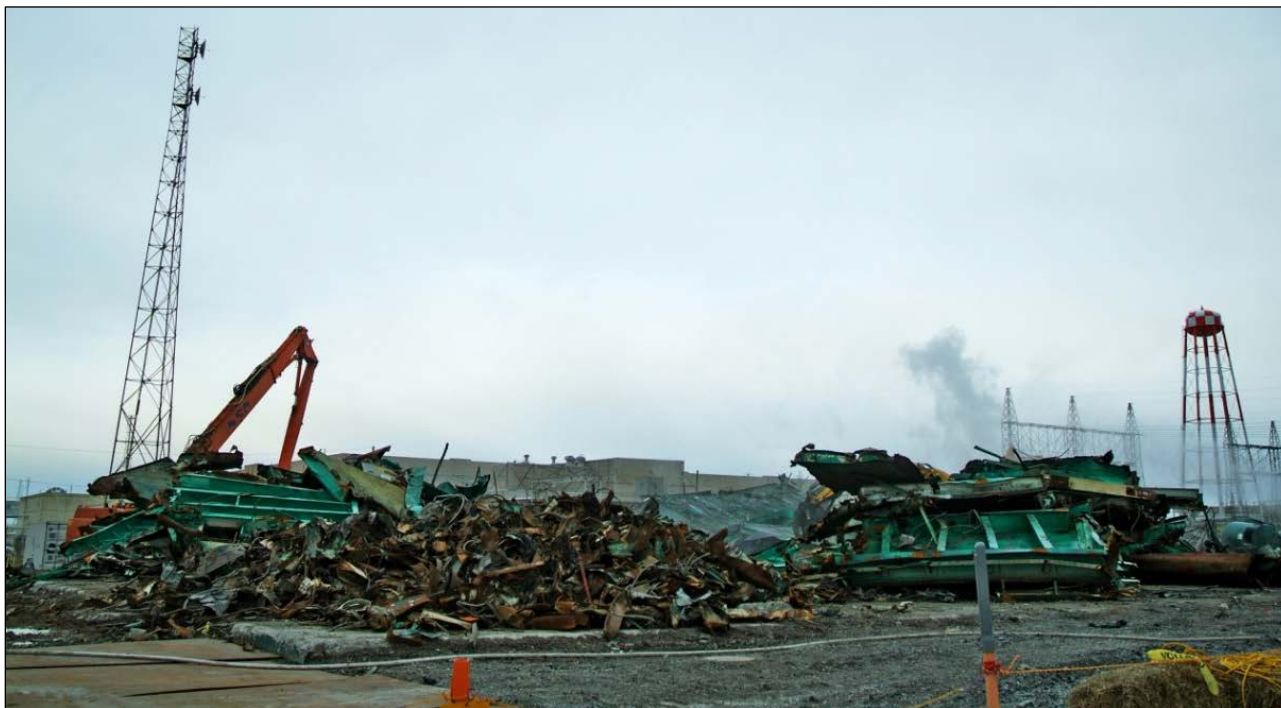
Figure 4. Debris Is Being Sorted into Waste, Part of Which Will Be Shipped to an Approved Disposal Facility and the Rest Taken to the On-site C-746-U Landfill

The waste packaging methods were dictated by the waste sizes and configurations and selected transportation and disposal options (Figure 4). Waste volumes were minimized by utilizing methods for component disassembly and size reduction. Heavy equipment was used to cut large steel sections into smaller pieces so that rail cars could accommodate more waste (Figure 5).

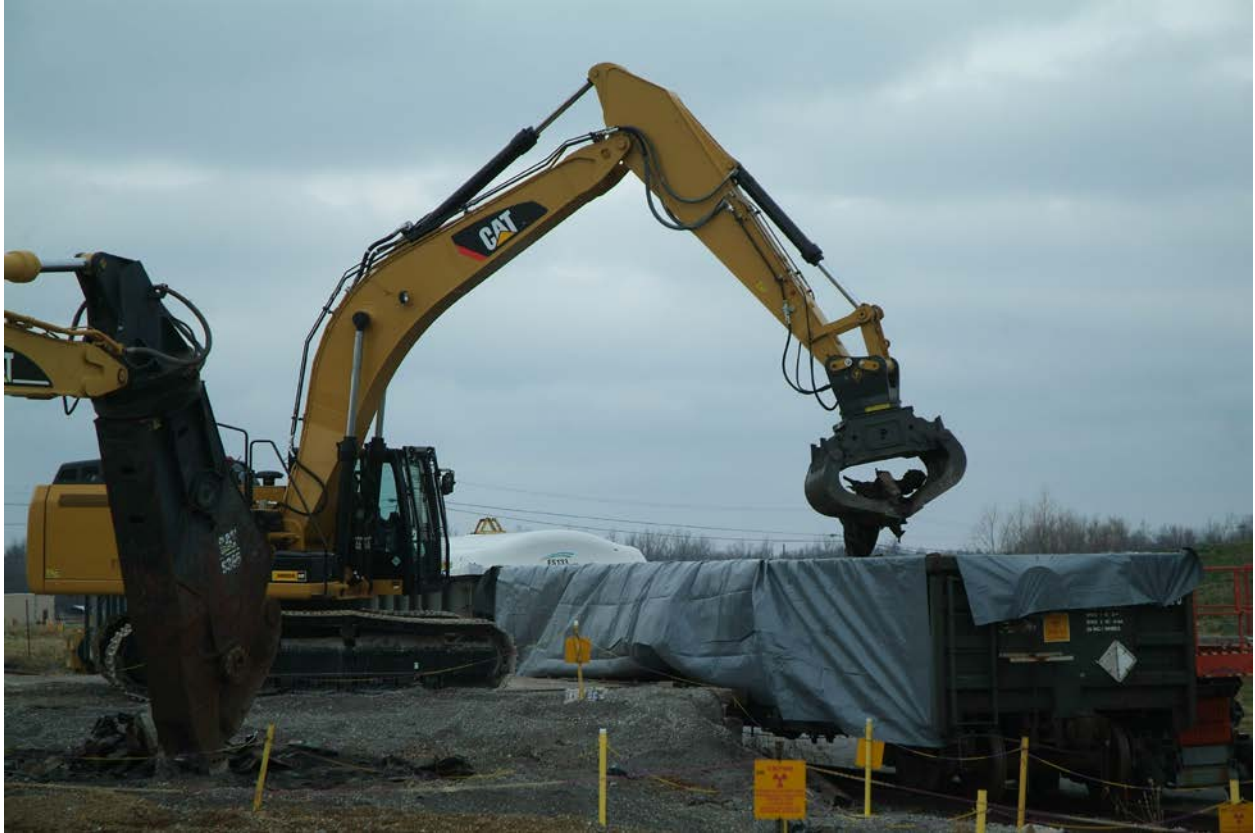
Figure 5. Heavy equipment was used to cut large steel sections into smaller pieces so that rail cars could accommodate more waste

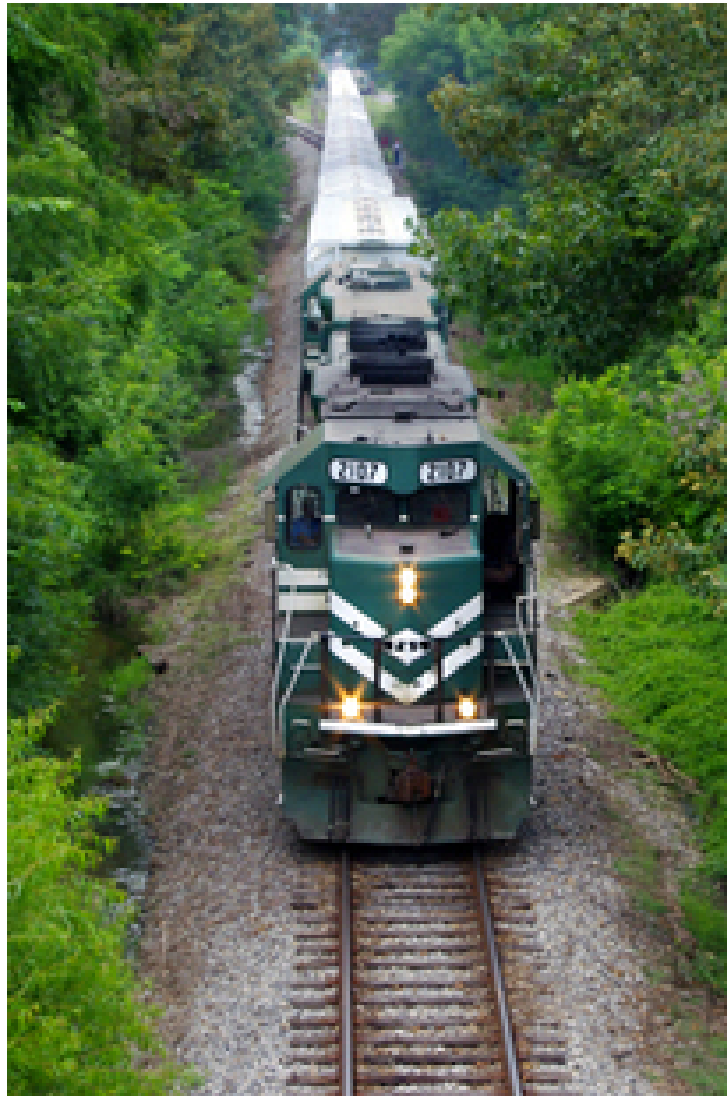
Figure 6. A P&L locomotive travels near Woodville Road, south of the Paducah site, with the waste shipment in tow.

Based on actual weights, approximately 1,920 tons (1,741 metric tons) of debris was loaded into 28 railcars for off-site shipment (Figure 6), or a variance of approximately 20% greater mass than expected. Using downsizing and careful loading of the railcars, an average density of nearly 50 pounds per cubic foot (1765 pounds per cubic meter) was achieved. Prior demolition activities and a scrap yard cleanup on-site using railcar shipment achieved significantly lower densities (average of 20 pounds per cubic foot or 706 pounds per cubic meter), indicating the downsizing and railcar loading techniques were effective in reducing costs for the PCB remediation waste disposition.
