Lessons Learned Concerning the Onsite Disposal Facility at the Fernald Preserve, Harrison, Ohio - 16176

ABSTRACT

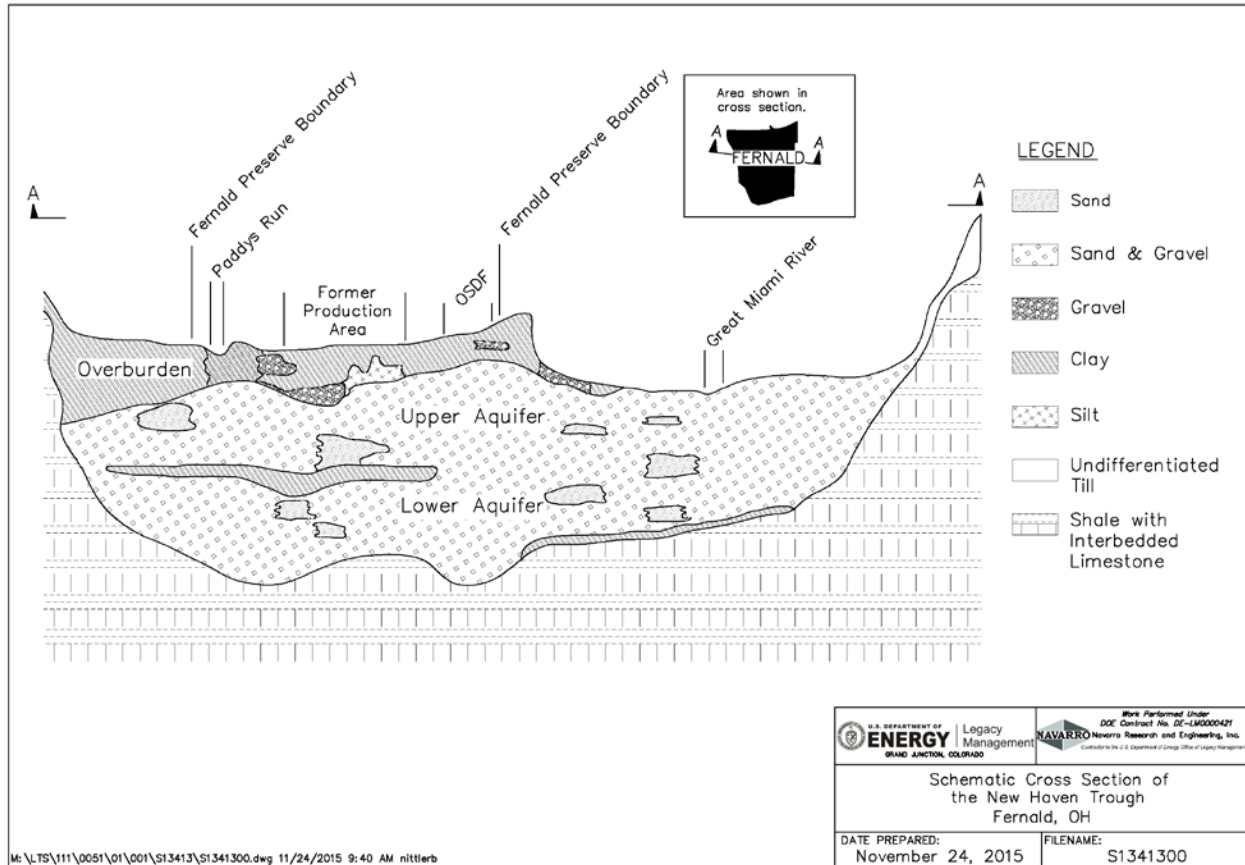
Fig. 2. Cross Section of Regional Aquifer at Fernald Site

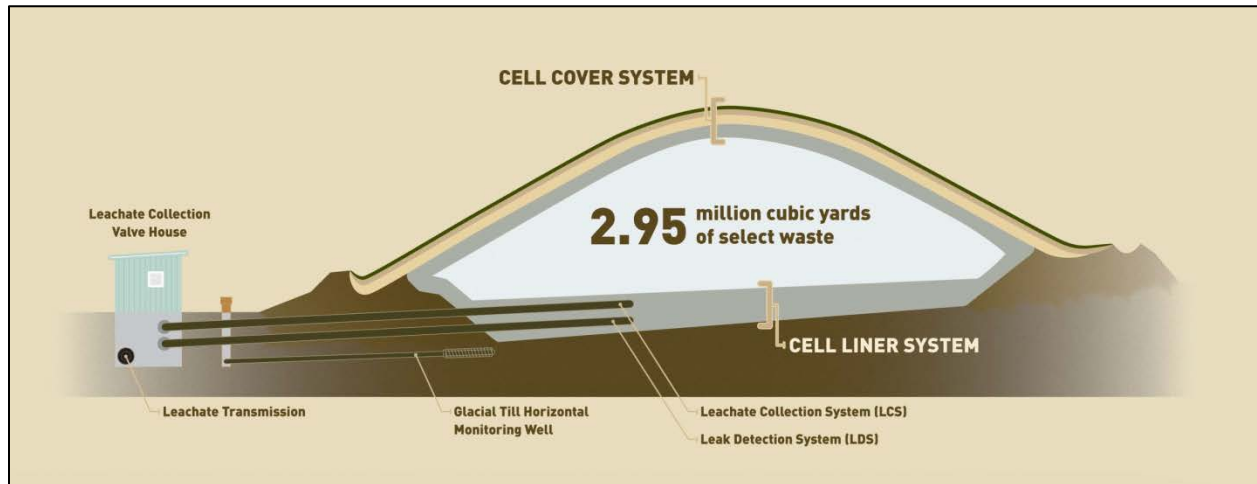
Each individual cell has a multilayer composite cover system, a leachate collection system (LCS), a leak detection system (LDS), a multilayer composite liner system, and a valve house. Figure 3 is a cross section of a typical waste cell. The multilayer composite cover system is nearly 3 m thick. The cover system serves to keep water, plant roots, and burrowing animals from getting down to the encapsulated waste. The LCS is installed in a gravel layer beneath the waste to collect rainwater that came into the contact with the waste during cell construction and additional moisture that is draining from the waste following capping of each cell. The LDS is located beneath the LCS and the primary geosynthetic liner system. It provides a mechanism for collecting and monitoring leakage through the primary geosynthetic liner system prior to any releases from the facility to the surrounding environment.

Fig. 3. Cross Section of a Disposal Cell

Both the LCS and the LDS drainage systems gravity drain to the west and extend beyond the synthetic liner systems into valve houses, where leachate becomes accessible for monitoring. The eight individual cells were designed with intercell berms so that the LCS and LDS for a cell capture only the liquids produced from that cell. The multilayer composite liner system located beneath the LDS is approximately 2 m (6 feet) thick.

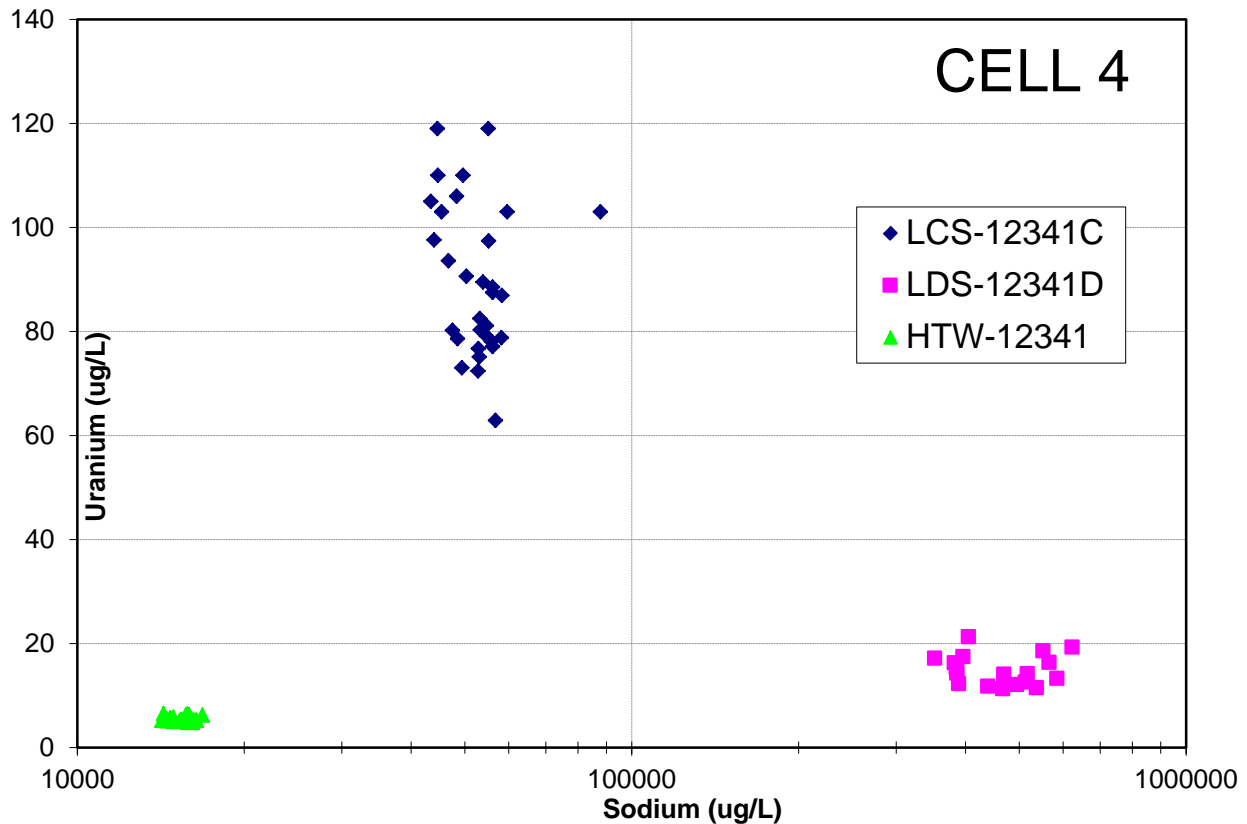
Figure 4 is an example of a bivariate plot for Cell 4. Sodium and uranium were selected for the plot because this combination provides a good distinction between the LCS, LDS, and HTW monitoring horizons. This combination was discovered during an evaluation of aqueous ions in the monitoring systems of the onsite disposal facility [12]. The bivariate plot provides a visual representation of the concentration signatures for uranium–sodium in each monitoring horizon for Cell 4.

Distinct clustering of data points for the LCS, LDS, and HTW samples indicates that the fluid chemistry in those different monitoring horizons is distinct and not mixing. Over time, should a leak occur, the water chemistries for the separate monitoring horizons would equilibrate and occupy the same space on the bivariate plot.

Fig. 4. Sodium-Uranium Bivariate Plot for Cell 4

Bivariate plots prepared for the OSDF (and reported each year in the Fernald Site Environmental Report) support that chemical signatures for the different monitoring horizons are separate and distinct, indicating that mixing between the horizons is not occurring; therefore, upward concentration trends measured beneath the cells in HTW and/or GMA wells seen in some constituents are attributed to fluctuating ambient concentrations beneath the cell, rather than poor liner performance.
