Progress on Resolution of Technical Issues at the Hanford Waste Treatment And Immobilization Plant Project – 16285

Langdon Holton, Isabelle Wheeler
U.S Department of Energy, Office of River Protection
P.O. Box 450, MSIN H6-60, Richland, WA, 99352
Langdon_K_Holton@orp.doe.gov, Isabelle_Wheeler@orp.doe.gov

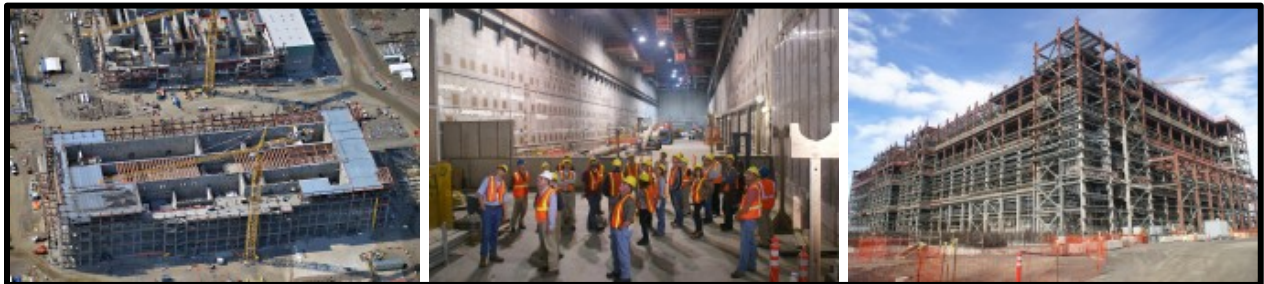
Figure 1. Pretreatment Facility Construction State

The Pretreatment Facility, also known as the PT Facility, is the first step in the process of vitrifying Hanford's tank waste. The PT Facility is the largest of the four major nuclear facilities that compose the Vitrification Plant. It is 165 m (540 ft) long and 66 m (215 ft) wide, the size of nearly four football fields, and 36 m (120 ft) tall, or 12 stories, high. When complete, its total area will be more than 45 500 sq m (490,000 sq ft).

The high-level solids will be sent to the High-Level Waste Vitrification Facility, and the low-activity liquids will be sent to the Low-Activity Waste Vitrification Facility for further processing. The PT Facility is shown in its current construction state in Figure 1.
