**Demolition of the K-27 Building at the  
East Tennessee Technology Park (ETTP) —  
17423**

Kenneth Rueter, President and Project Manager  
URS | CH2M Oak Ridge LLC, [Kenneth.rueter@ettp.doe.gov](mailto:Kenneth.rueter@ettp.doe.gov)  
East Tennessee Technology Park  
P.O. Box 4699, Oak Ridge, TN 37831

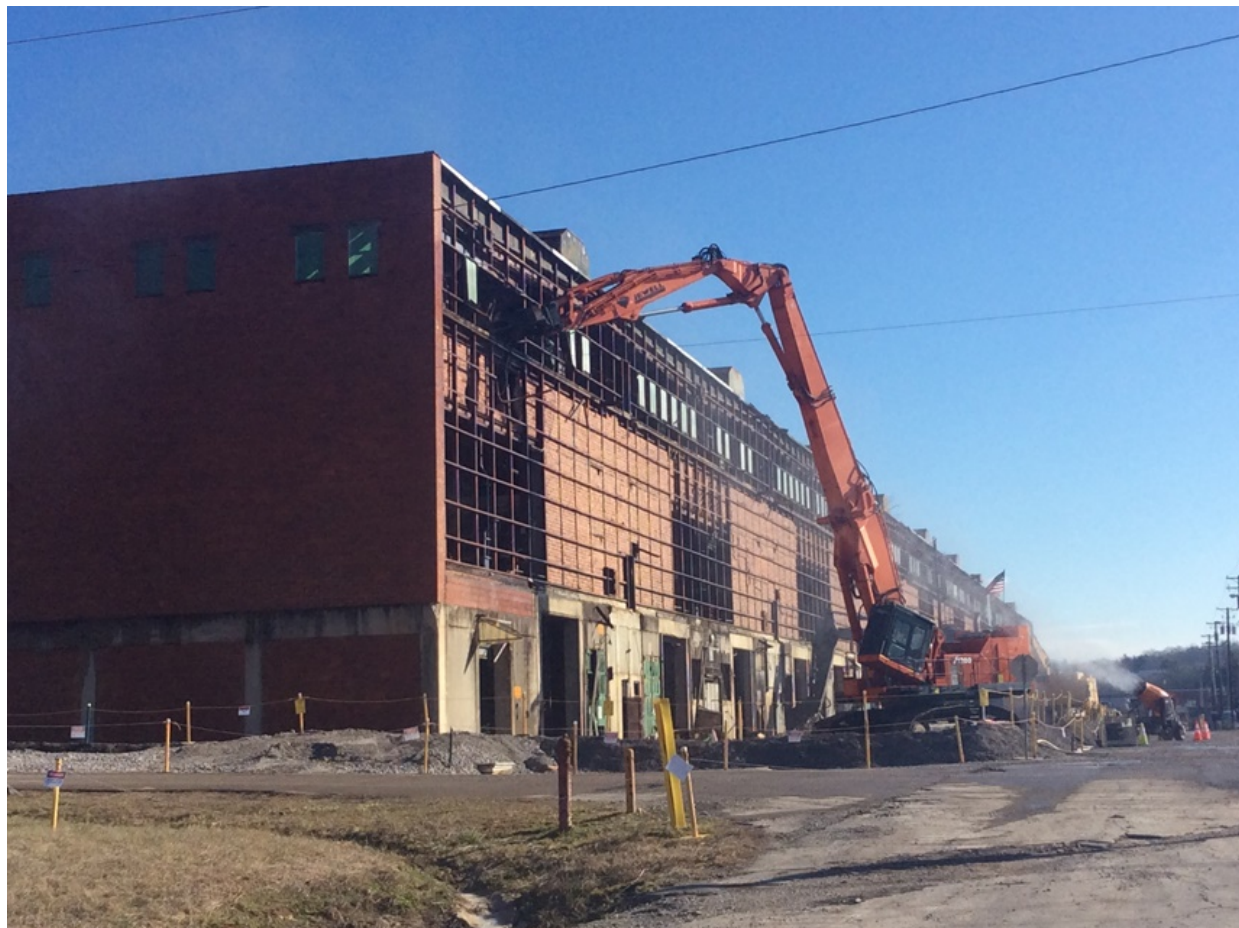
Fig. 1. First day of K-27 demolition, February 8, 2016.

K-27 was the fifth and final gaseous diffusion building in DOE's Oak Ridge Office of Environmental Management (OREM) program to be demolished (see Fig. 1). Demolition was completed in August 2016, and coincided with completion of DOE's *Vision 2016*, which called for tear-down of all five gaseous diffusion buildings at ETPP by the end of calendar year 2016.

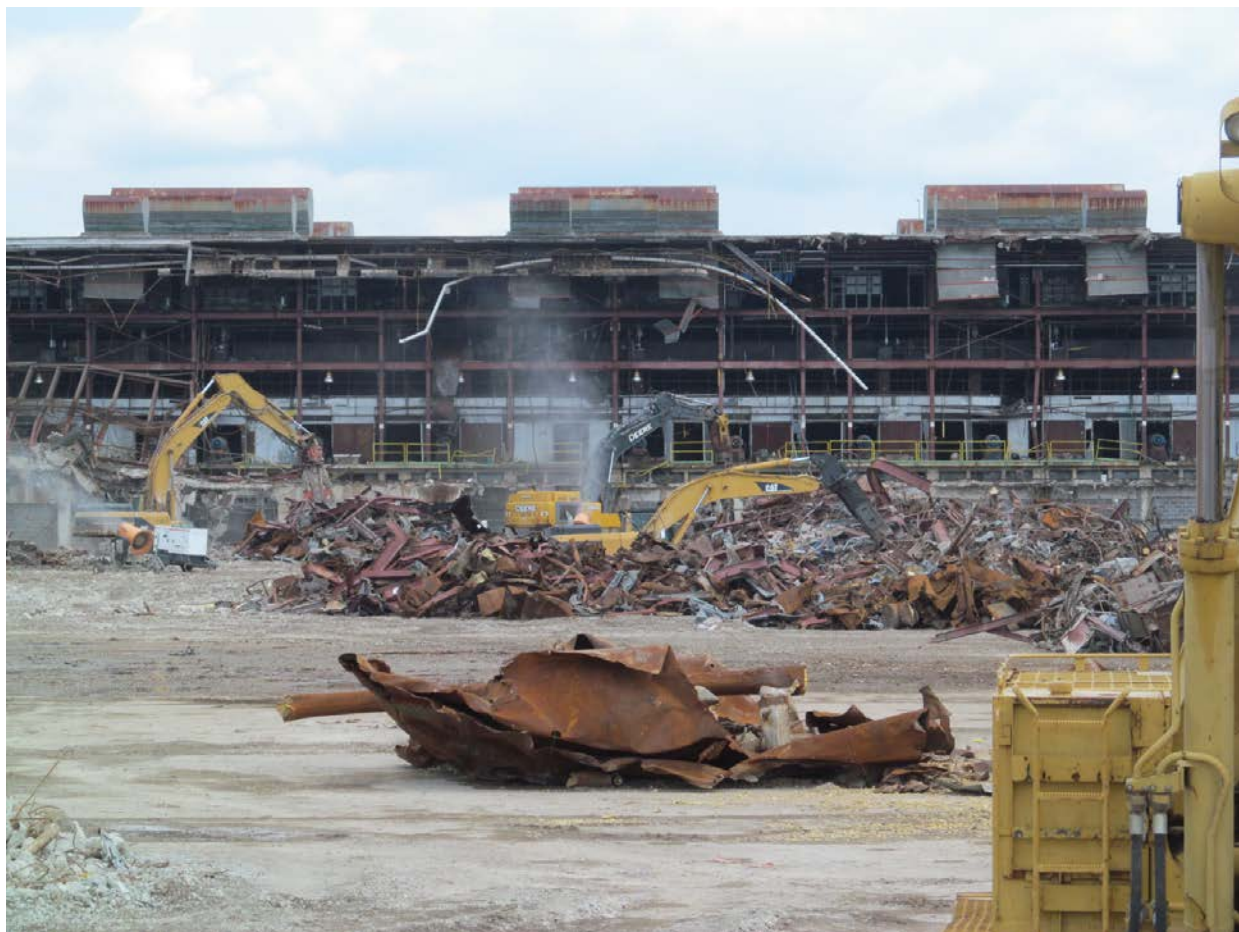
Fig. 2. Demolition equipment operating in the demolition field with continuous water misting being used for dust control.

Airborne contamination was a potential with the open-air method of demolition that was required for a building of this size. The work team’s significant experience with these types of facilities provided a good defense-in-depth protection strategy for preventing any offsite releases to the environment or surrounding community. To minimize dust generation, the actual demolition was accomplished in a very controlled fashion by using fixative and water spray to control any dust caused by the activities (see Fig. 2).

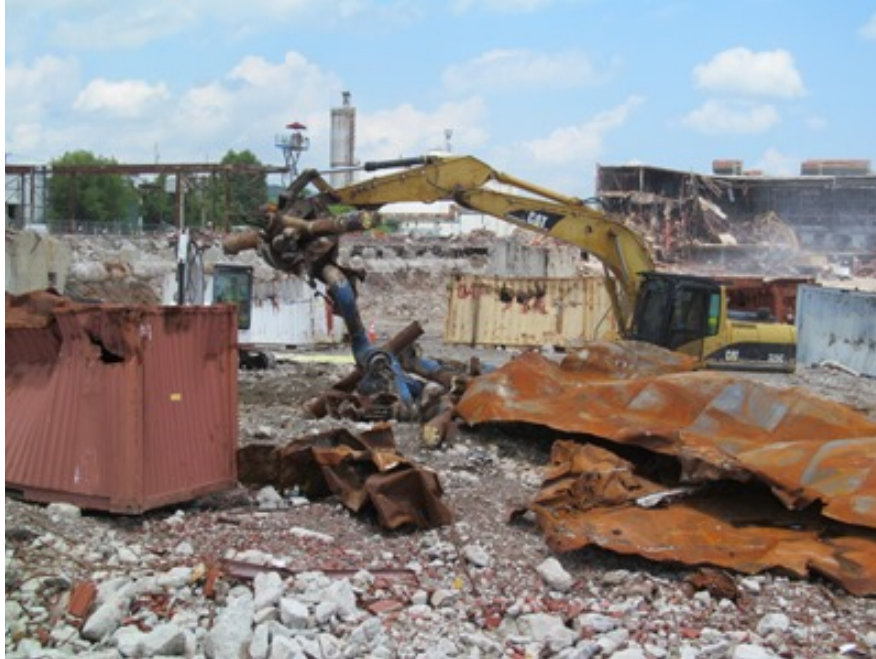
Fig. 3. Special handling of process piping and equipment.

Process equipment and process piping containing the greatest quantities of nuclear material were separated from the building debris pile, placed in lined and protected work areas prior to processing, and containerized/packaged prior to being removed from the general work area (see Fig. 3). Over 14 air monitors encircled the demolition area to confirm that no contamination became airborne and traveled beyond the perimeter of the demolition area. At no time during demolition did the air monitors detect any reportable air release events.

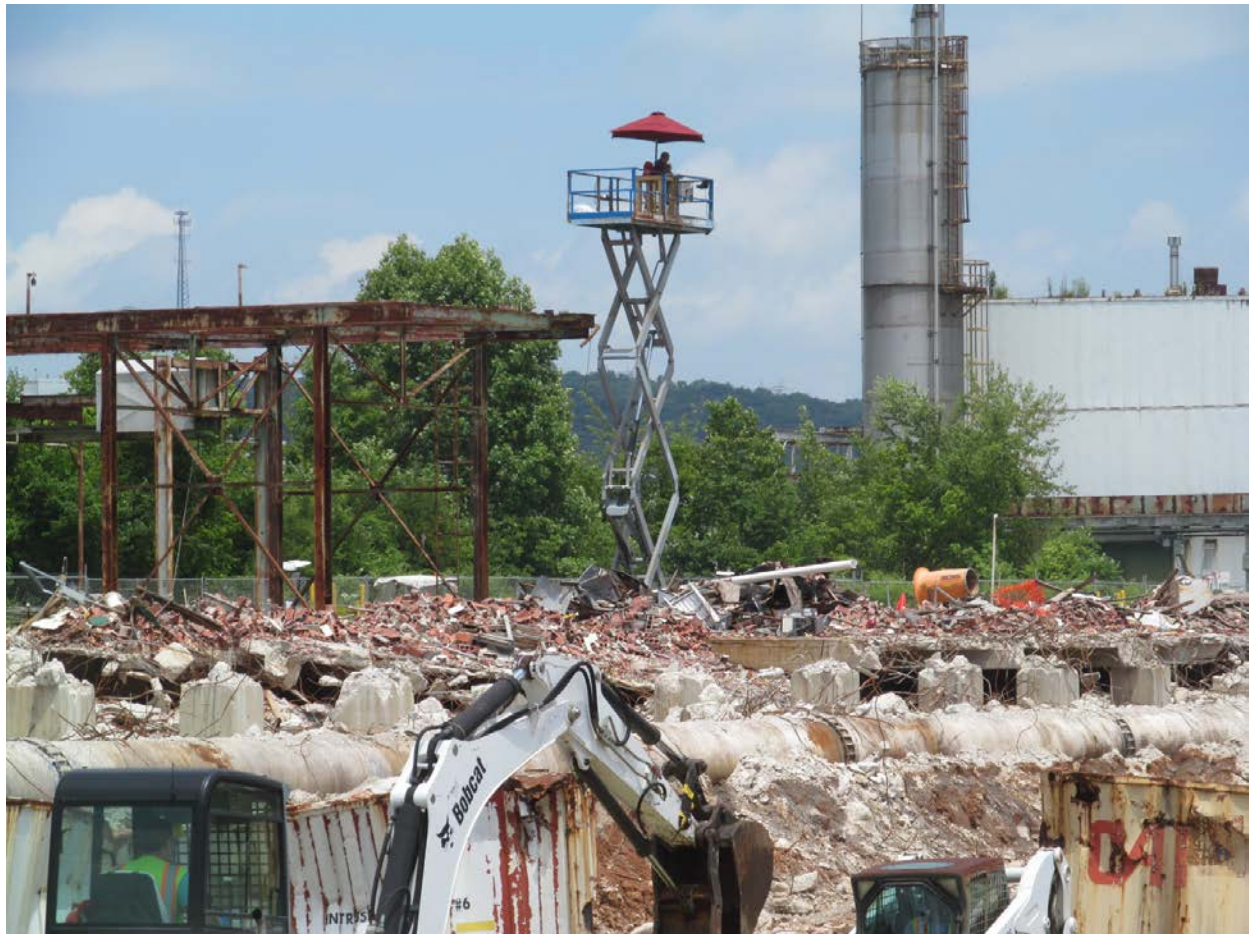
Fig. 4. Spotters overseeing the demo field and monitoring each piece of heavy equipment.

3. Assignment of dedicated equipment spotters around the perimeter of the work Exclusion Zone to monitor each piece of demolition equipment and its movements. Up to 20 pieces of heavy equipment were used at the same time.
4. Additional protection was added to the operator's cab due to the potential for flying debris.
5. Oversight by a lead spotter of "the big picture," with real-time communication to all equipment operators and other spotters (see Fig. 4).

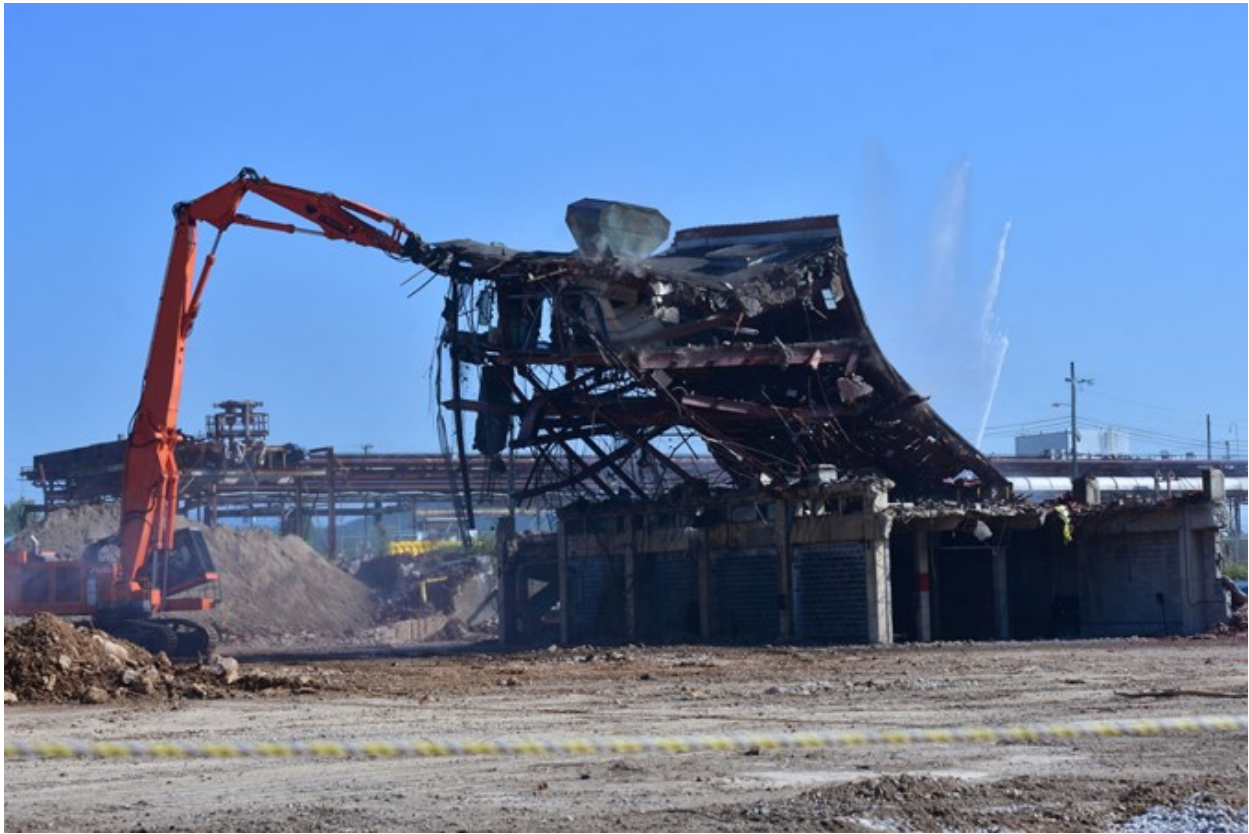
Fig. 5. The last portion of Bldg. K-27 comes down on August 30, 2016.

UCOR collaborated with DOE on a plan to accelerate the deactivation and demolition schedule for K-27 because of the building's deteriorated condition. Accelerating the schedule allowed for safer demolition before the building deteriorated further. It also saved surveillance and maintenance costs. The K-27 demolition project was completed nine months ahead of the baseline schedule (Fig. 5), with over \$2.8
