## **REDUCING OF THE DOES RATE OF HAWC CONTAMINATED CONCRETE BLOCKS**

A. Graf, U. Stutz  
Forschungszentrum Karlsruhe GmbH  
Central Operations Decontamination Department (HDB)  
P. O. Box 3640  
76021 Karlsruhe  
Germany

### **ABSTRACT**

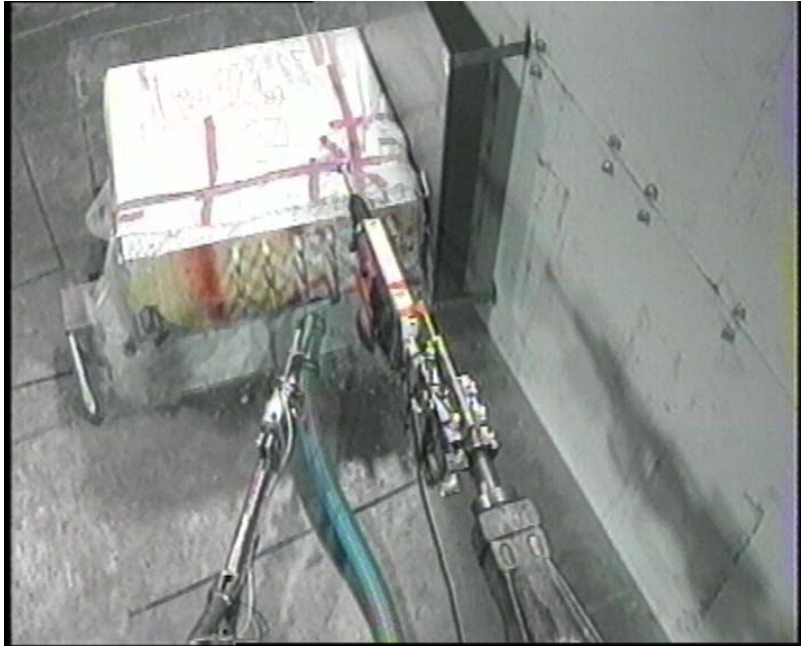
**Fig. 1a. Coupling system, percussion jackhammer and suction hose of the vacuum cleaner**

For the operational application a remote-controlled miniature excavator, originally designed to work indoors, was selected. Equipped with a percussion jackhammer coupled to the excavator arm with a self-constructed absorber unit, which had to compensate and control the excavator contact pressure acting upon the jackhammer (See Figure 1). A loosening chisel (die-shaped chisel with mounted mandrels) was used as standard tool, allowing the removal of about 2 - 3 mm in one step.

In order to maintain the working area as clean as possible the removed material had to be collected and vacuumed continuously. For this purpose a modified industrial vacuum cleaner equipped with a cyclone separator unit for coarse dust removal upstream of the filters into a dust collection drum. The drum was placed in a shielded 200-liter cask and the suction hoses fixed to the cask with quickly opening bayonet locks. This allowed for very short exposure times during dust cask exchange.

The suction tube was installed on a separate manipulator for an optimum removal of coarse parts and dust arising during the treatment of the block surface. By means of the manipulator, the suction tube always was to be moved parallel to the loosening chisel, as a result of which a maximum suction rate was ensured. In addition the manipulator was used to clean out the floor of the working area.

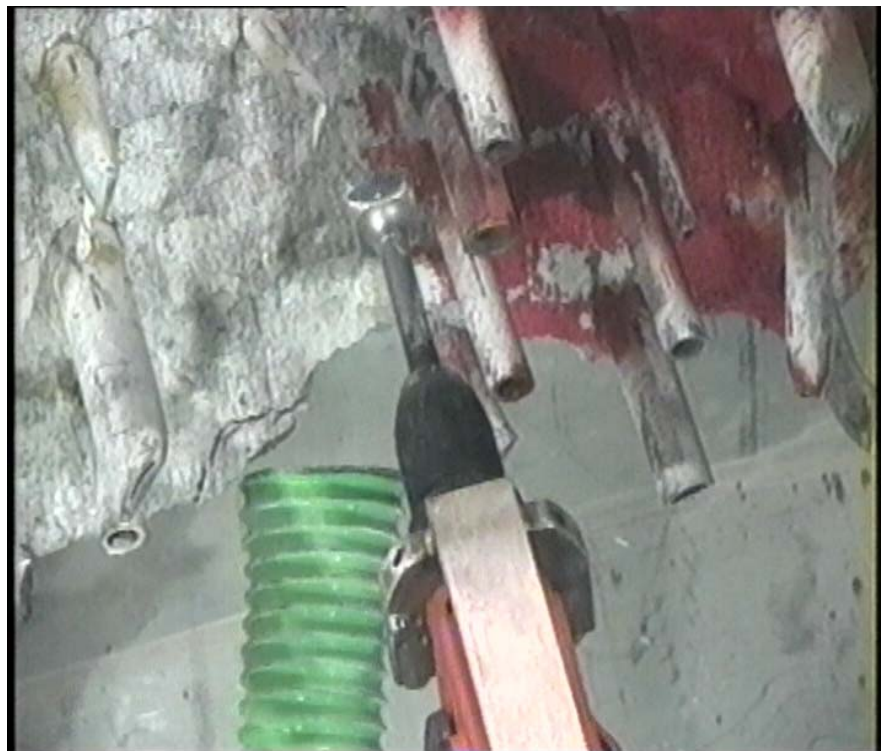
**Fig. 1b. Mock-up Tests**

All components were intensively tested on mock-ups to demonstrate the functionality and handling features of the whole equipment.

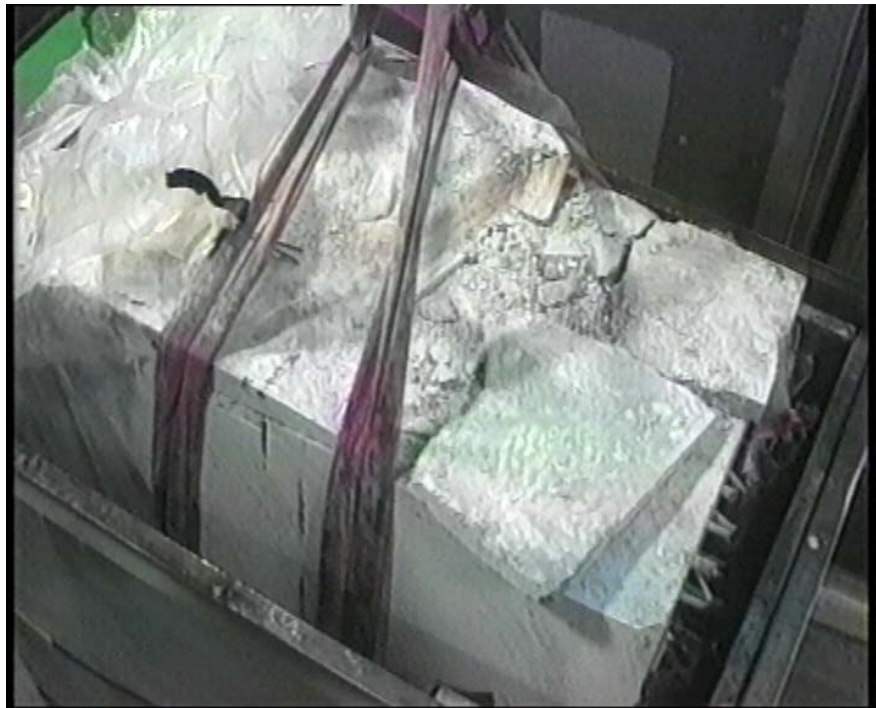
**Fig. 2. Unloading of the concrete block from the shielding box**

The measurements were also used to estimate the intervention time for the staff as well as for the identification of the positions with the lowest dose rates to guide the workers who had to attach the lifting tackles. Then the block was lifted and placed on the workbench (See Figure 2).

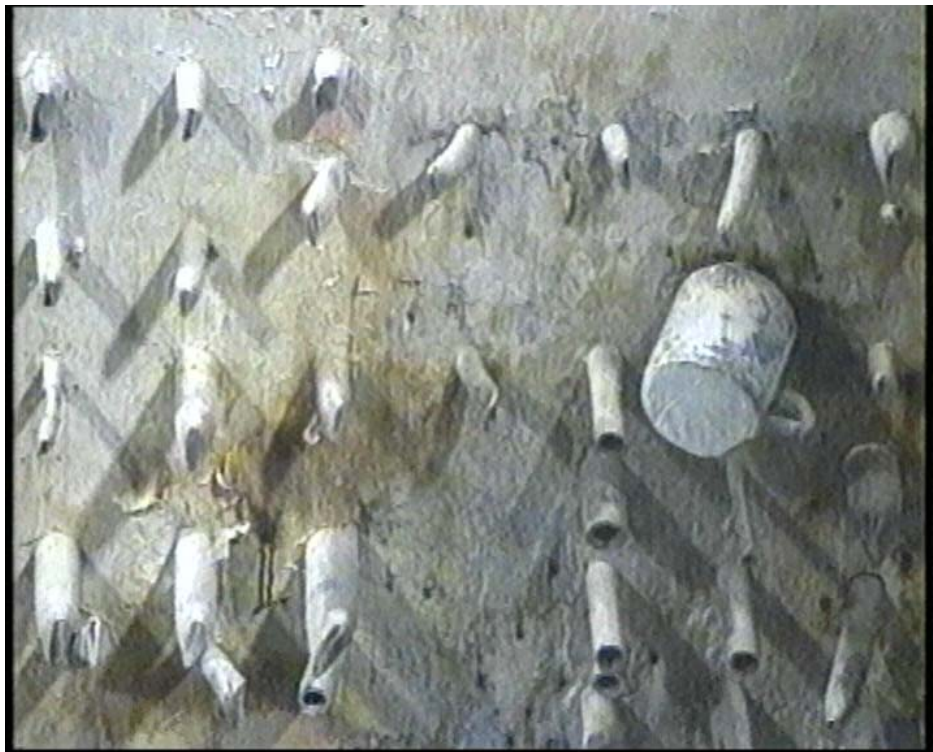
According to the information supplied by WAK, the ducts in the concrete blocks had been closed by welding on the outer side of the block (lower dose rate) and by squeezing on the inner side (high dose rate) to prevent contamination spreading. When taking the block out of the box, however, it was found that only some of the ducts were closed on the inner side. In the area of the increased dose rate, the ducts were completely open. In one case, a type of lead beaker had been put over the duct for additional shielding (See Figure 3).

**Fig. 3. Partly open ducts with additional shielding**

Prior to the remote treatment of the concrete blocks one had to establish appropriate technical conditions, especially for the surface treatment as well as for the collection of the removed material and dust produced. Some aggravating circumstances came in addition, e.g. the tubes penetrating the block jut out approx. 15 cm from the surface that had to be treated; furthermore, the distance between the tubes (see Figure 3) was rather short allowing only the use of small machines and tools.

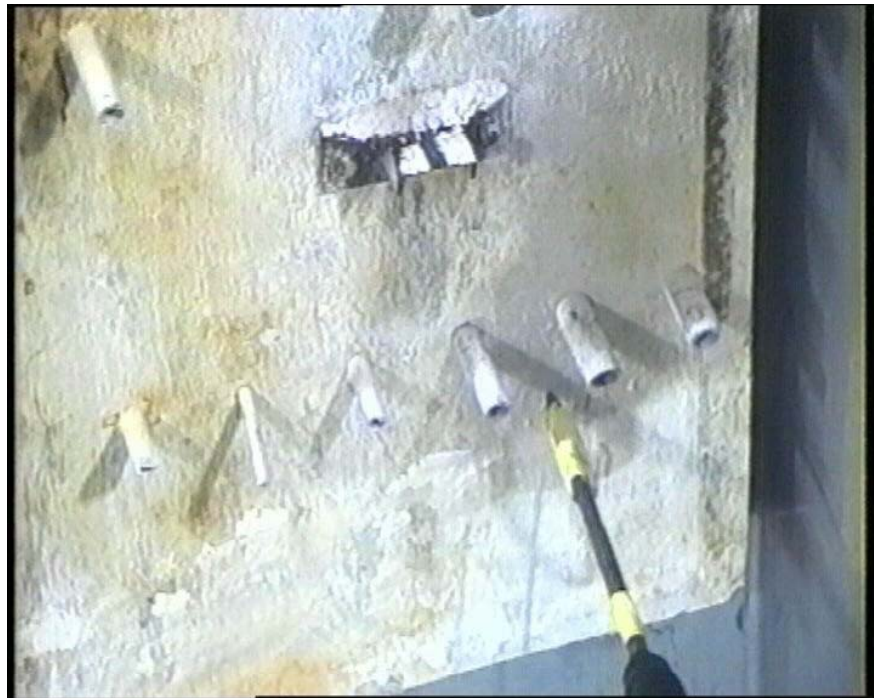
Also in this case, the information supplied by WAK in advance was that the ducts had been closed by squeezing on the side of the high dose rate. This, however, did not correspond to reality, as all ducts were open and did not reveal any trace of squeezing (See Figure 4).

**Fig. 4. Open ends of the ducts in the concrete block C 3.2**

The epoxy resin layer on the inner side of the block could be removed easily by means of the loosening chisel. The areas of increased dose rate were found to be located outside of the dark discoloration. Upon the removal of the first concrete layers, the dose rate was found to be reduced to a maximum value of 15 mSv/h. By this first treatment step, the target dose rate of < 5 mSv/h was reached for about 75% of the block surface. After a second treatment of the block surface, the dose rate was found to have increased to a maximum value of 18 mSv/h, as in case of the block C 3.1. By a further removal of the surface, the dose rate was reduced to a value of < 5 mSv/h. Further treatment of the block C 3.2 by a wire saw to reduce the size was not necessary, as the dimensions of the block were smaller than declared by WAK. The block fitted well into a Konrad container without further cutting being required.
