MONITORING WELL REHABILITATION AT THE DEPARTMENT OF ENERGY PADUCAH GASEOUS DIFFUSION PLANT PADUCAH, KENTUCKY

T. L. Brindley, J. J. Tarantino CDM Federal Programs 325 Kentucky Ave., Kevil, Kentucky 42053

This paper will discuss details about how the Blended Chemical Heat Treatment (BCHTTM) process was used for rehabilitation of 89 wells at the Department of Energy Paducah Gaseous Diffusion Plant (PGDP) at Paducah, Kentucky. A summary will be provided of the various types of problems observed in the wells and the benefits resulting from performing the BCHTTM process

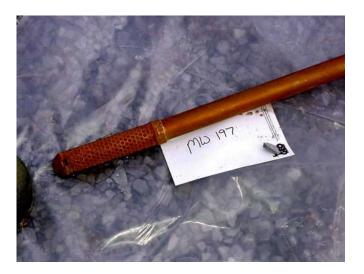
Fig. 2. MW300 tubing and screen

Eighty MWs underwent treatment with the BCHTTM process from September 2003 to January 2004. The project was completed with one rig called a "Stinger" (Fig 1). Figs 2 and 3 represent the condition of many of the well interior components prior to rehabilitation.

Biofouling has been shown to be a common problem threatening MWs at PGDP. To control biofouling and maintain sample quality and integrity, BCHTTM will be applied to 30 MWs each year. Depending on the severity of fouling and results from the maintenance monitoring program, BCHTTM will be applied as either preventive maintenance or full rehabilitation.

Full rehabilitation is conducted after severe biofouling and/or microbial plugging have occurred. This method combines conventional mechanical treatments (brushing, jetting, surging, and airlift pumping) with BCHTTM application. Although specific chemicals are recommended in this plan, chemical selection may be slightly modified based on the observed effectiveness of the chemicals during rehabilitation, and practical considerations relating to their application. It is anticipated that the total time for rehabilitating each well is four days. The rehabilitation time may increase if operational, effectiveness, or compatibility problems arise. Preventive maintenance applications are anticipated to take approximately one to two days.
